Contamination Screening Evaluation Report

Florida Department of Transportation
District 1

US 41 and Bonita Beach Road PD&E Study

February 2024

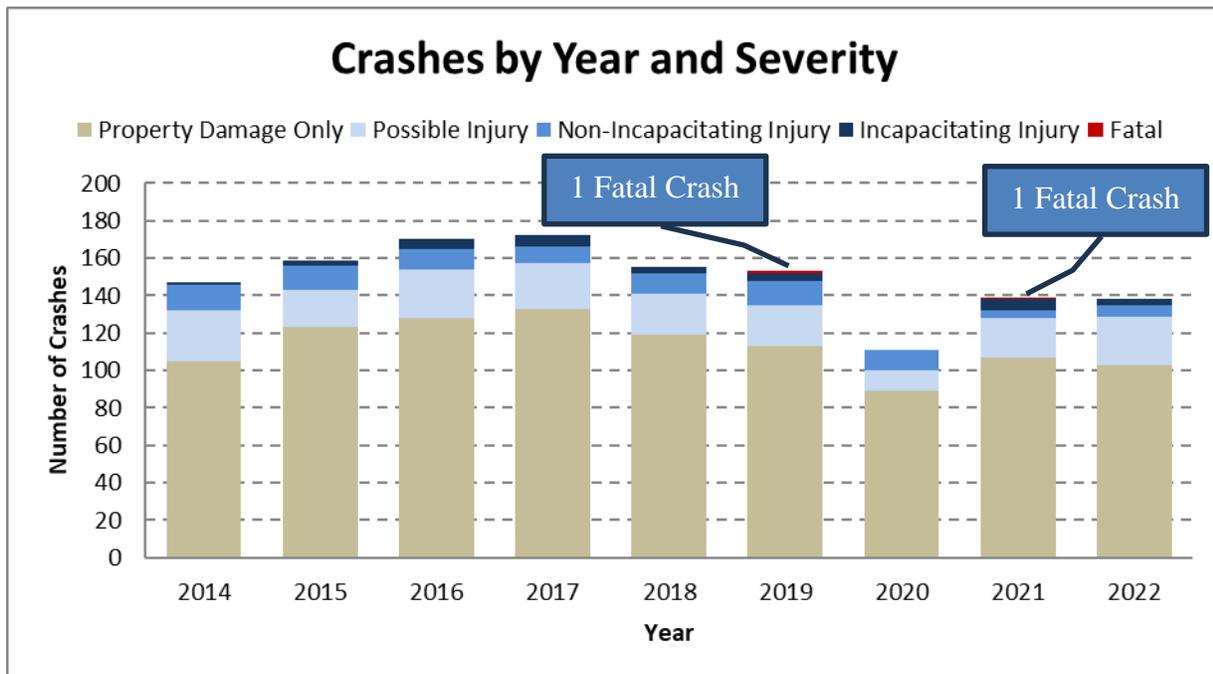
FIGURE 3: CRASHES PER YEAR (ENTIRE STUDY AREA)

Figure 3 displays a summary of crash frequency by year along with the respective severities from 2014 to 2022. There was an increase in crashes between 2014 and 2017, but there has been a decrease in crashes between 2017 and 2019 before an approximate 30 percent drop in crashes due to the COVID-19 pandemic in 2020. The number of crashes have stayed relatively constant in 2021 and 2022. There were 163 crashes per year on average between 2014 to 2017. However, there were 146 crashes per year on average in the study area between 2018 to 2022, not including 2020 (a 10 percent decrease). The fatal crash in 2019 involved a vehicle striking a pedestrian on US 41 just south of Bonita Beach Road, and the fatal crash in 2021 involved an angle crash at the intersection of US 41 at Foley Road/Shanna Lane.

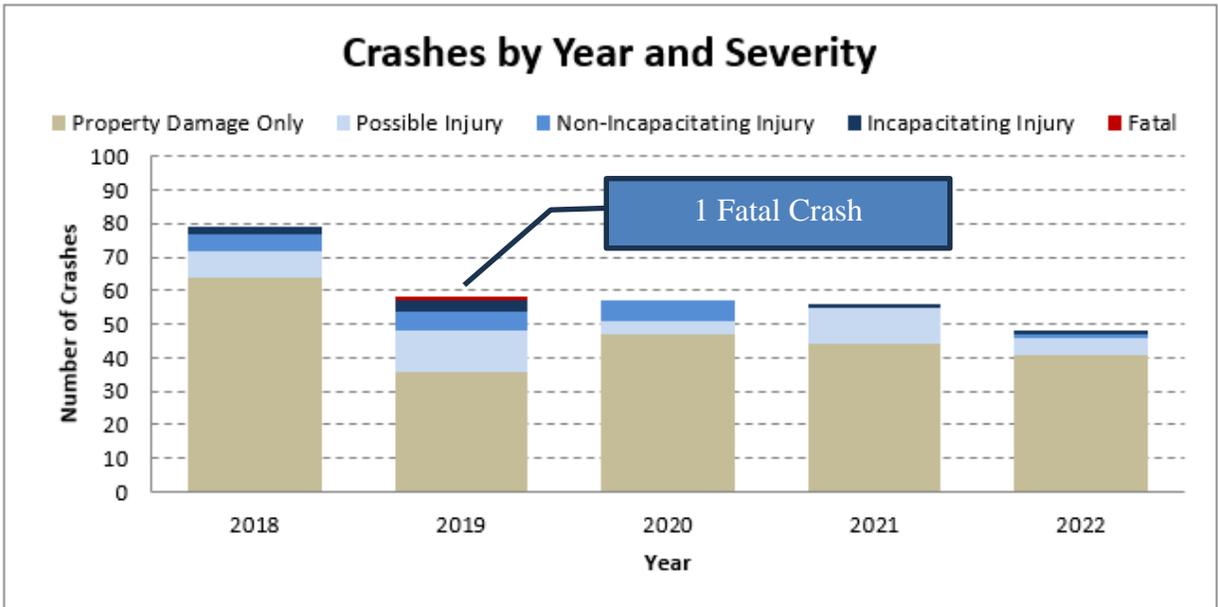
FIGURE 4: CRASHES PER YEAR (US 41 AND BONITA BEACH ROAD INTERSECTION)

Forty three percent of the total study area crashes were located within the intersection influence area of US 41 and Bonita Beach Road. **Figure 4** displays a summary of crash frequency by year along with the respective severities from 2018 to 2022. There was a total of 298 reported crashes during this period, 65 injury crashes (22 percent), and one fatal crash (in 2019). As displayed in **Figure 4**, there were an average of 60 crashes per year at the intersection.

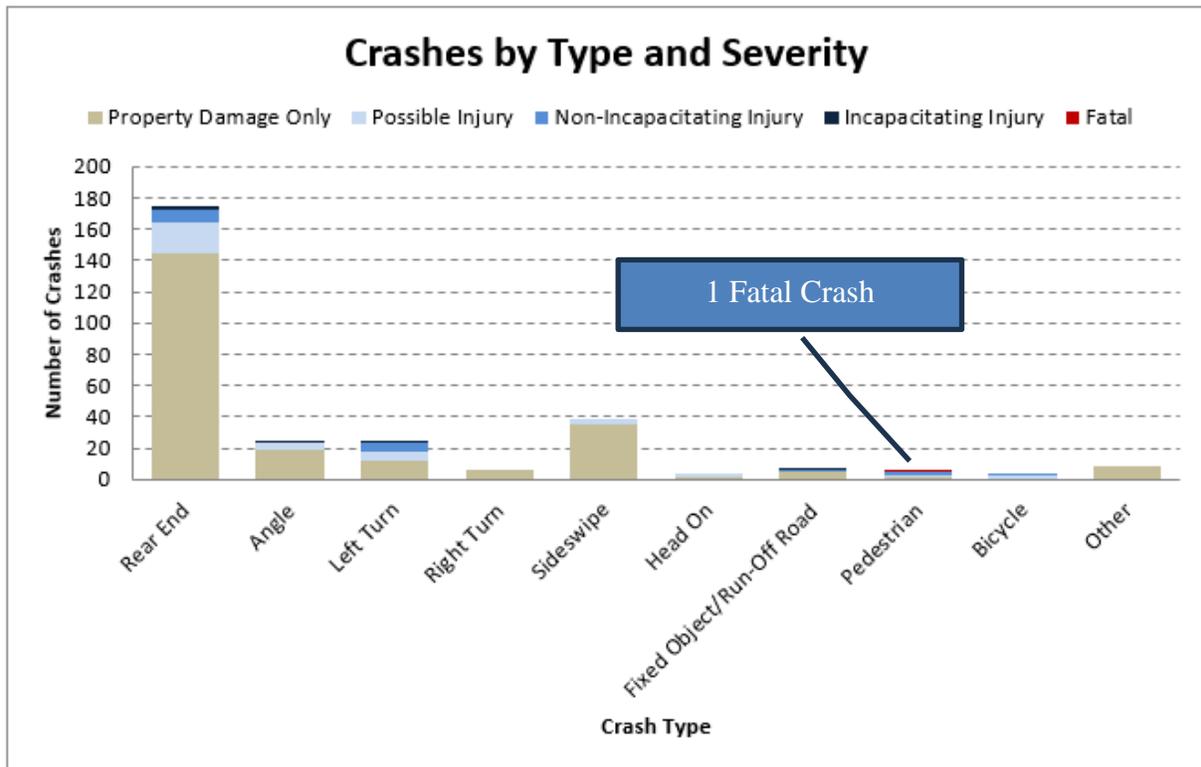
FIGURE 5: CRASHES BY TYPE AND SEVERITY (US 41 AND BONITA BEACH ROAD INTERSECTION: 2018 TO 2022)

Figure 5 displays the crashes at the intersection by type and severity for the five-year study period. The highest crash type observed was rear end, comprising 59 percent of the total crashes. Sideswipe crashes (13 percent) and left turn (8 percent) were the second and third highest crash types. These trends are consistent with the overall study area. The fatal crash in 2019 occurred when a vehicle struck a pedestrian crossing US 41.

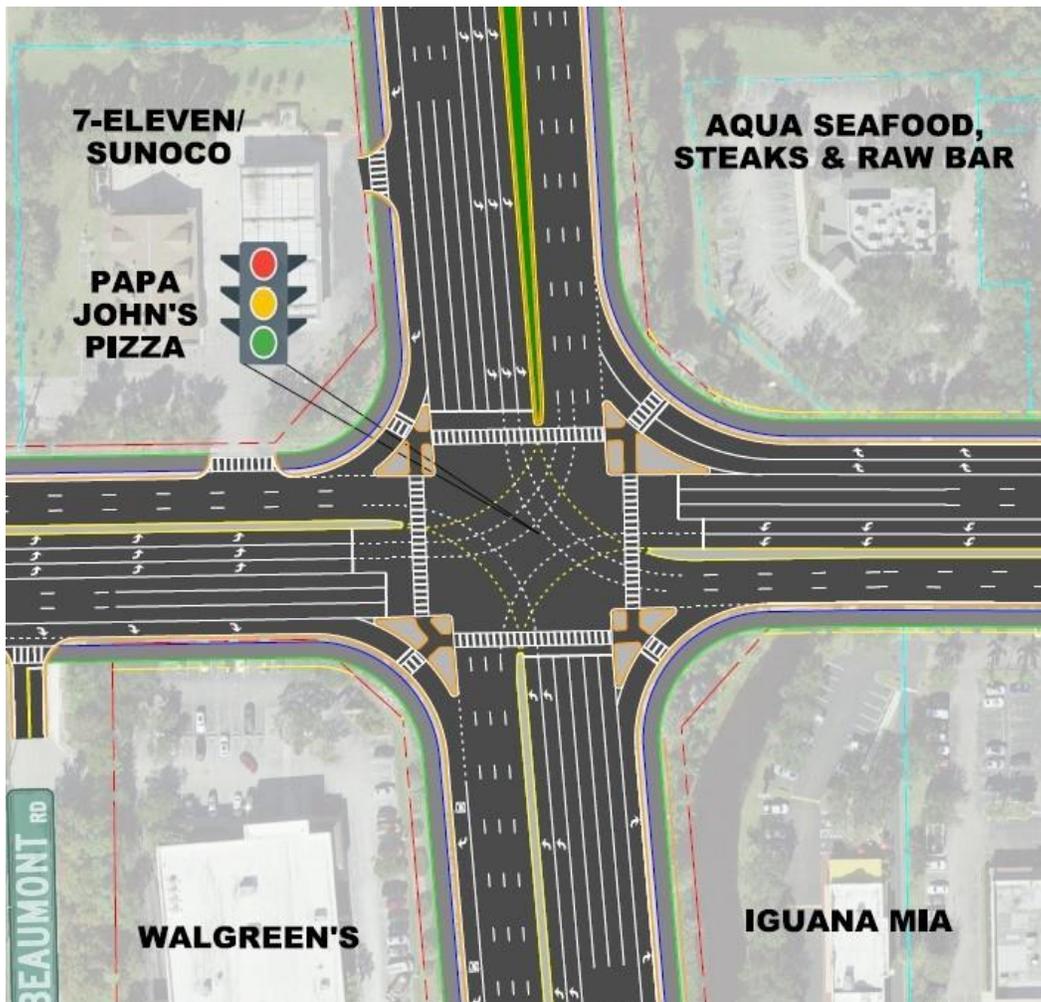
FIGURE 6: ALTERNATIVE A – ENHANCED TRAFFIC SIGNAL

The intersection alternatives were developed using design provisions from the FDOT Design Manual (FDM). Each of the proposed intersection alternatives were applied along US 41 from Sta. 221+19 to Sta. 271+81 and along Bonita Beach Road from Sta. 254+57 to Sta. 300+33.

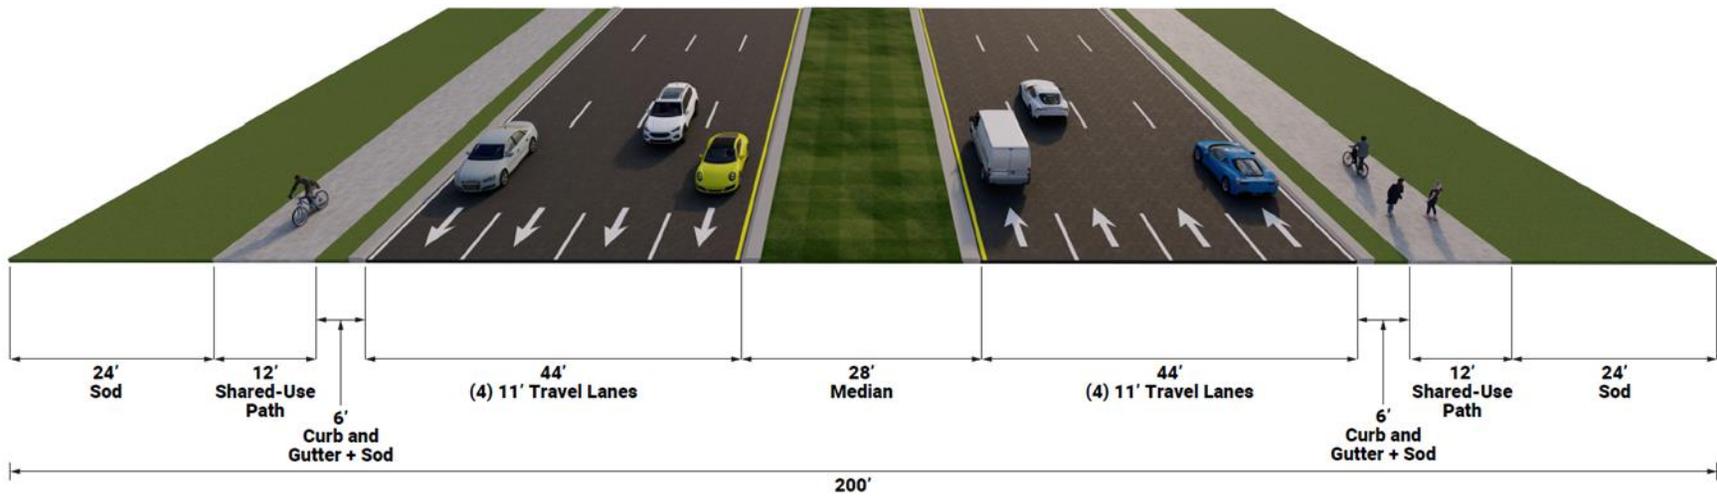
FIGURE 8: ALTERNATIVE A US 41 ROADWAY FEATURES

A graphic depiction of the roadway features for Alternative A is shown in **Figure 8** below.

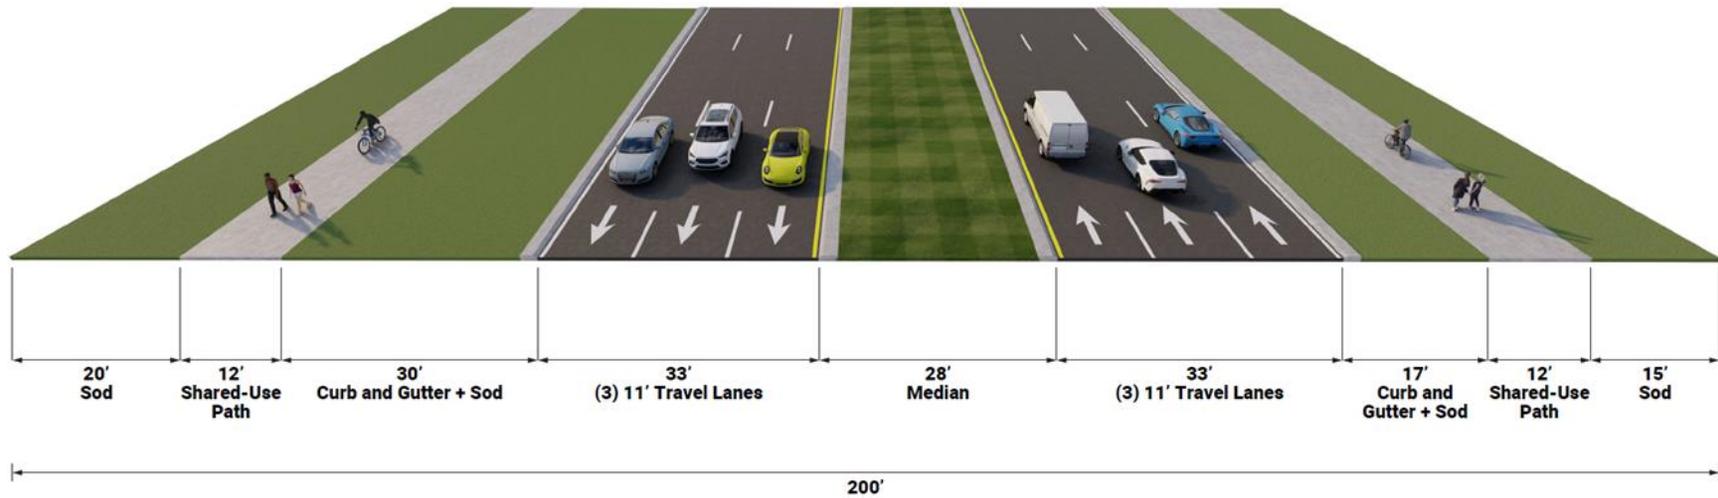
FIGURE 9: ALTERNATIVE B US 41 ROADWAY FEATURES

- In the southbound direction from just south of Access Road (Sta. 237+00) to Foley Road (Sta. 222+75).

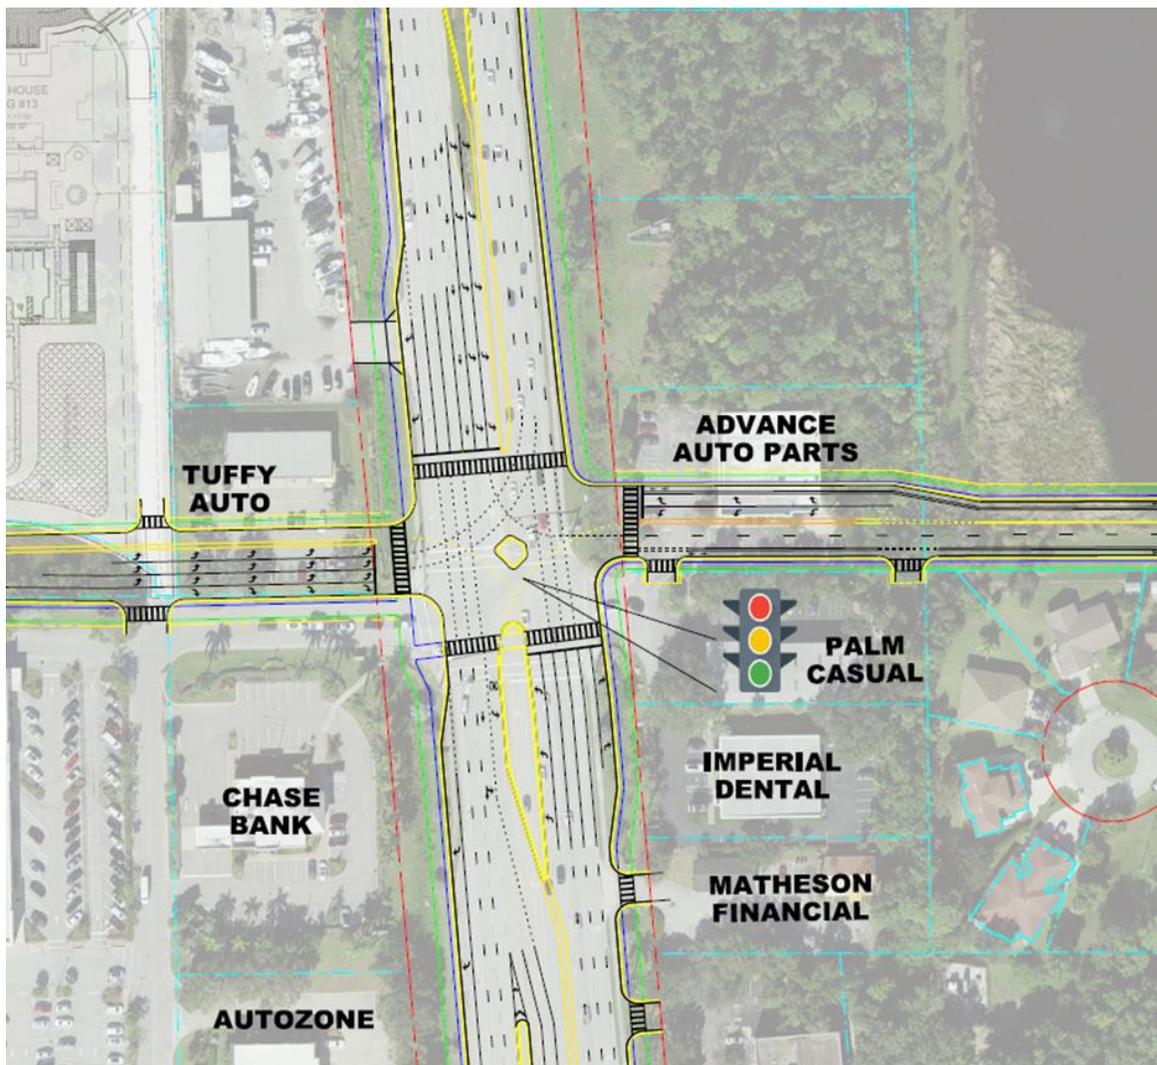
FIGURE 10: US 41/CENTER OF BONITA SPRINGS “THRU-CUT” INTERSECTION

- Signalization and turn lane improvements at the intersection of US 41 and Foley Road (Sta. 222+75).
- Modified “thru-cut” signalized intersection at US 41 and Center of Bonita Springs (Sta. 260+00) as shown in **Figure 10**:
 - A thru-cut intersection restricts through movements from the minor street typically due to operational and/or geometric conditions. In this case, the west leg is being widened from two lanes to five lanes (four eastbound approach lanes and one westbound receiving lane) and the east leg is being widened from two lanes to four lanes (two westbound approach lanes and two eastbound receiving lanes).
 - Dual southbound left turn lanes are also proposed in the new thru-cut configuration.

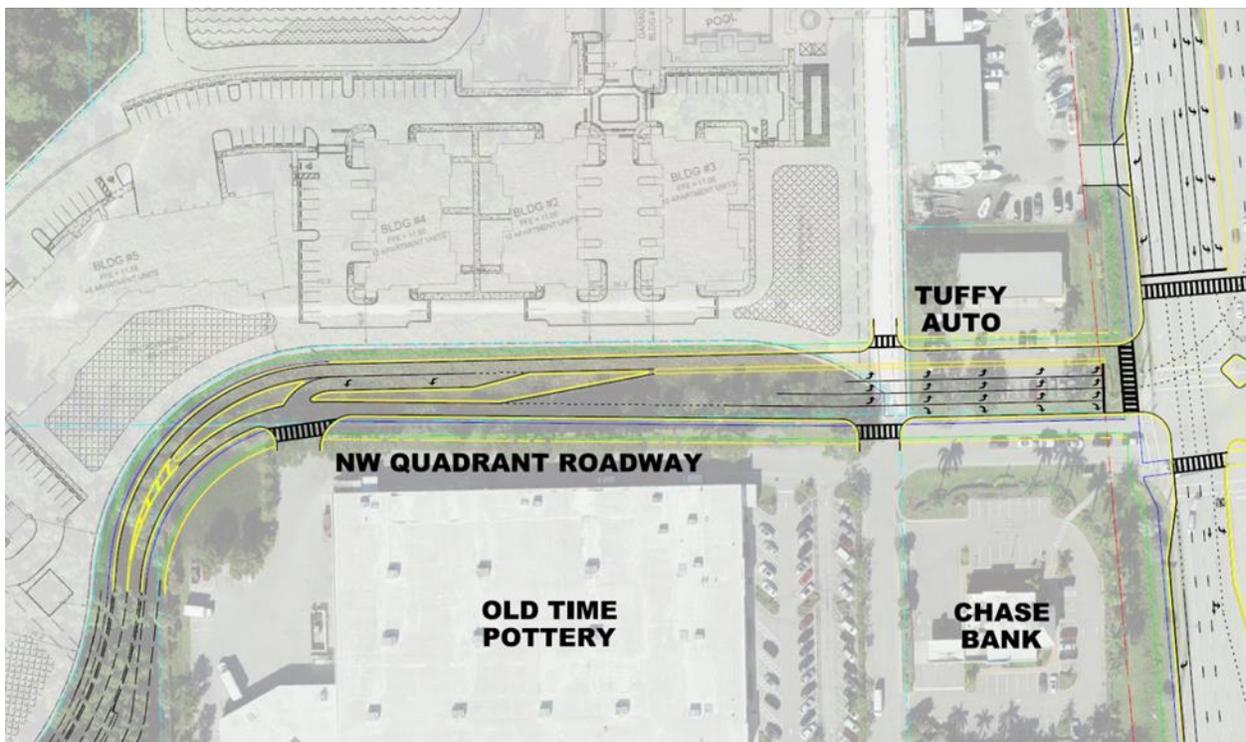
FIGURE 12: NORTHWEST QUADRANT ROADWAY – WEST LEG AT US 41

The design concept for the City’s Northwest Quadrant Roadway ties in at the existing US 41/Center of Bonita Springs intersection and is not making any improvements to this intersection. In the future condition, this intersection will not have enough capacity to accommodate the forecasted traffic demand, necessitating additional turn lane improvements on the intersection’s west leg. As part of the preferred alternative, the Northwest Quadrant Roadway is being modified from the northwest corner of the Center of Bonita Springs Shopping Plaza to US 41. These changes are described below and shown in **Figure 12**:

- Roadway is widened to develop a center median with varying width.
- One 11' travel lane in each direction.
- 6' sidewalk on the north side of the roadway.
- 12' shared-use path on the south side of the roadway.
- New 11' westbound left turn lane into Center of Bonita Springs behind the Old Time Pottery building.
- West Leg at US 41 Intersection:
 - One 11' eastbound right turn lane.
 - Three 11' eastbound left turn lanes.
 - One 11' westbound receiving lane.

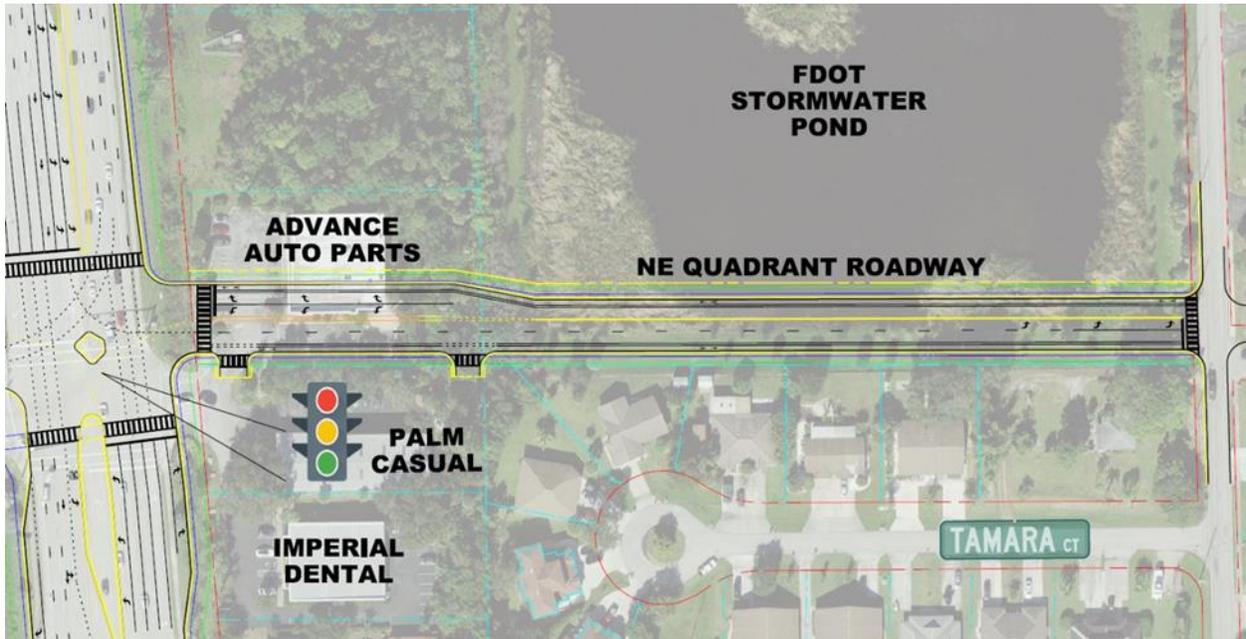
FIGURE 13: NORTHEAST QUADRANT ROADWAY – EAST LEG AT US 41

- Two 11' eastbound receiving lanes.

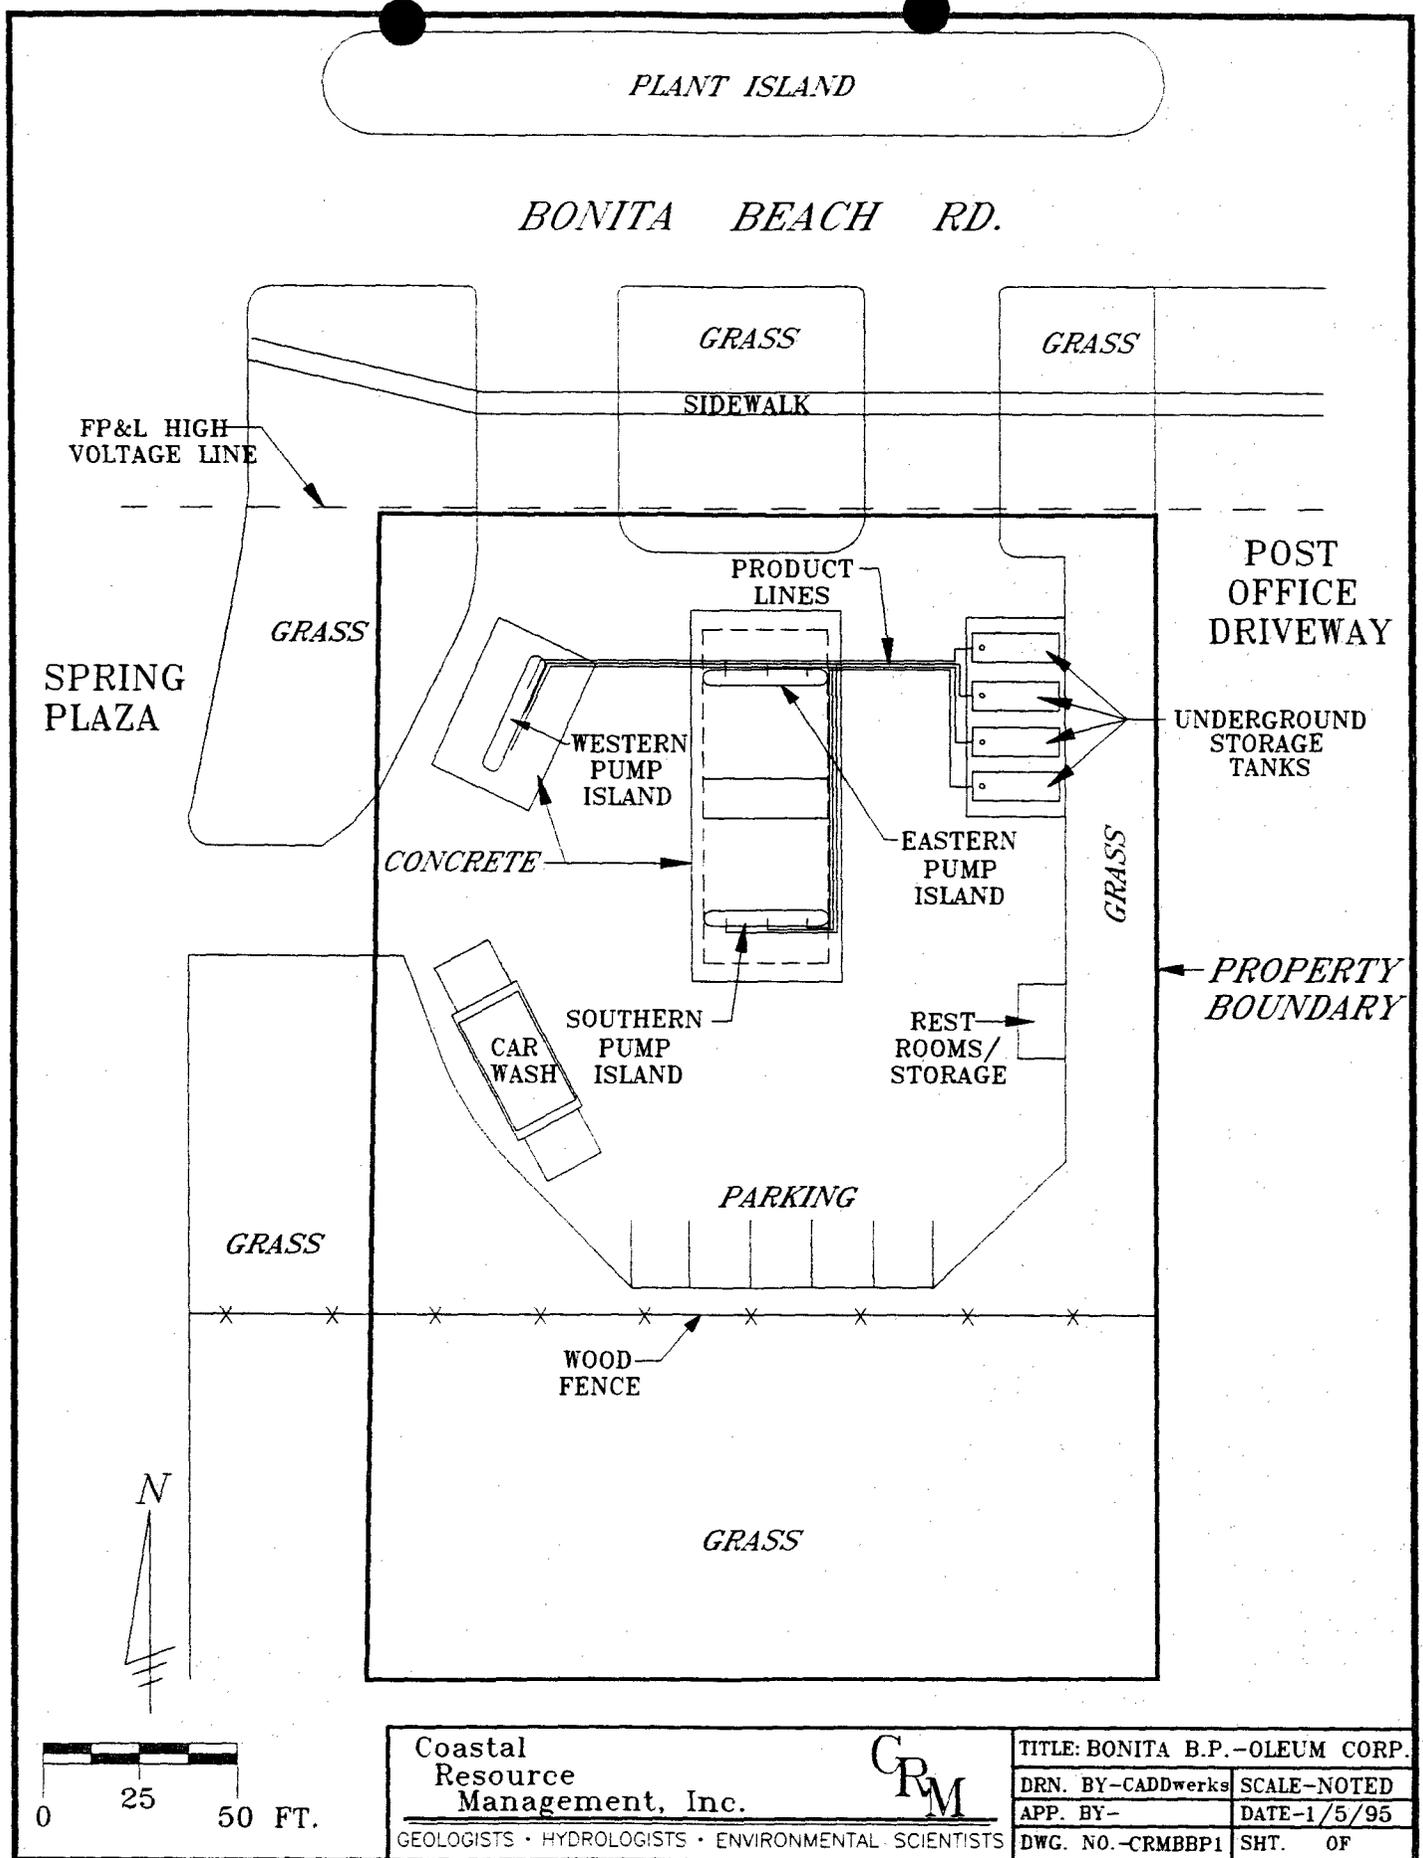
FIGURE 2. MAP SHOWING PERTINENT FEATURES, BONITA B.P., OLEUM CORP.

On November 9, 1994, WCM removed four (4) UST's from the Bonita B.P. facility. Three (3) of the UST's were reported to have been used to store gasoline and one (1) of the UST's was reported to have been used to store diesel fuel; all four (4) UST's had capacities of 10,000 gallons. The UST's were manufactured by Buffalo Tank and were

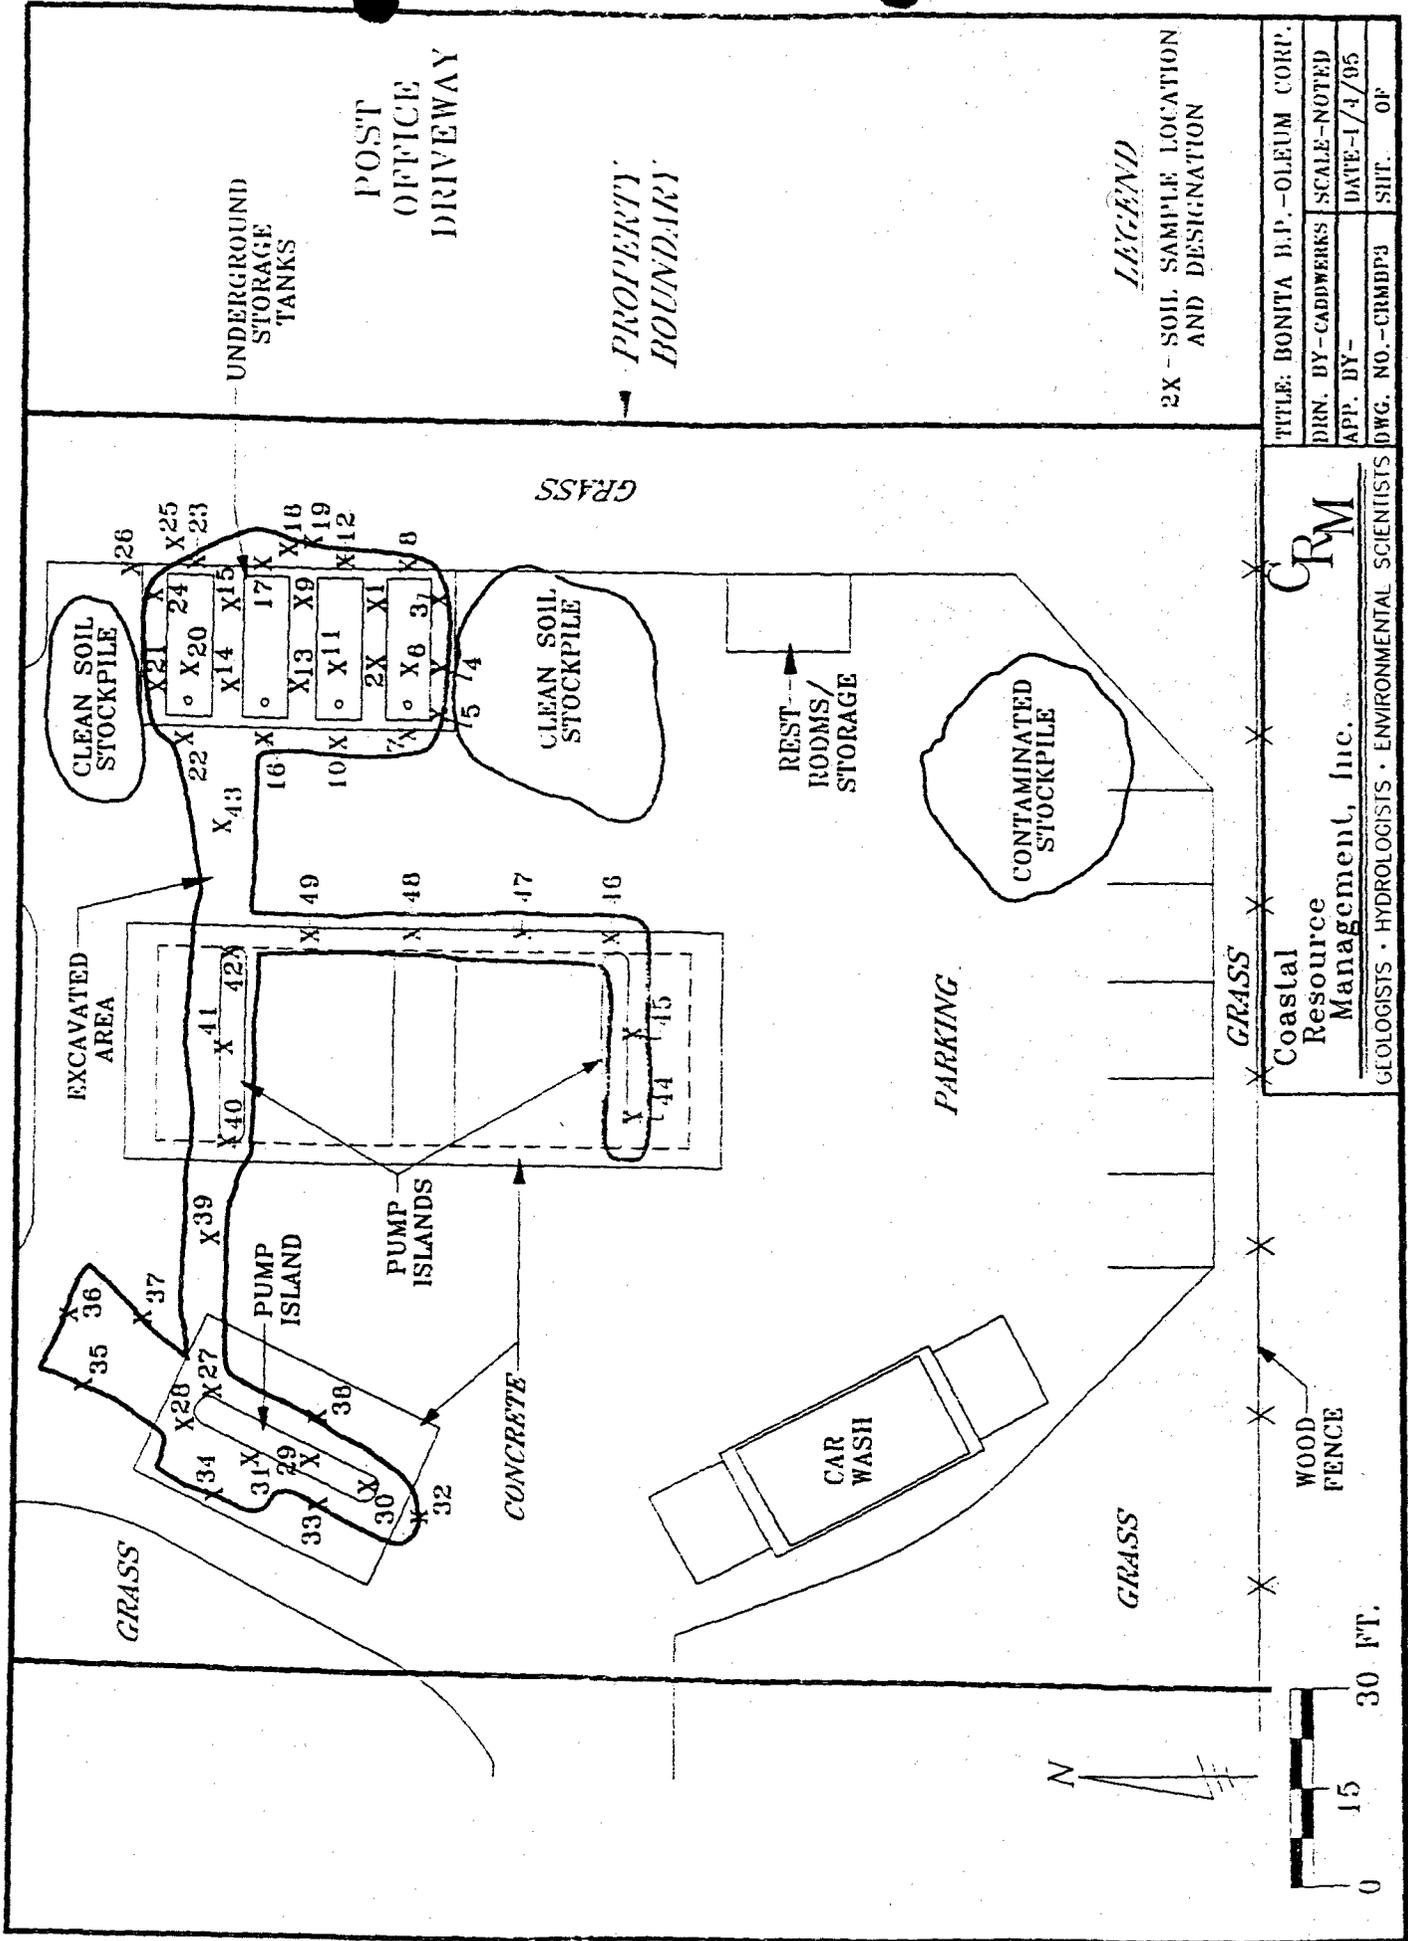
FIGURE 3. MAP SHOWING EXCAVATED AREA, SOIL STOCKPILES, AND SOIL SAMPLE LOCATIONS, BONITA B.P. - OLEUM CORP.

Site No.	Depth Below Grade (ft.)	OVA Readings (ppm)	OVA Reading with Carbon Filter	OVA Reading Adjusted
41	1.5	>1,000	110	>890
	2.5	>1,000	240	>760
42	1.5	>1,000	180	>820
	2.5	>1,000	220	>780
43	2.5	>1,000	120	>880
44	2	140	100	40
	4	80	58	22
45	1.5	180	180	0
	3	120	92	28
46	2.5	4	0	4
47	2.5	3	1	2
48	2.5	220	84	136
49	2.5	>1,000	420	>680
