# **Contamination Technical Memorandum**

Florida Department of Transportation  
District 1

US 41 and Bonita Beach Road PD&E Study

Lee County, Florida

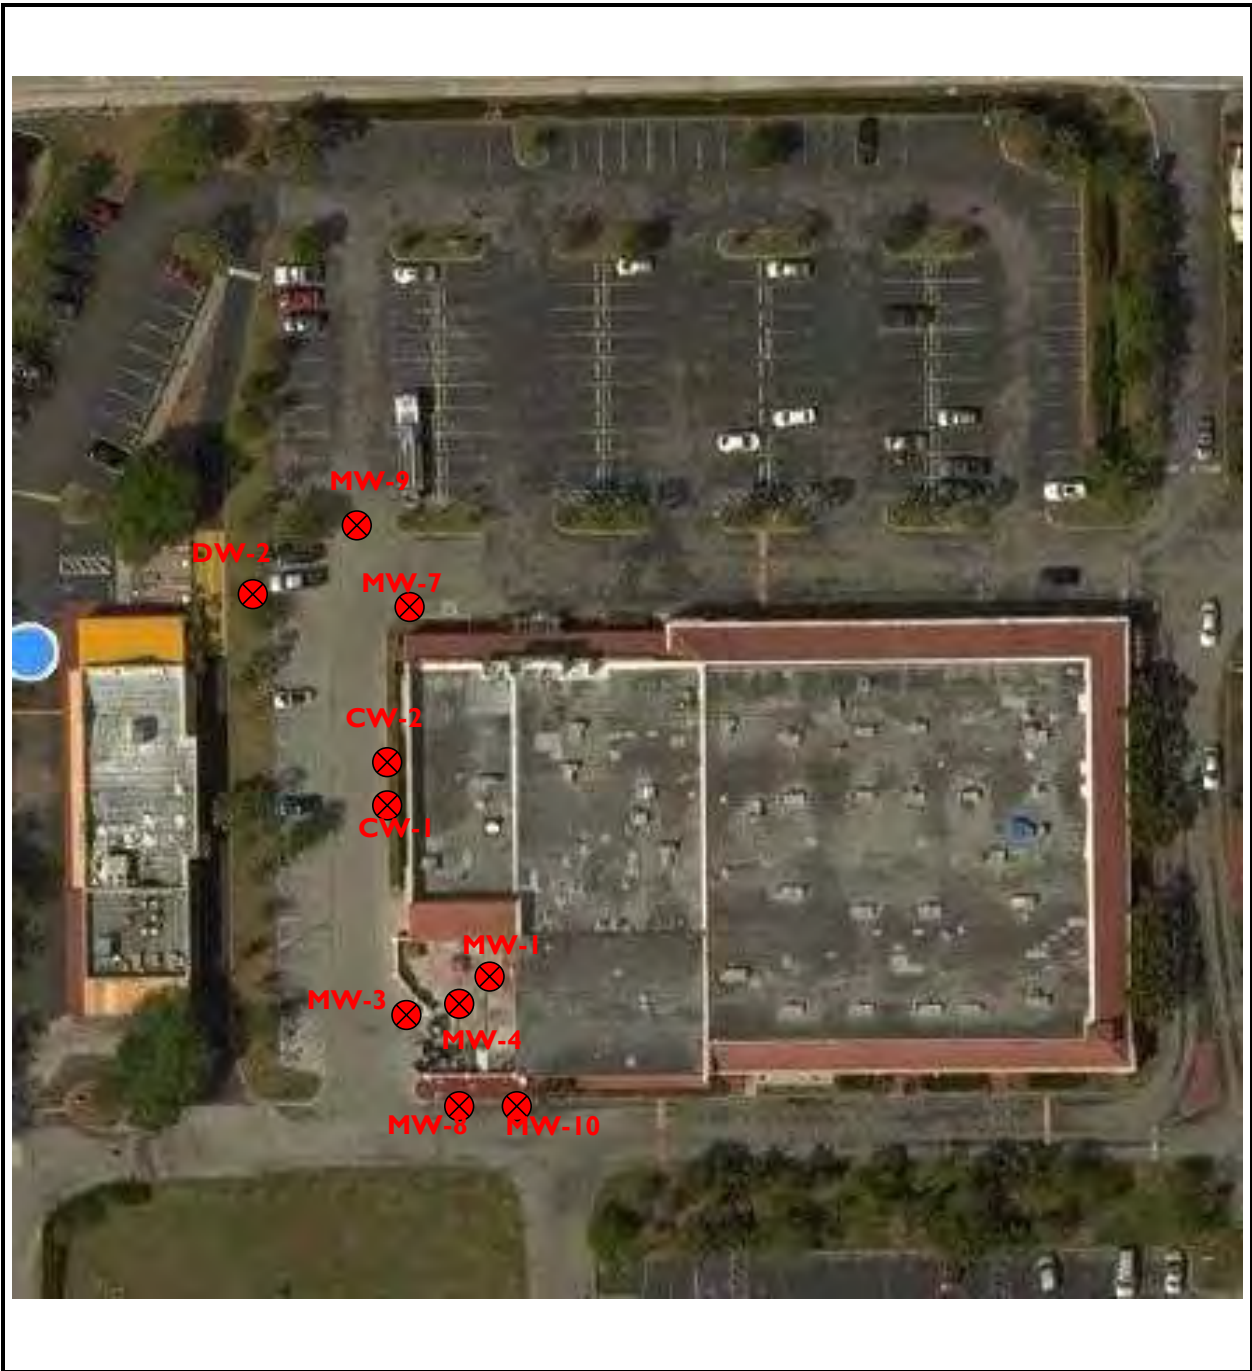
Monitoring Well Location Map
