DRAFT CONTAMINATION SCREENING EVALUATION REPORT

S.R. 70 PD&E Study

Limits of Project: From C.R. 721 S to C.R. 599/128th Avenue

Highlands and Okeechobee Counties, Florida

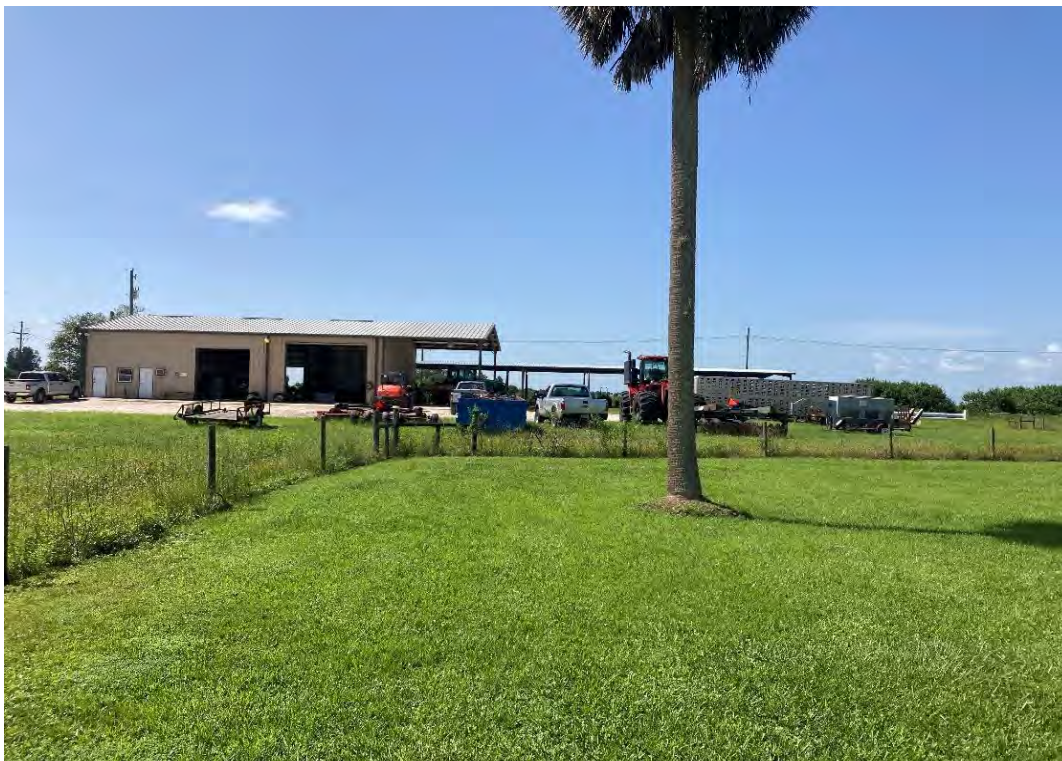
Low. Contamination may be present; however, there is no reason to believe there would be any involvement with the project.

View facing south of Lykes Bros Inc. Taken August 15th, 2023.

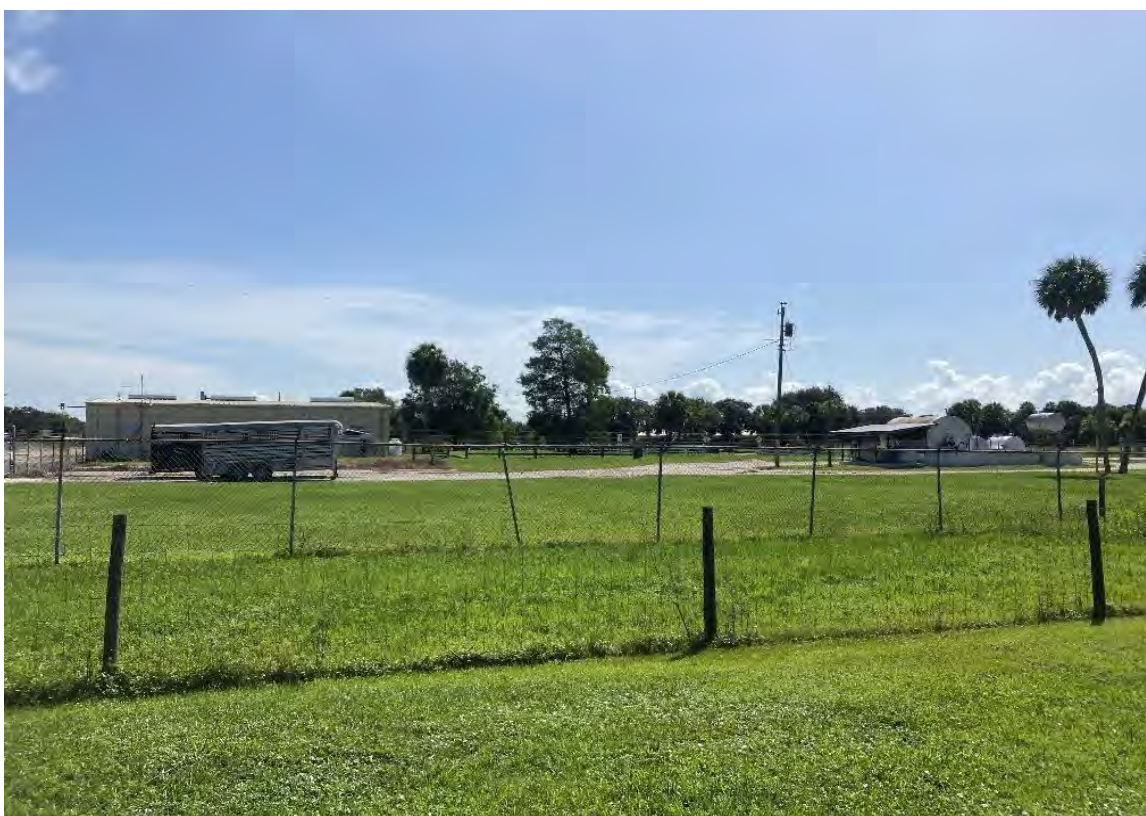
View facing southeast of Lykes Bros Inc. Taken August 15th, 2023.

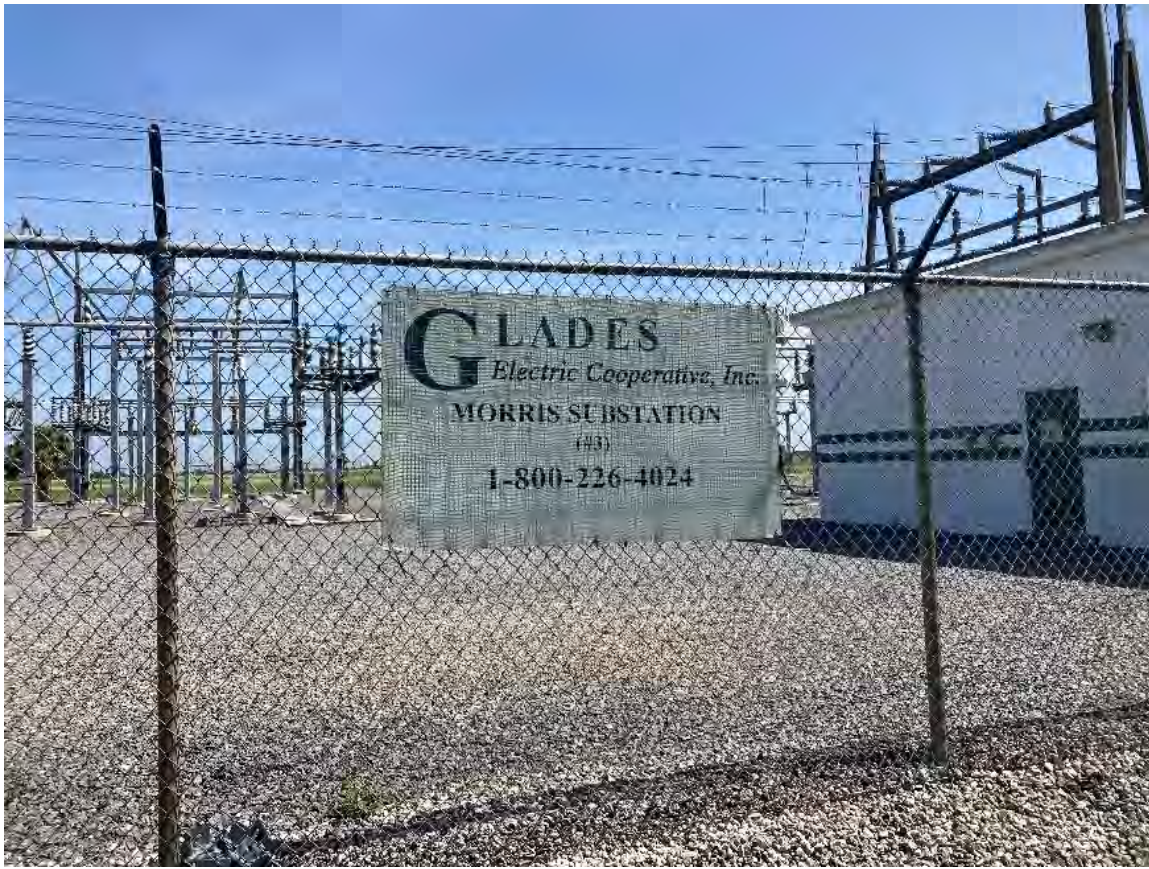
No. Impacts to construction from this site are not anticipated.

View facing north of Glades Electric Cooperative Ing Morris. Taken August 15th, 2023.

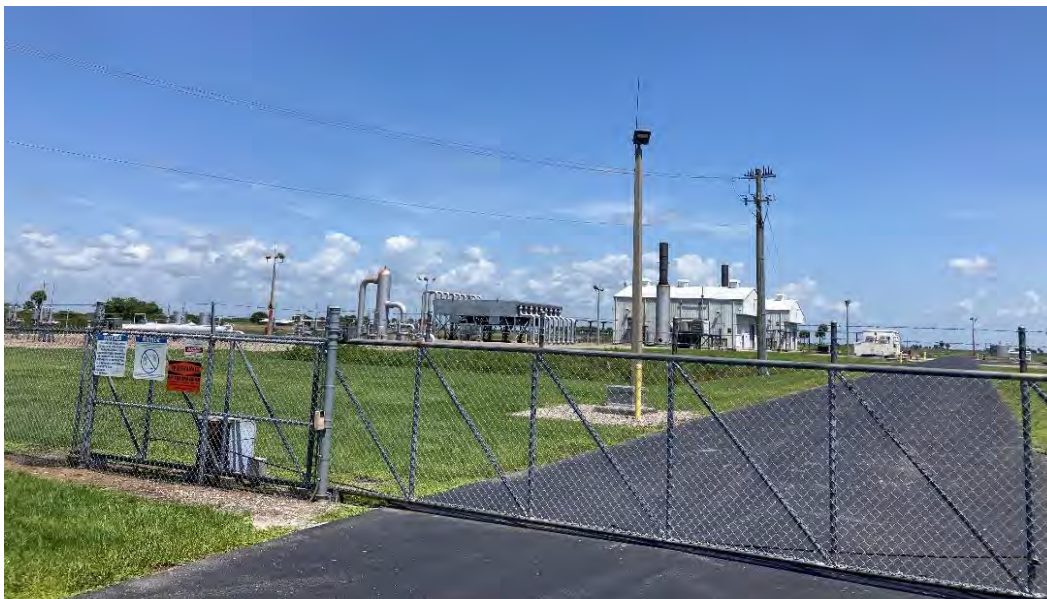
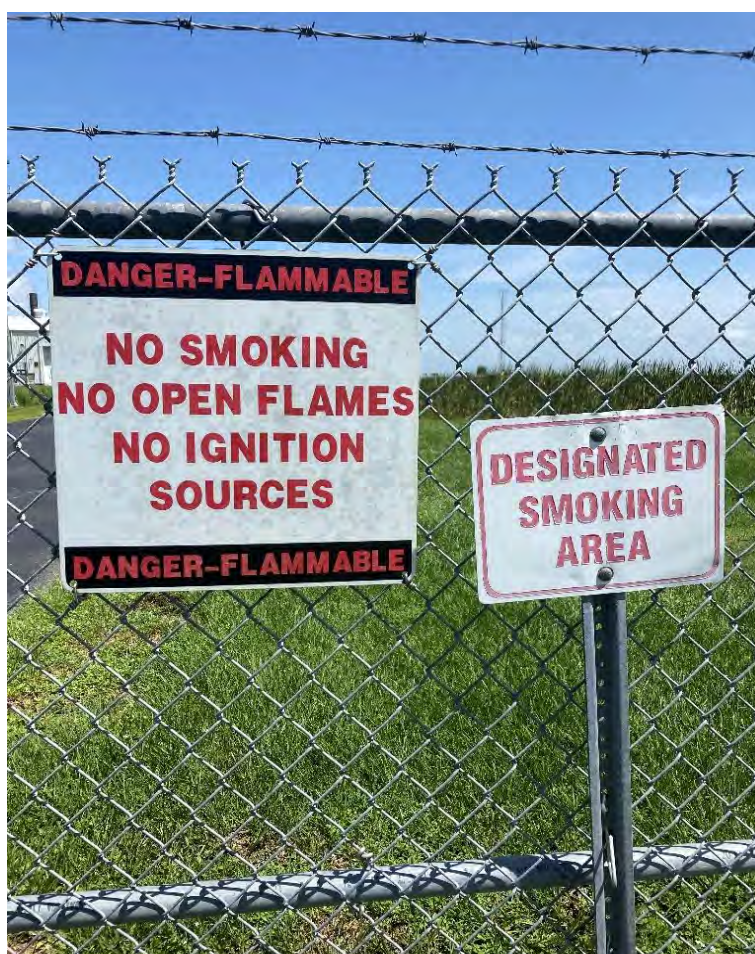
Low. Contamination may be present; however, there is no reason to believe there would be any involvement with the project.

View facing northwest of Florida Gas Transmission Company. Taken August 15th, 2023.

View facing north of Florida Gas Transmission Company. Taken August 15th, 2023.

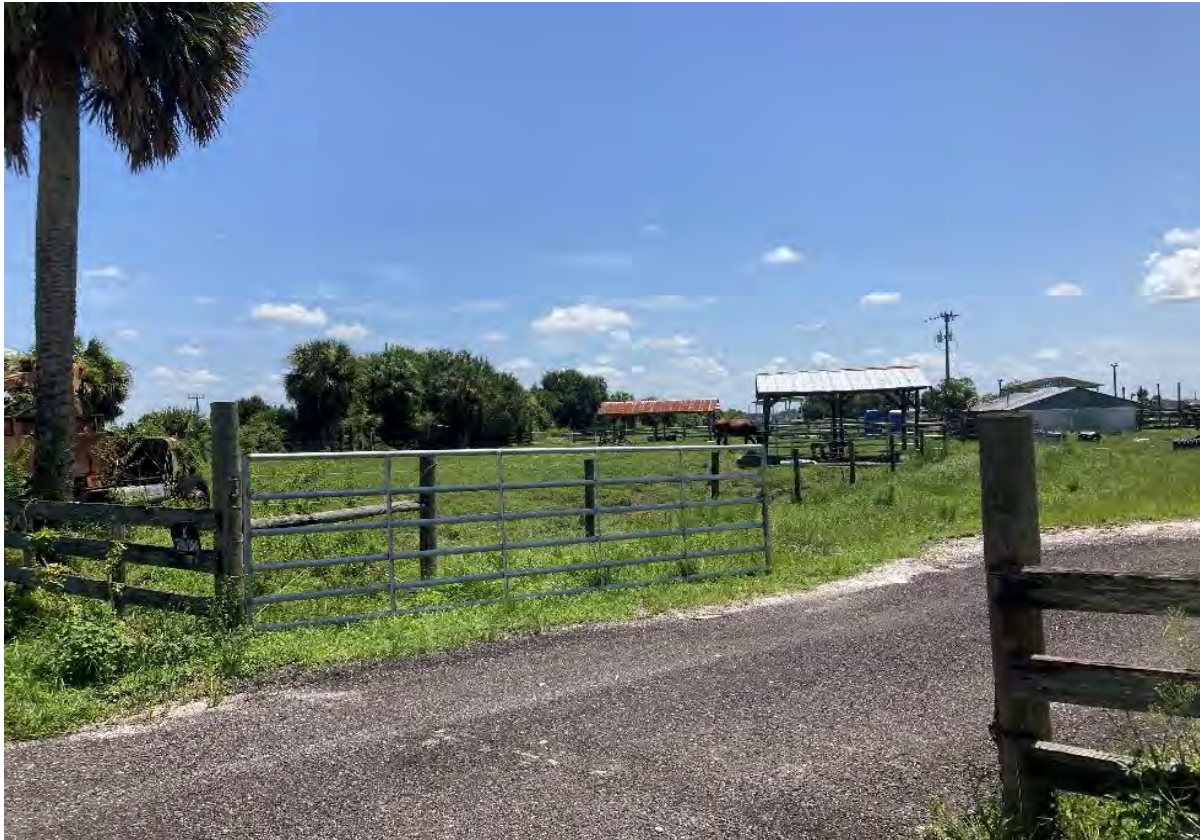
View facing southwest of Arrow B Ranch. Taken August 15th, 2023.

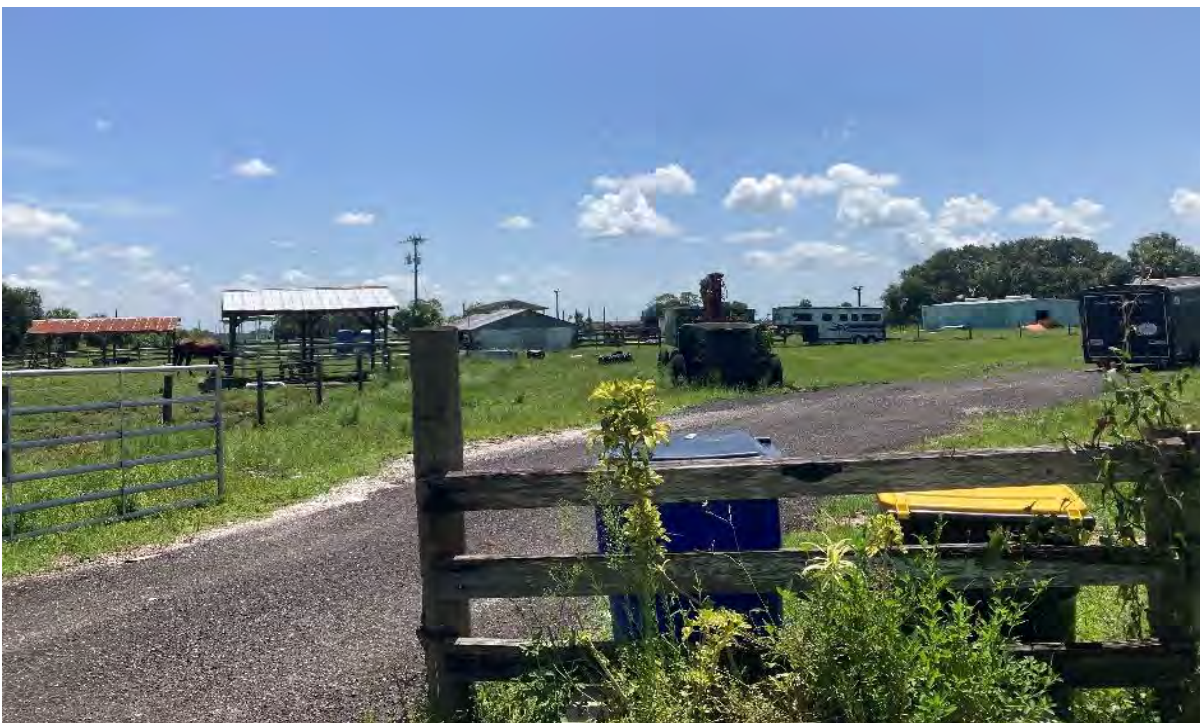
View facing south of Arrow B Ranch. Taken August 15th, 2023.

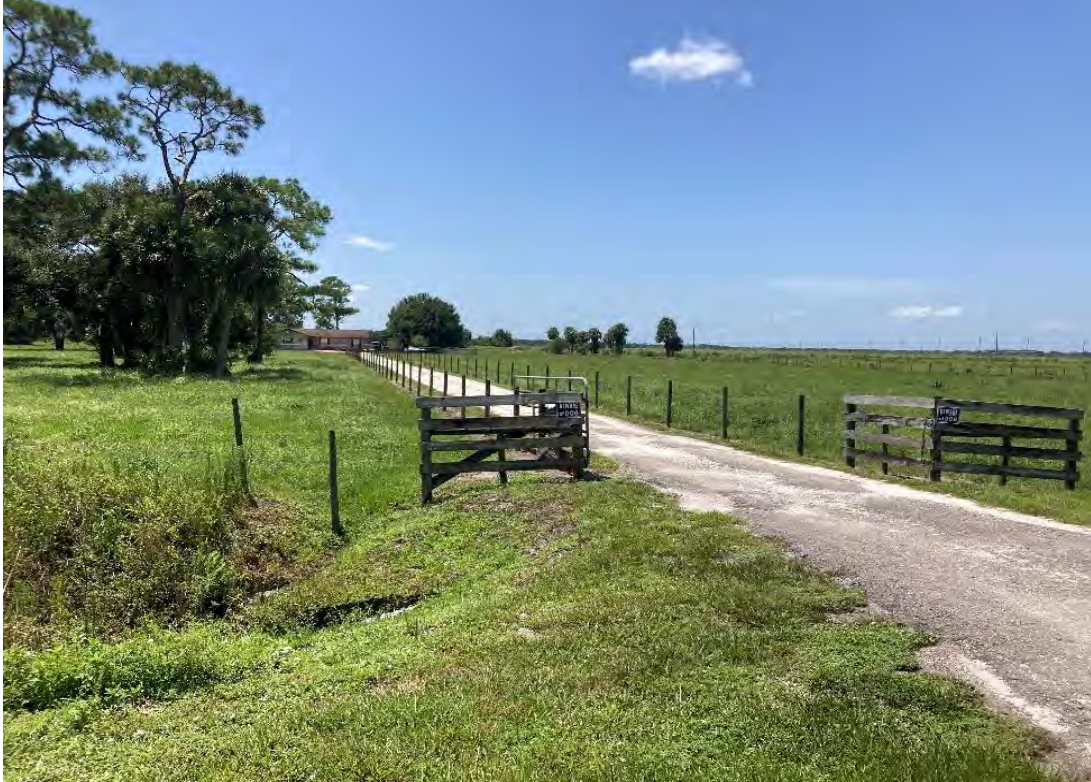
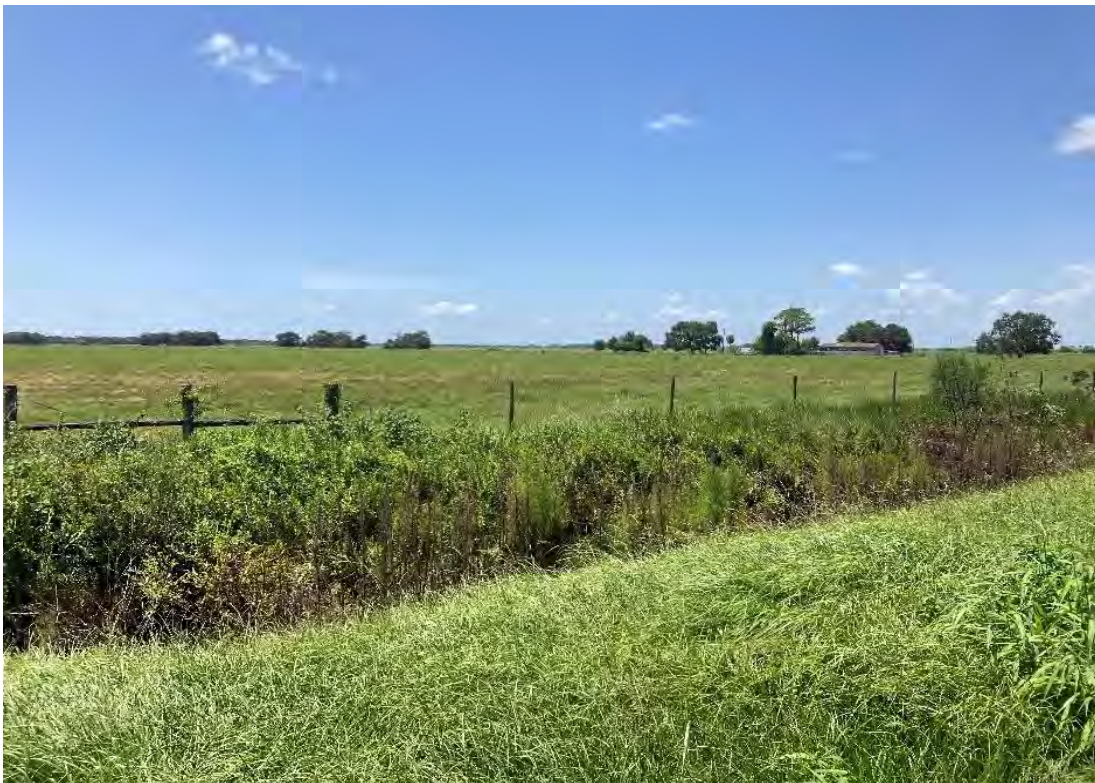
Low. Contamination may be present; however, there is no reason to believe there would be any involvement with the project.

View facing south of Circle G Ranch. Taken August 15th, 2023.

View facing southwest of Circle G Ranch. Taken August 15th, 2023.

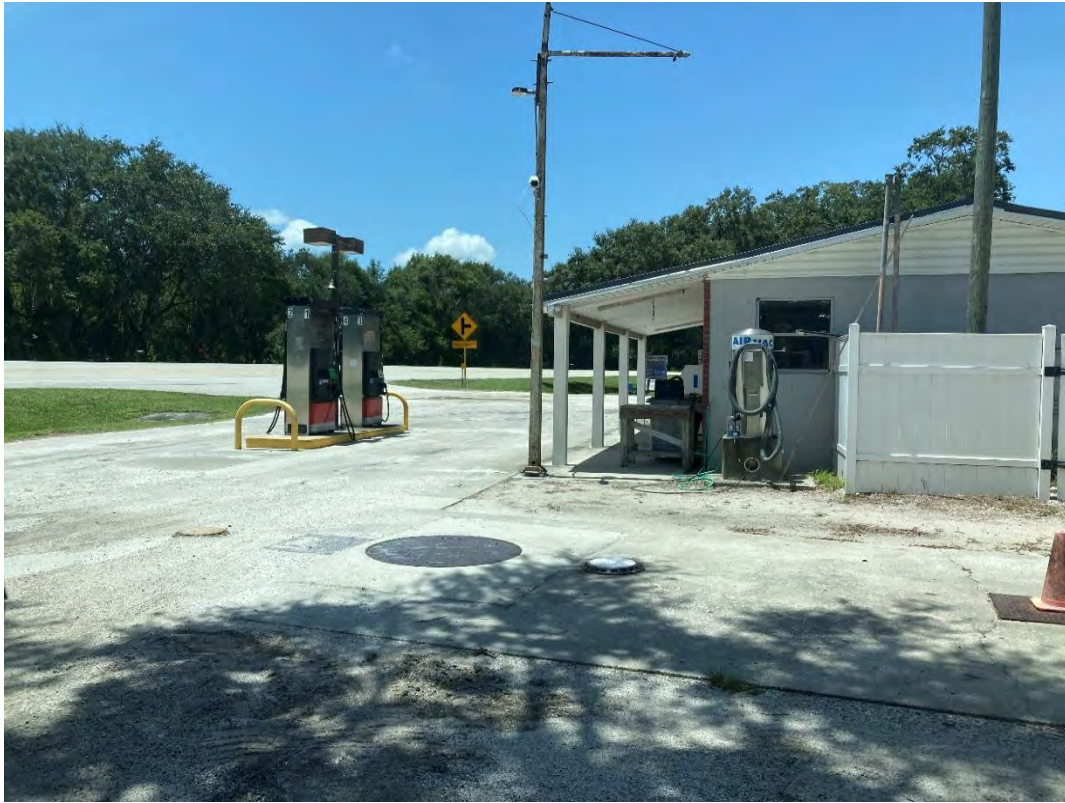
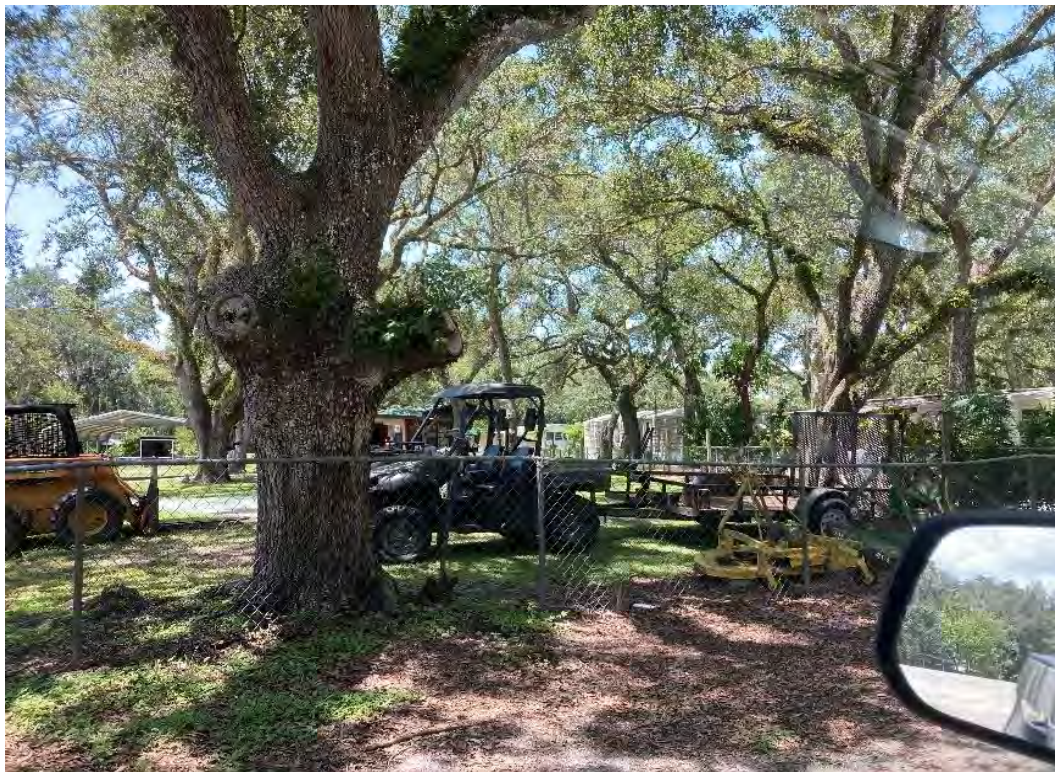
Medium. Contamination exists; however, required remediation is complete, is in progress, or is not necessary.

View facing north of Kissimmee River Fishing Resort. Taken August 15th, 2023.

View facing northeast of Kissimmee River Fishing Resort. Taken August 15th, 2023.

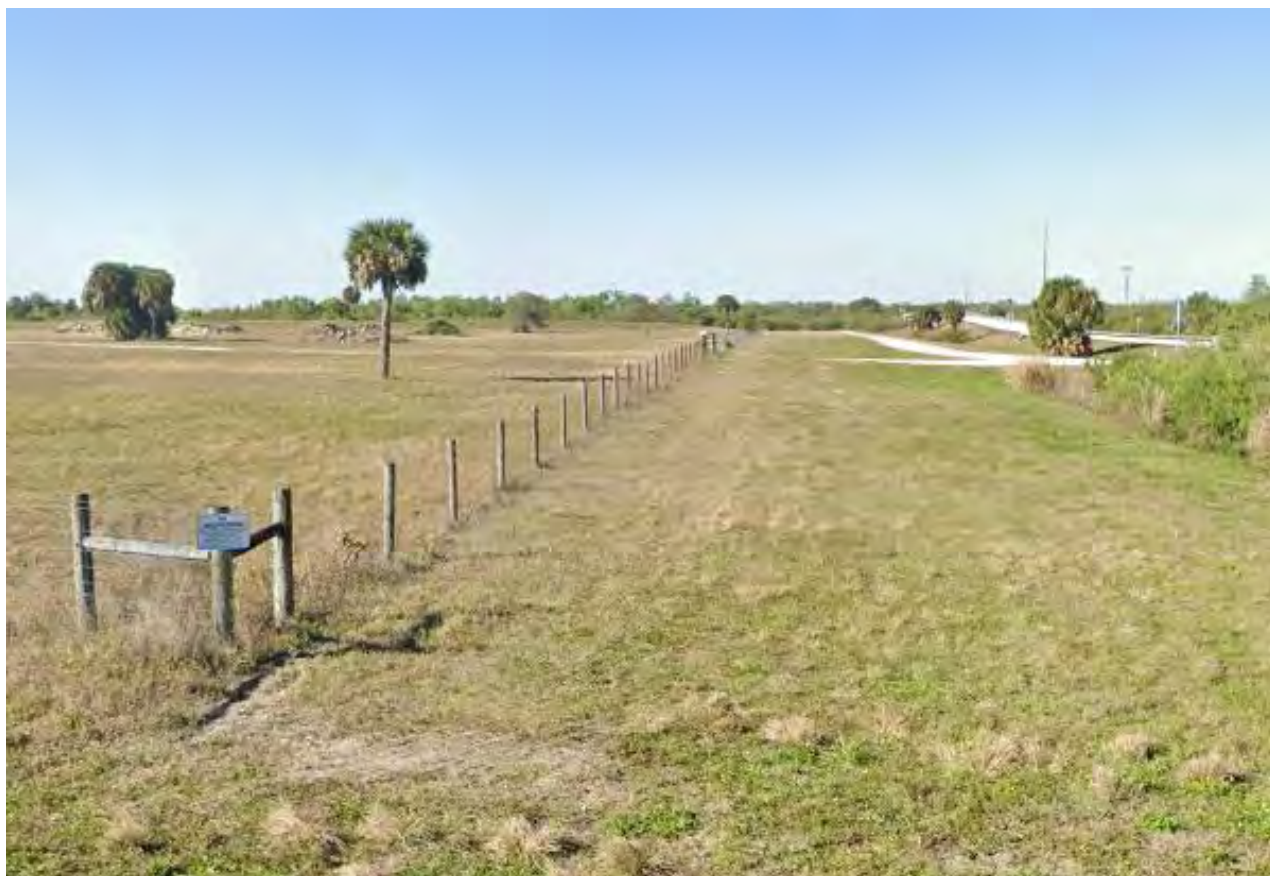
No. Impacts to construction from this site are not anticipated.

View facing west of intersection between Park St and SW 144th Pkwy.

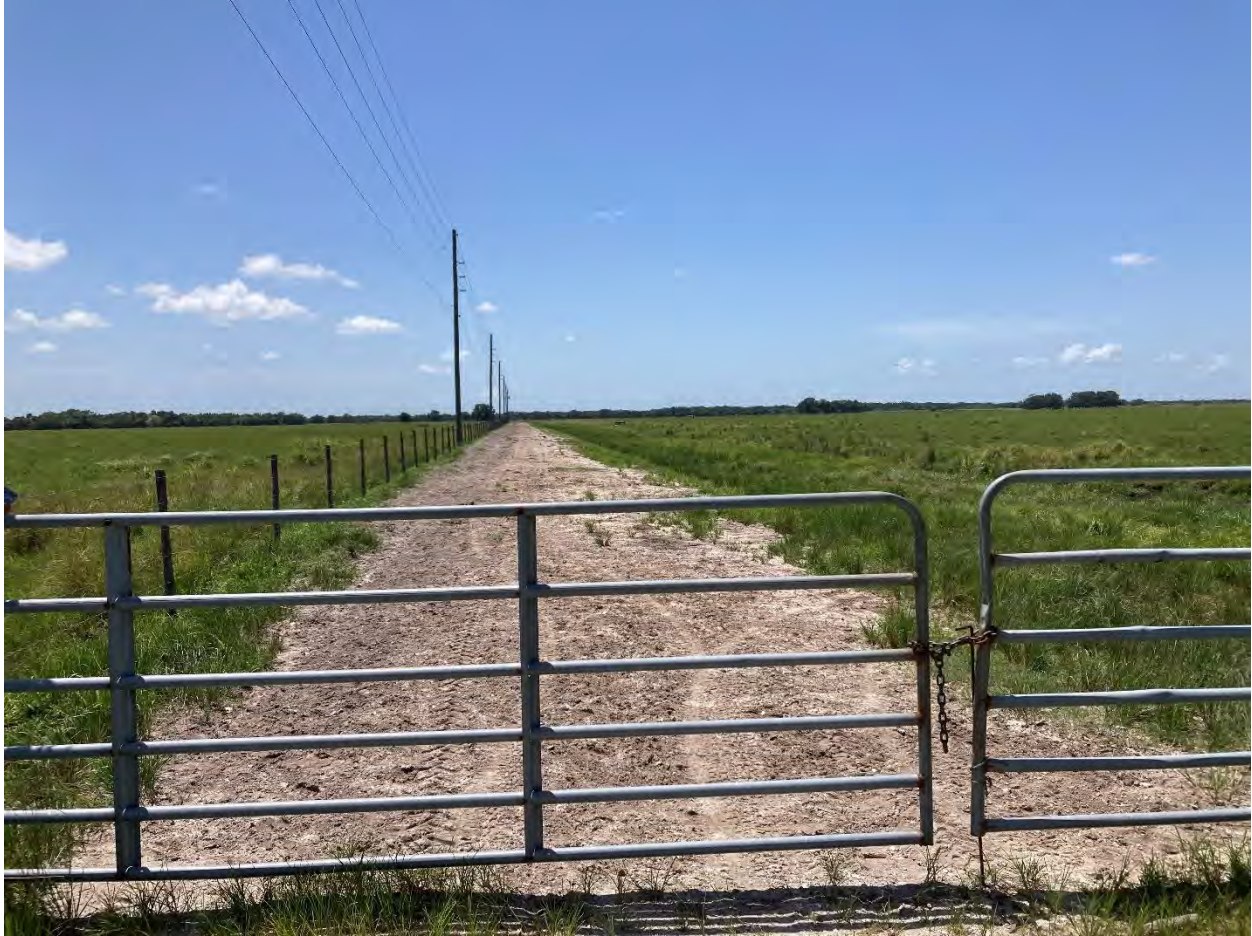
No. Impacts to construction from this site are not anticipated.

View facing north of Gloria Farms Inc. Taken August 15th, 2023.

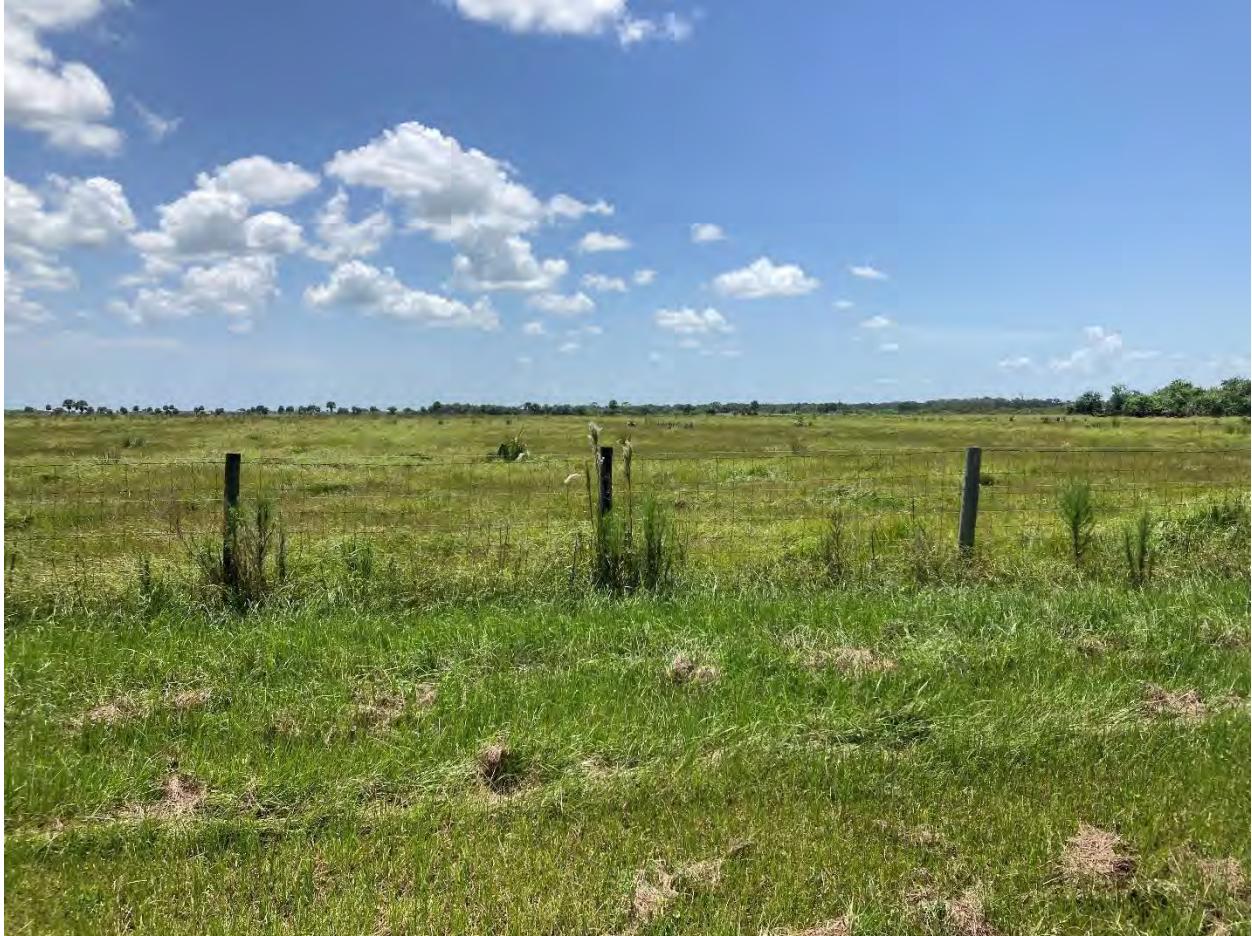
Medium. Contamination exists; however, required remediation is complete, is in progress, or is not necessary.

View facing south of Rio Rancho Corp. Taken August 15th, 2023.

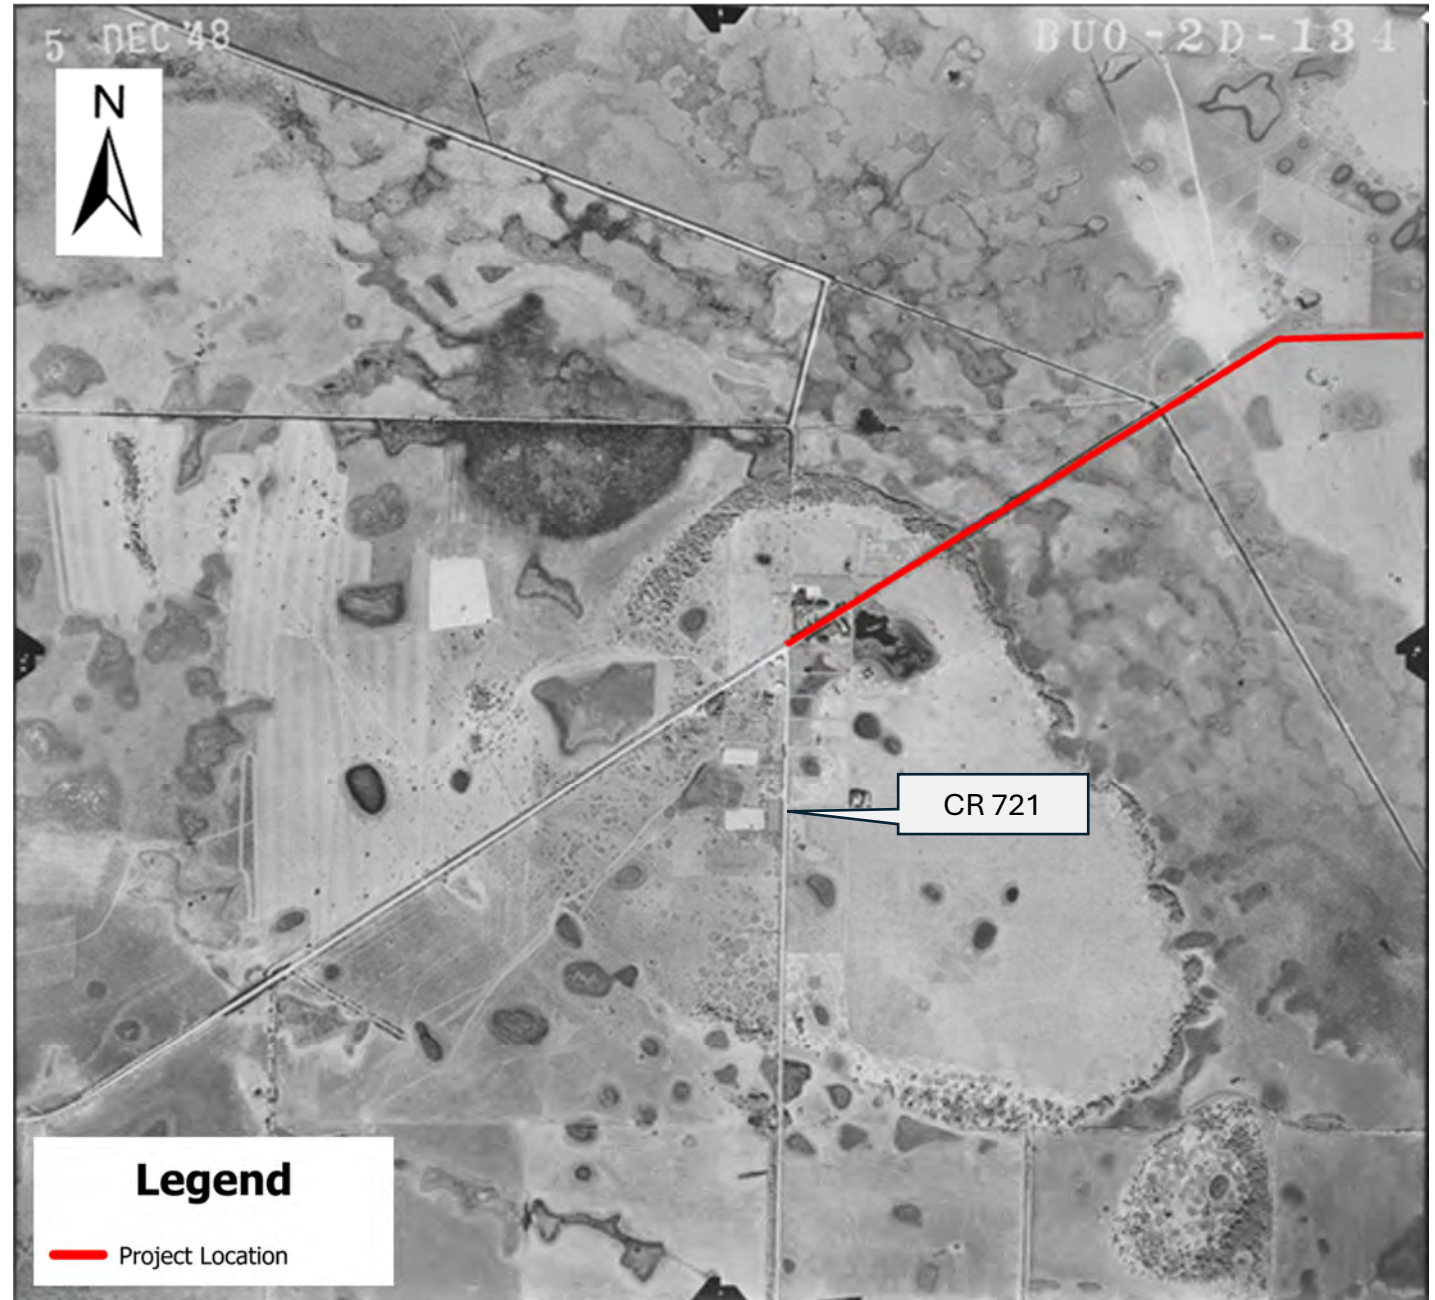
1948: This is the second aerial out of four from the 1940s. The landscape is predominantly agricultural farmland with scattered natural wetlands.

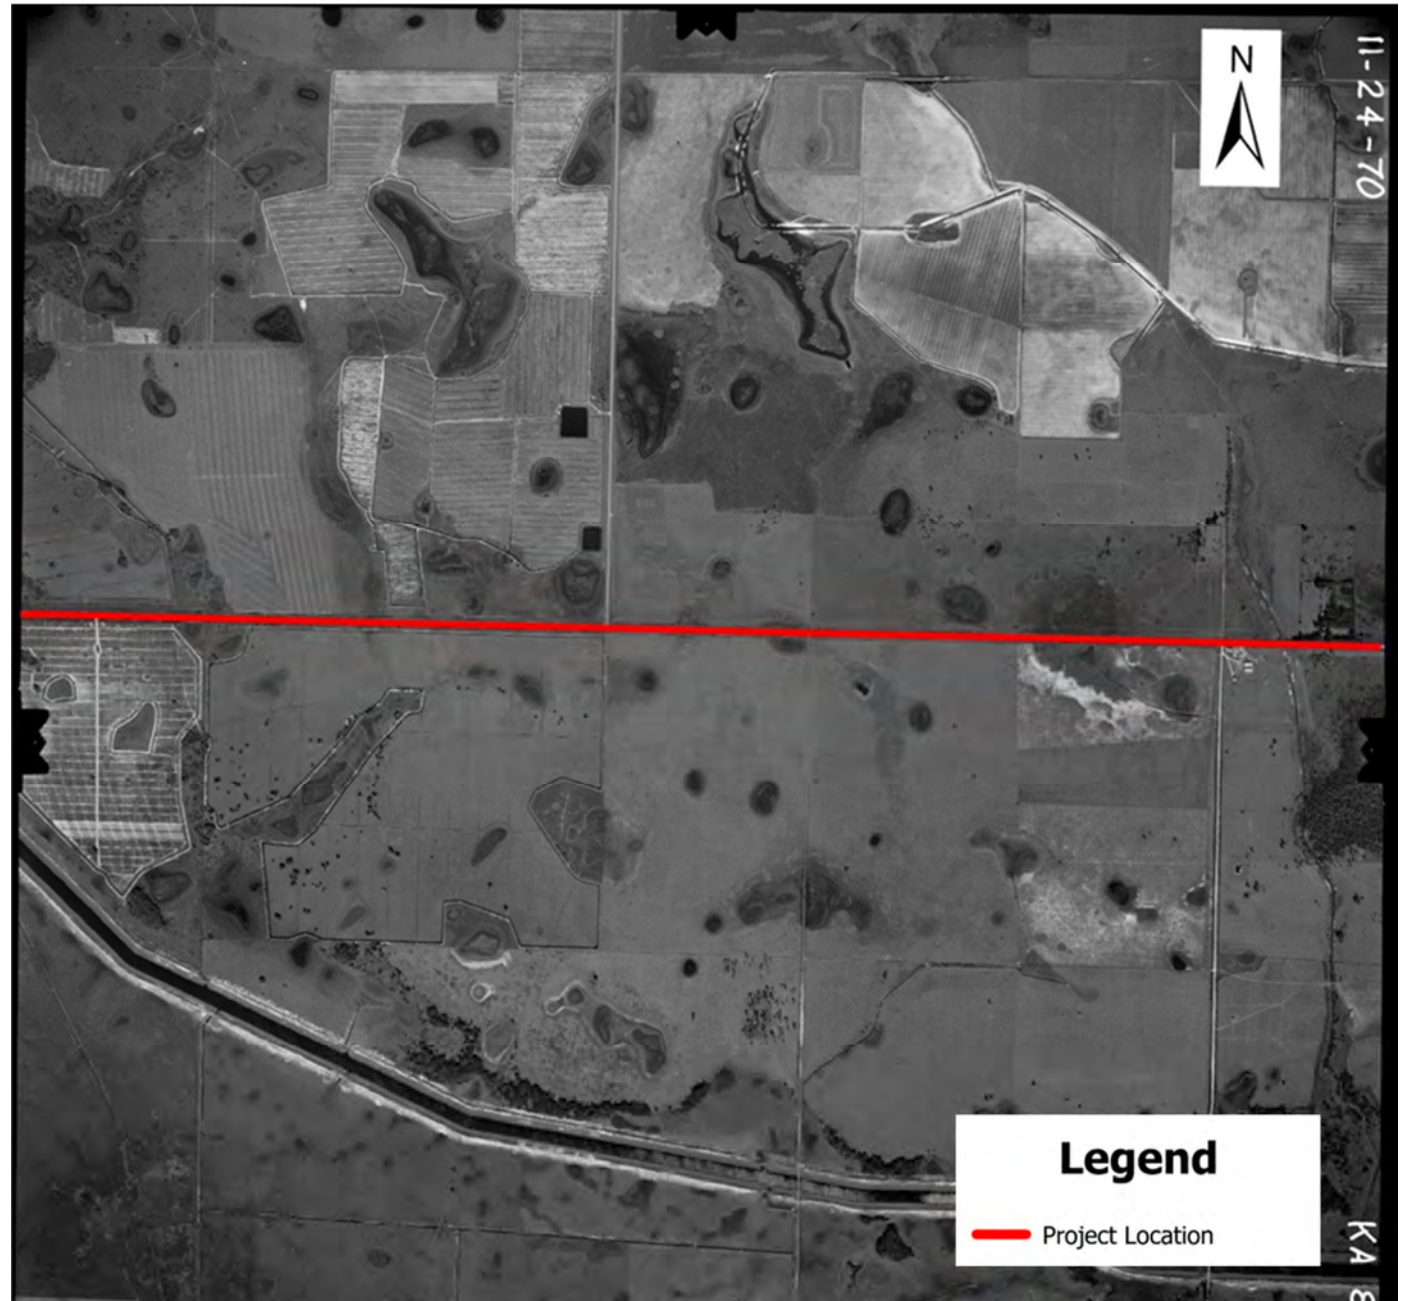
1970: This is the third aerial out of four from the 1970s. A natural prairie community located south of the project limits is more distinctly defined and outlined in blue. Additional farmland development, outlined in green, is also evident.

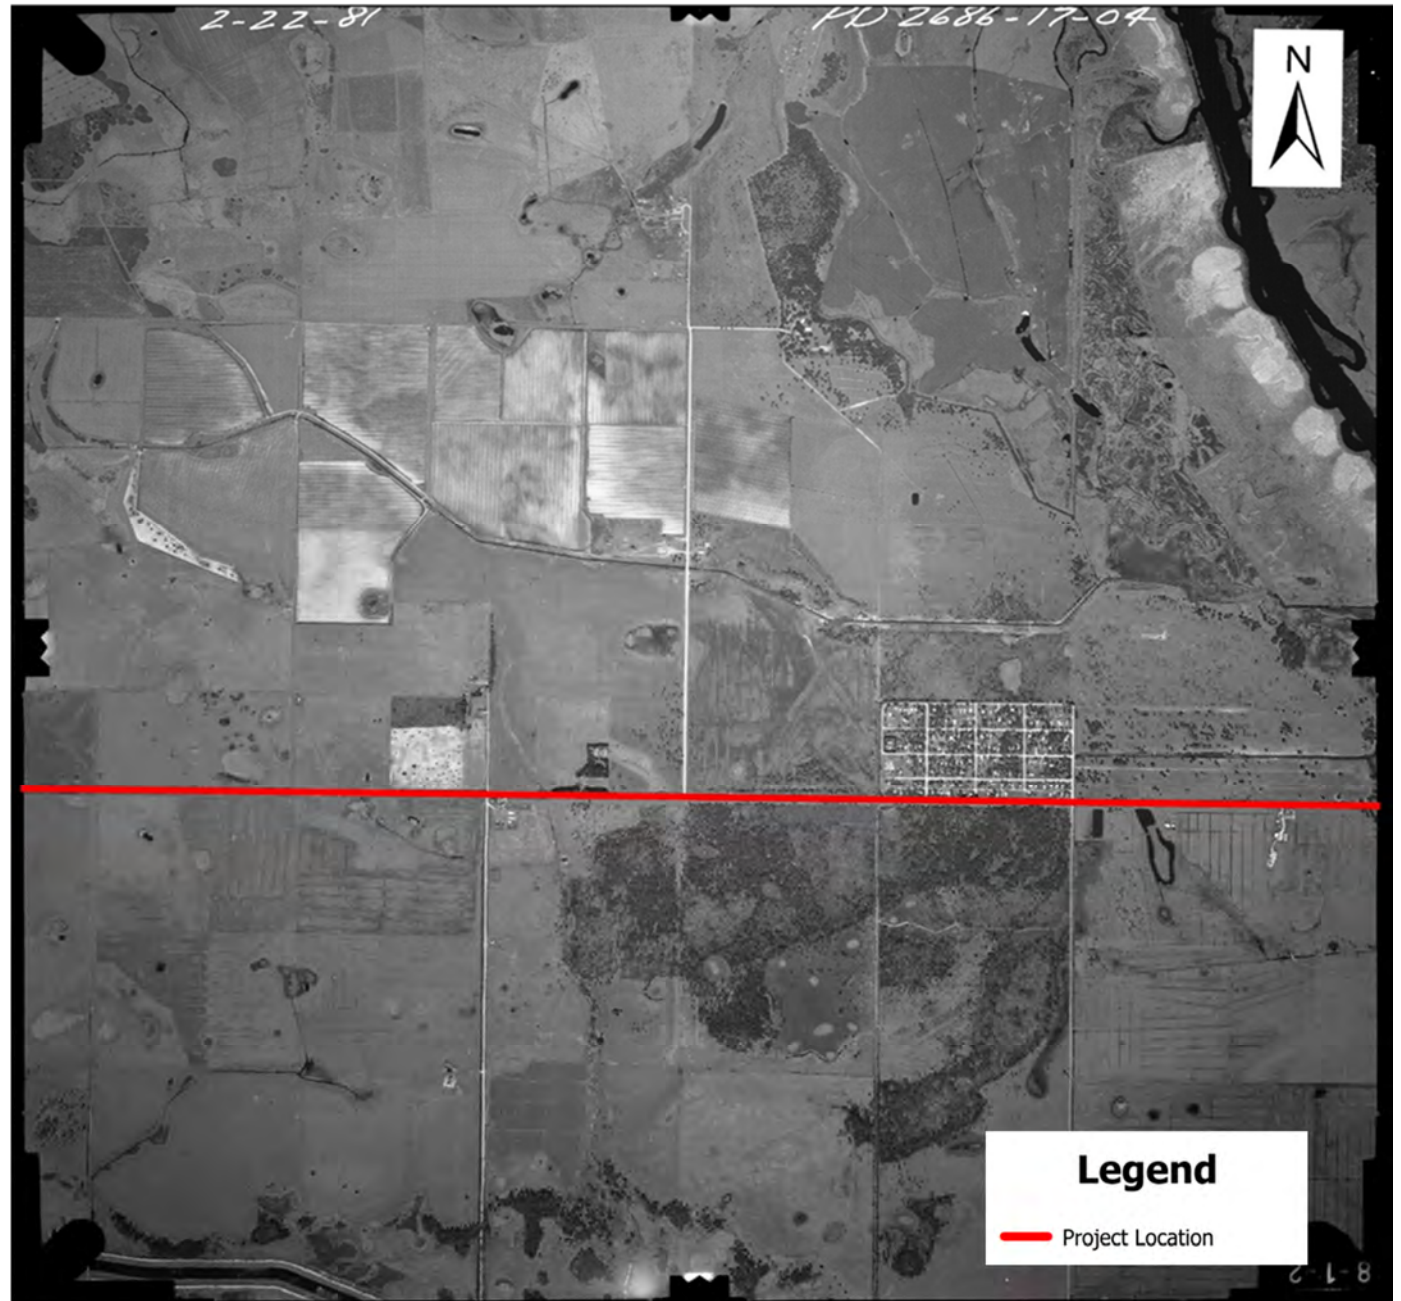
1981: This is the fourth aerial out of five from the 1980s. There are no significant differences in land use observed from previous aerals.

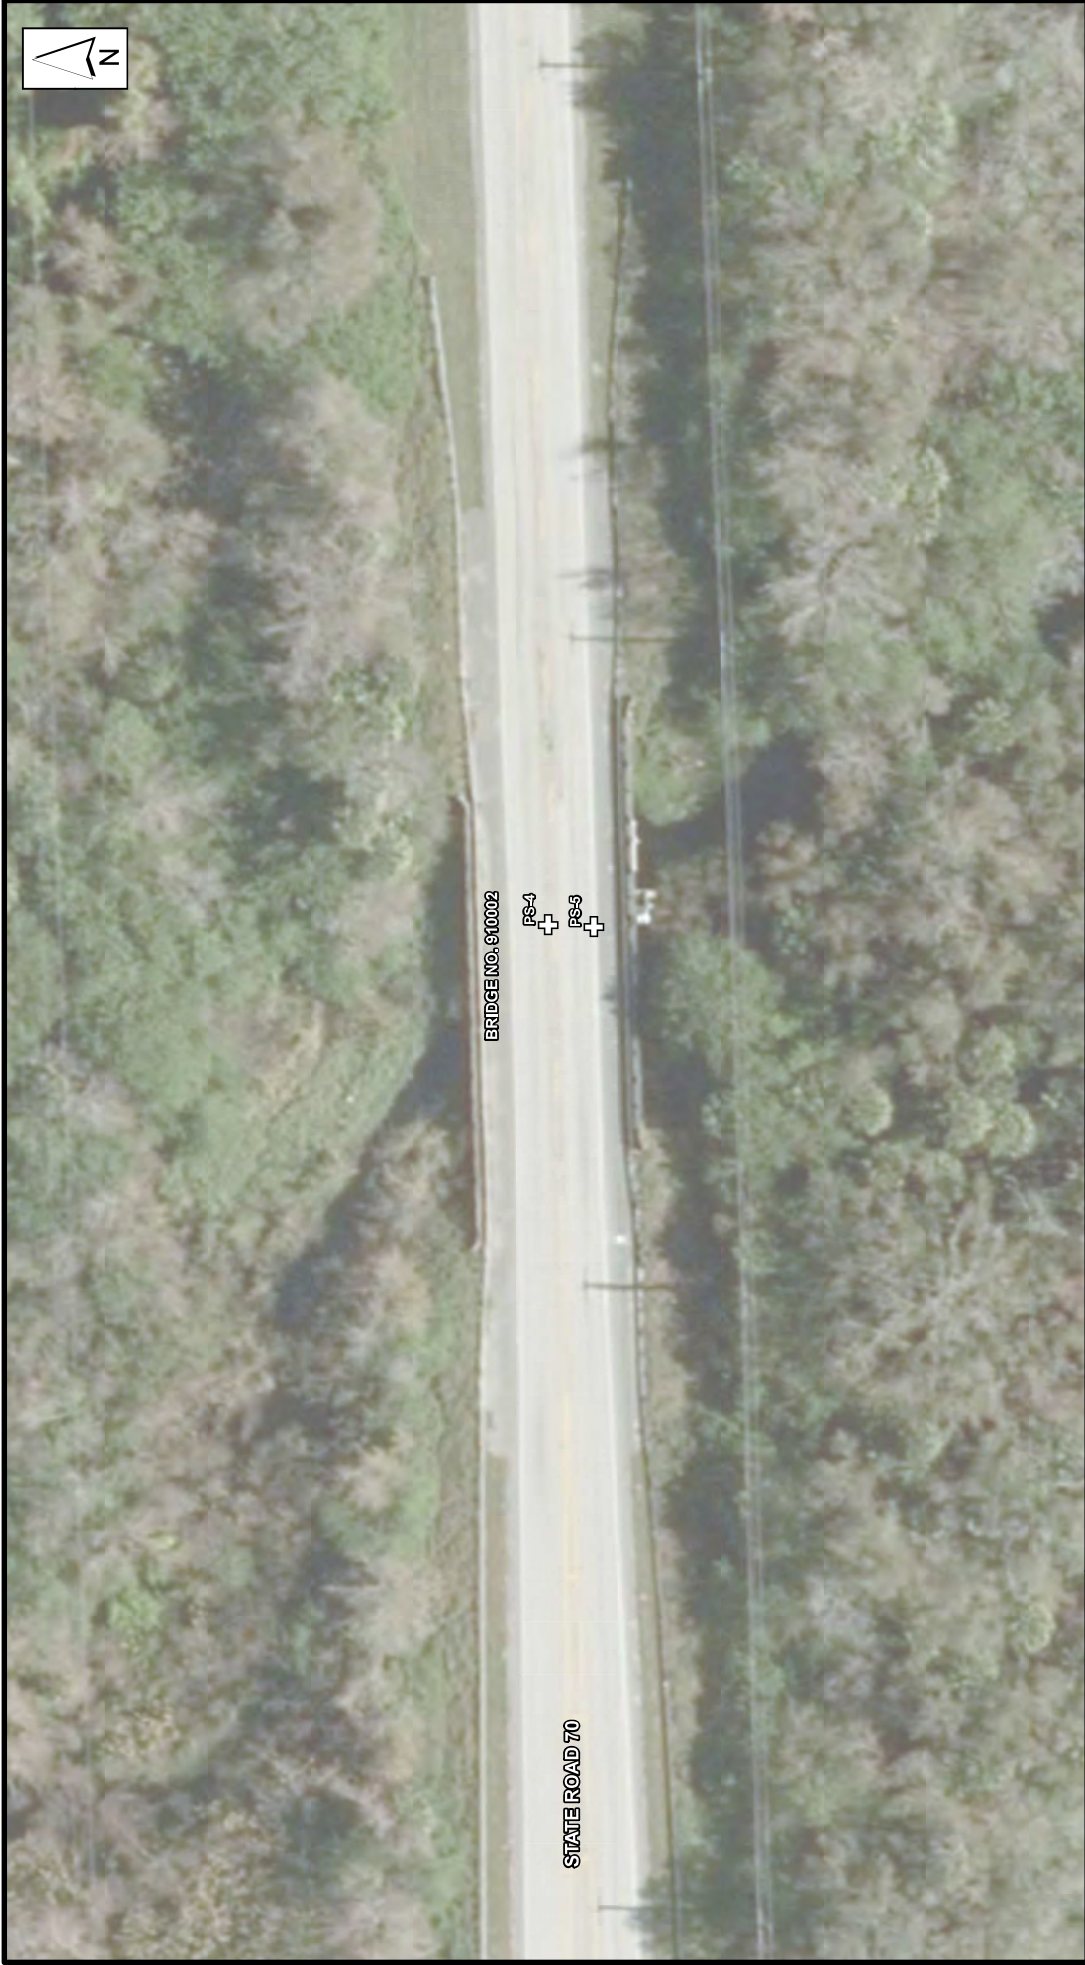
Legend		200 Feet	
	Paint Chip Sample Location		
	PROJECT NO.: 40-22-104		
	PROJECT MANAGER: PHILIP GLOVER, P.G.		
	GIS ID: 4022104A005		
	DRN BY: MT		
DATE: 4/7/2022		REVISION NO.: 00	
CHK BY: PG		REVISION DATE: N/A	
		STATUS: FINAL	
		2760 FALKENBURG ROAD, RIVERVIEW, FLORIDA 33387 PHONE: (813) 684-4100 FAX: (813) 684-9177 FLORIDA BOARD OF PROFESSIONAL ENGINEERS CERTIFICATE OF AUTHORIZATION NO.: 30941	
		FIGURE 5 METALS BASED COATINGS SAMPLE LOCATIONS MAP (BRIDGE NO. 910002) STATE ROAD 70 FROM COUNTY LINE TO SW 21ST AVENUE OKEECHOBEE, OKEECHOBEE COUNTY, FLORIDA FDOT FINANCIAL PROJECT NO. 445474-J

NorthStar's MBC inspector conducted a site walk of the bridges to identify any surface coatings that may contain lead, arsenic, cadmium, chromium or zinc. The survey methodology was based on "Guidelines for the Evaluation and Control of Lead-Based Paint Hazards in Housing" [Department of Housing and Urban Development (HUD), 1995; 1997 for Chapter 7 Revision]. At Bridge No. 910001, three (3) samples were collected including tan coating, yellow lane paint and white lane paint. At Bridge No. 910002, two (2) samples were collected including yellow lane paint and white lane paint. The approximate sampling locations are presented on **Figure 3** and **Figure 5**.

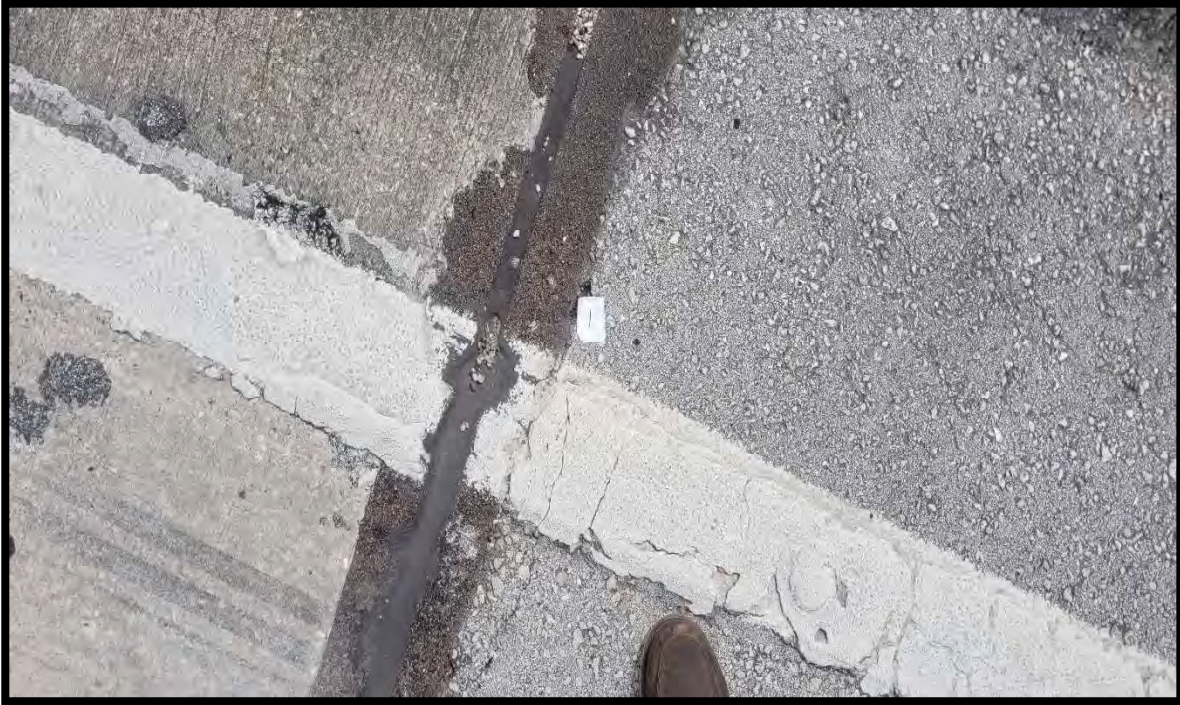
Photograph 3
View of Asbestos Homogeneous Area 1 – Asphalt – Approach Roadway of Bridge 910001
(Sample Location 1).

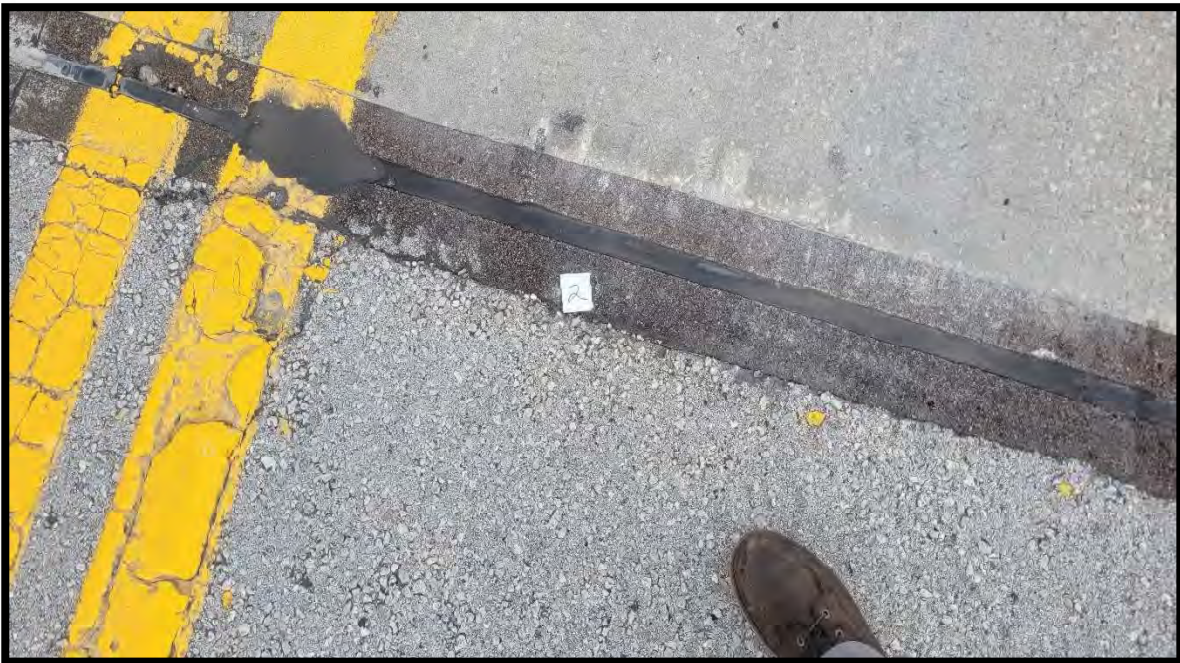
Photograph 4
View of Asbestos Homogeneous Area 1 – Asphalt – Approach Roadway of Bridge 910001 (Sample Location 2).
