DRAFT CONTAMINATION SCREENING EVALUATION REPORT

S.R. 70 PD&E Study

Limits of Project: From C.R. 721 S to C.R. 599/128th Avenue

Highlands and Okeechobee Counties, Florida

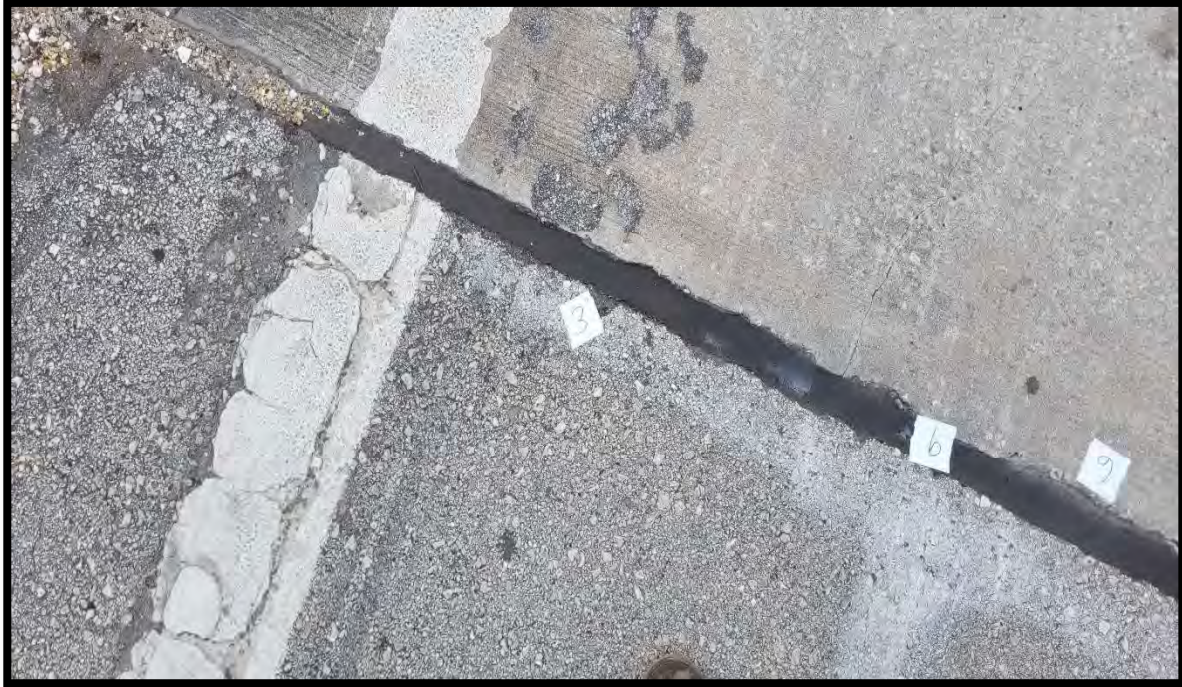
Photograph 5
View of Asbestos Homogeneous Area 1 – Asphalt – Approach Roadway of Bridge 910001
(Sample Location 3).

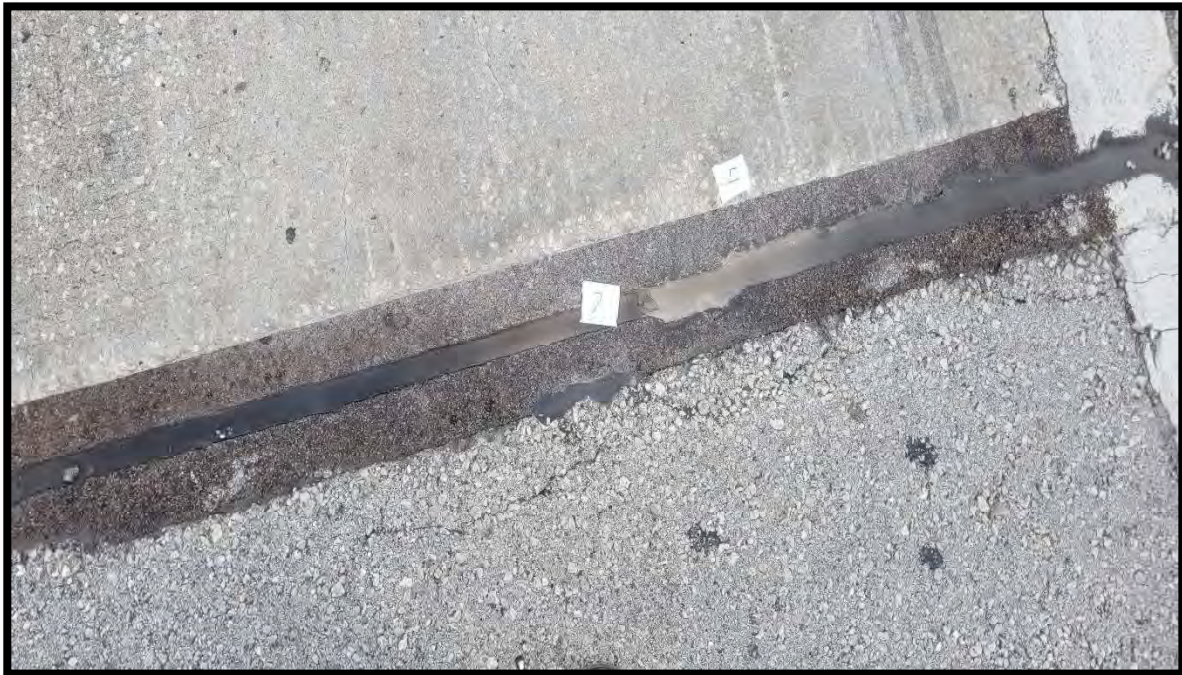
Photograph 6
View of Asbestos Homogeneous Area 2 – Concrete – Bridge Roadway of Bridge 910001 (Sample Location 4).

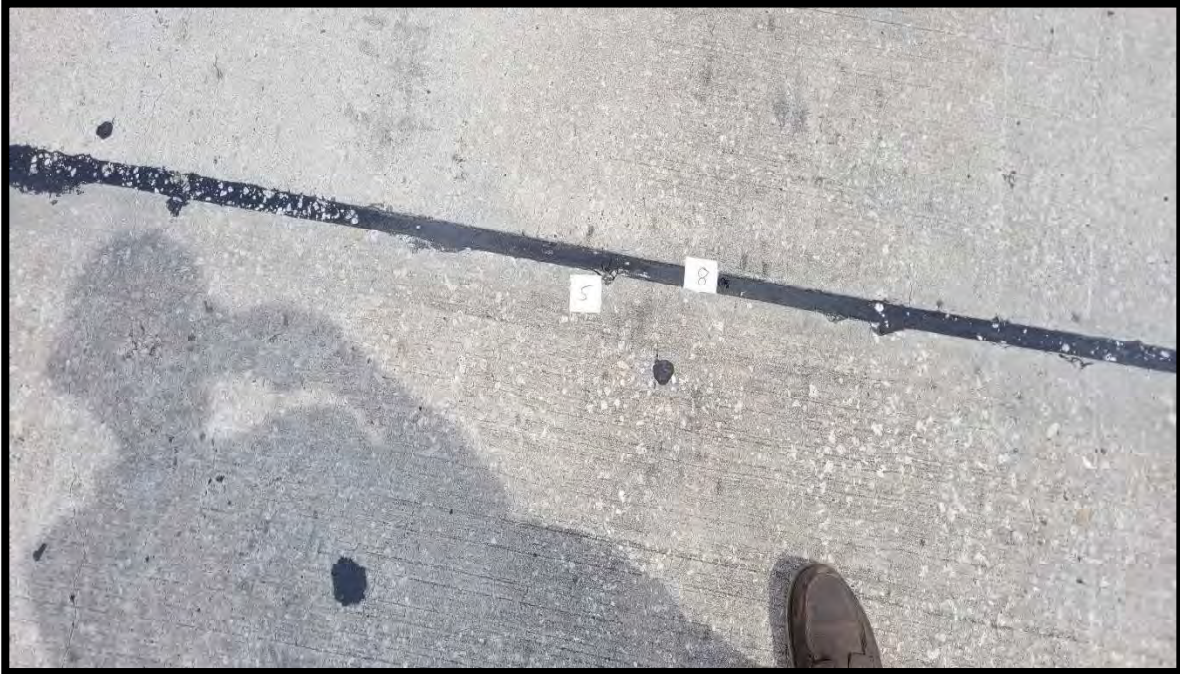
Photograph 7

View of Asbestos Homogeneous Area 2 – Concrete – Bridge Roadway of Bridge 910001 (Sample Location 5).

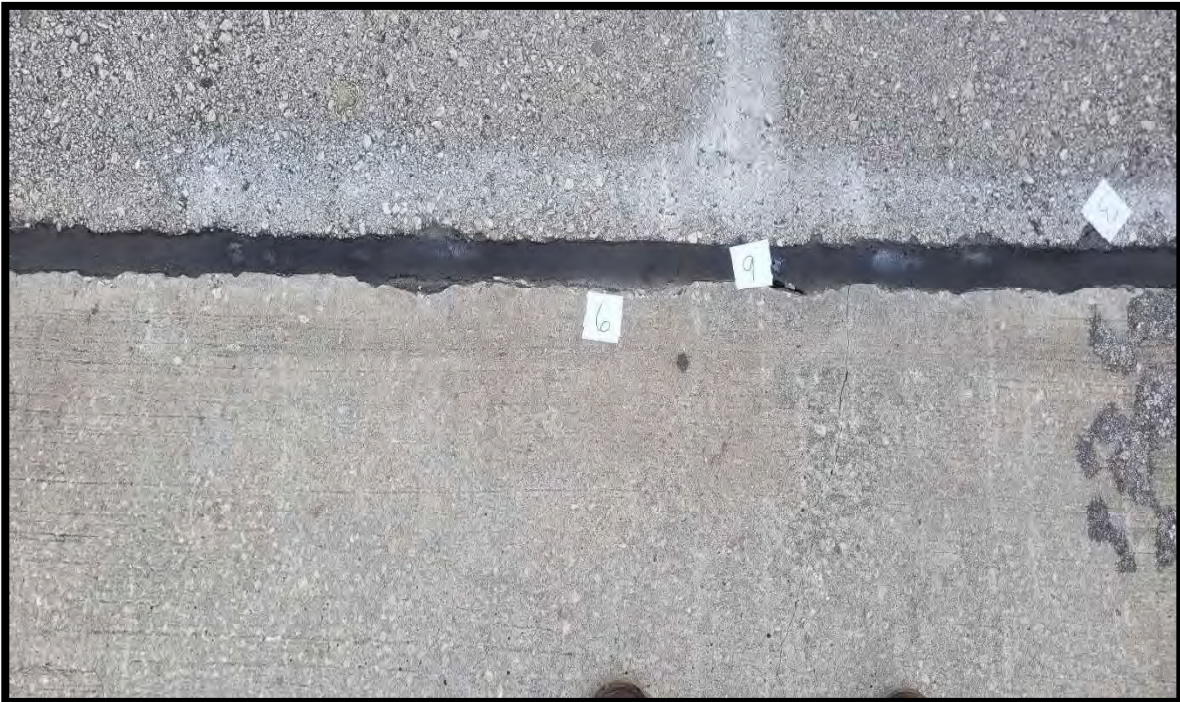
Photograph 8

View of Asbestos Homogeneous Area 2 – Concrete – Bridge Roadway of Bridge 910001 (Sample Location 6).

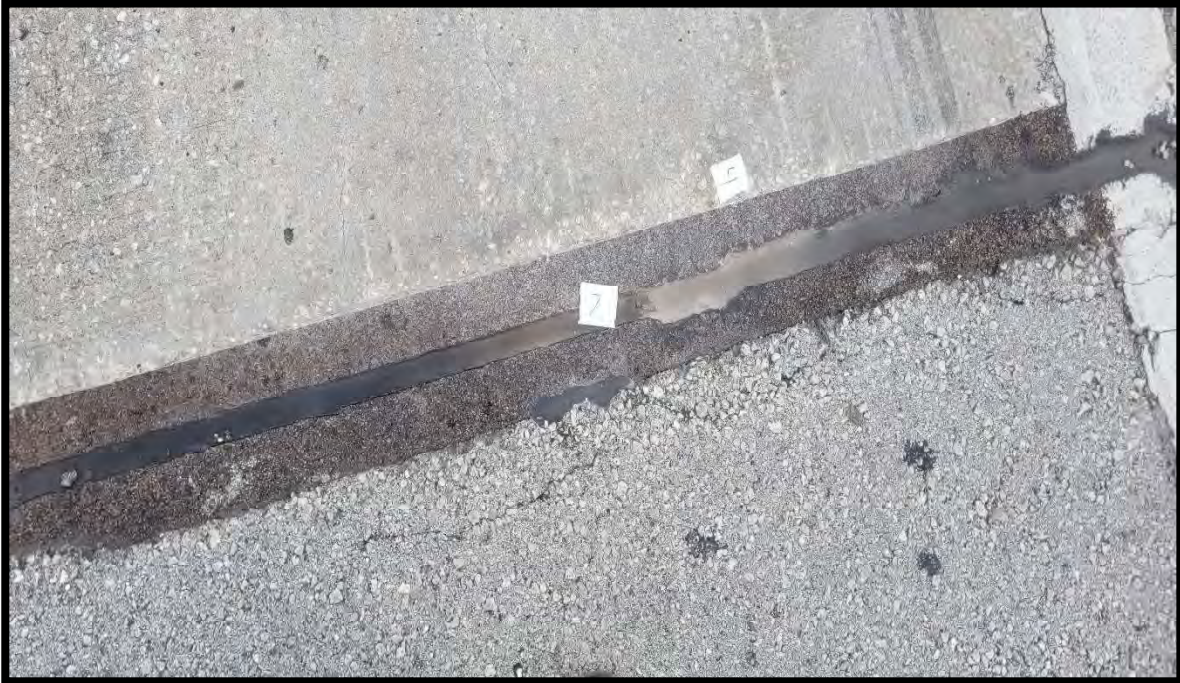
Photograph 9
View of Asbestos Homogeneous Area 3 – Closed-Cell Foam – Expansion Joint of Bridge 910001
(Sample Location 7).

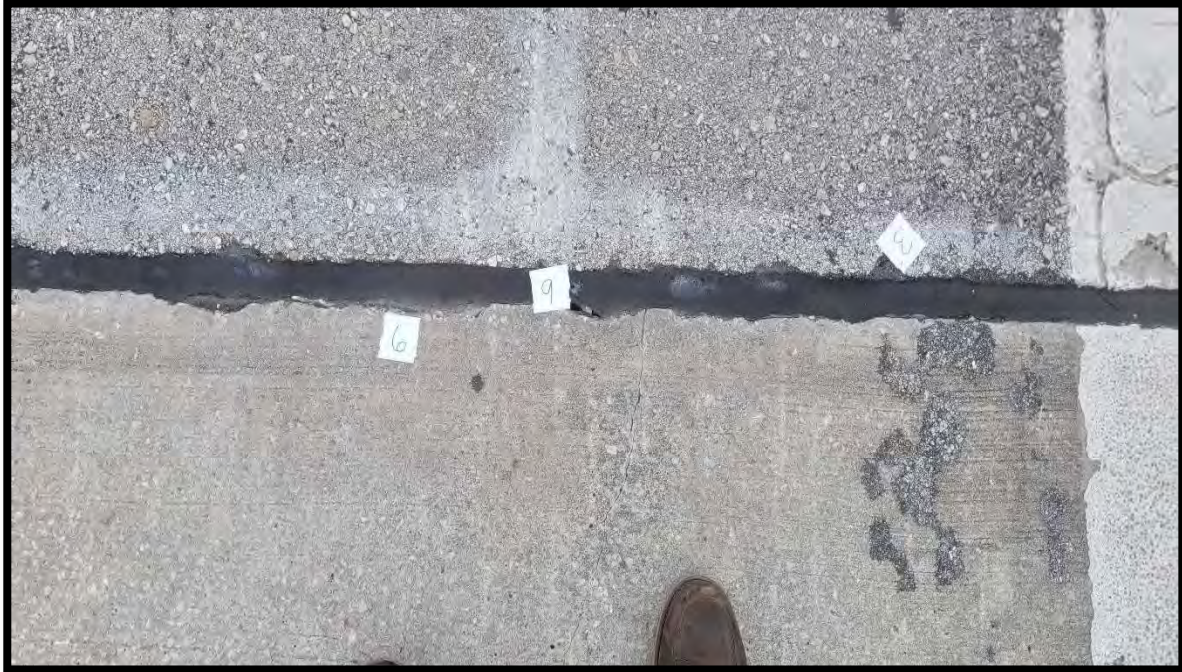
Photograph 11
View of Asbestos Homogeneous Area 3 – Closed-Cell Foam – Expansion Joint of Bridge 910001
(Sample Location 9).

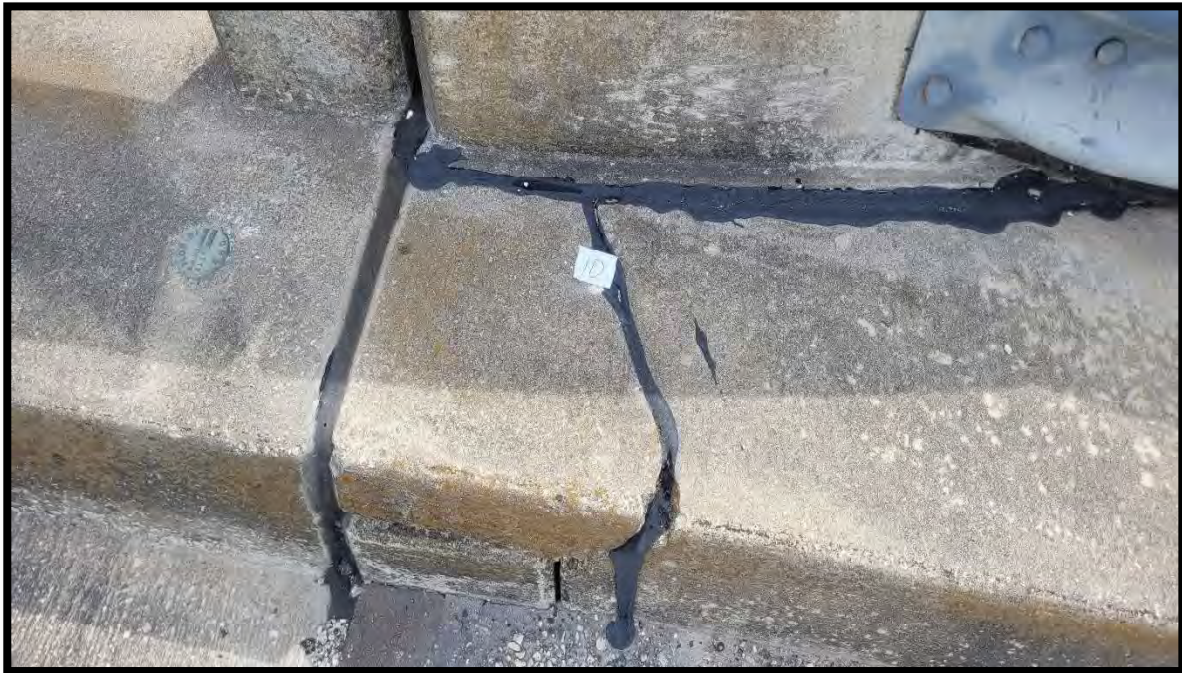
Photograph 12
View of Asbestos Homogeneous Area 4 – Bitumen Black Sealant – Seams and Cracks of Bridge 910001
(Sample Location 10).

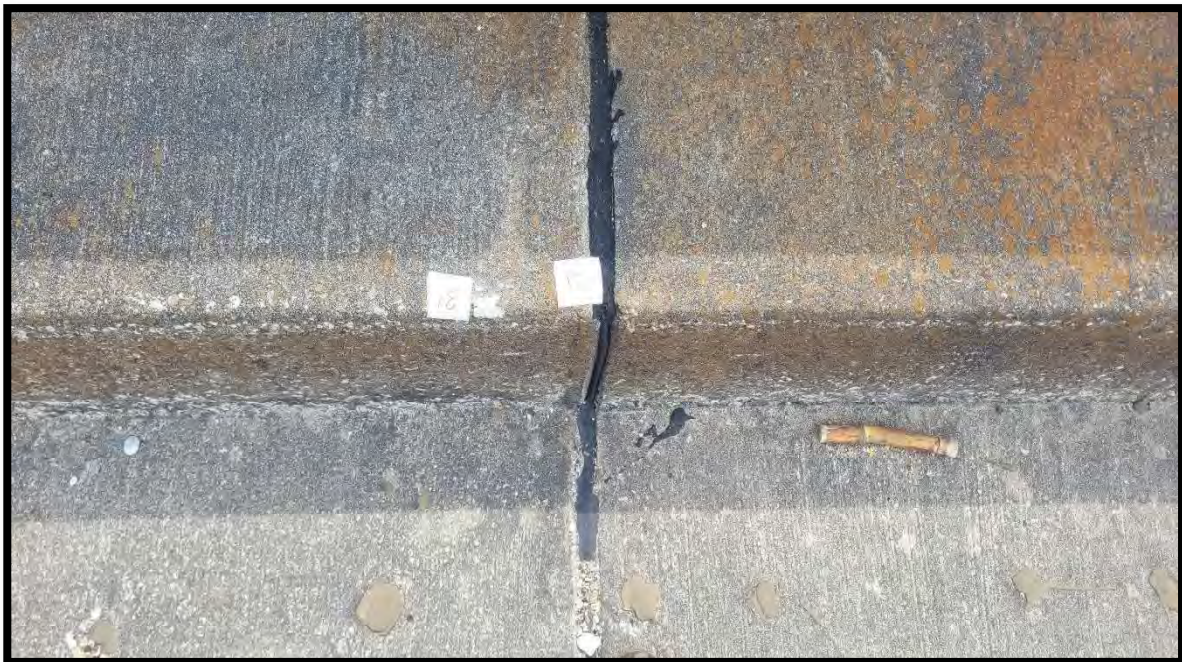
Photograph 14
View of Asbestos Homogeneous Area 4 – Bitumen Black Sealant – Seams and Cracks of Bridge 910001
(Sample Location 12).

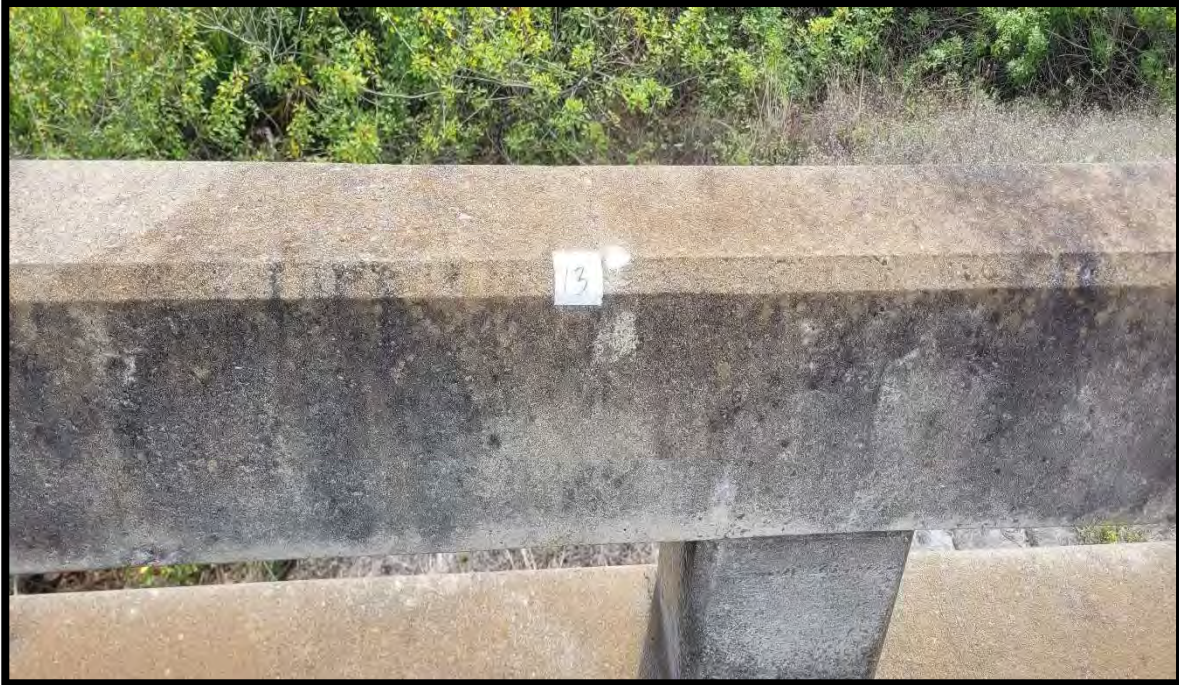
Photograph 15
View of Asbestos Homogeneous Area 5 – Concrete, Class V Coating – Guardrail of Bridge 910001
(Sample Location 13).

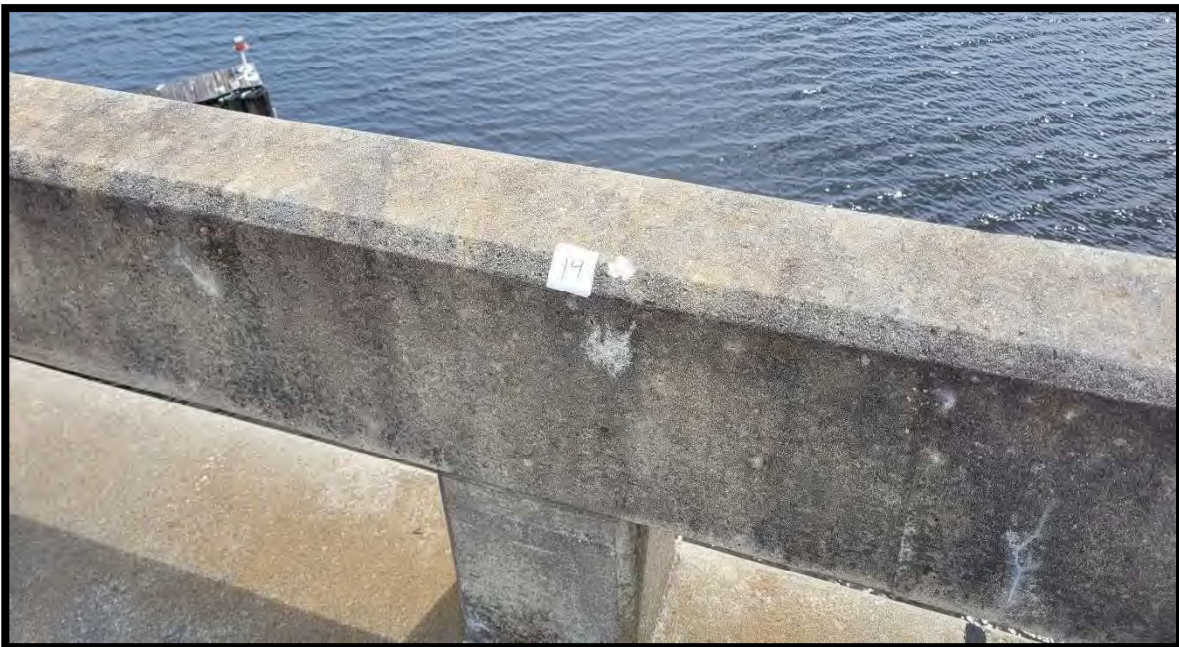
Photograph 16
View of Asbestos Homogeneous Area 5 – Concrete, Class V Coating – Guardrail of Bridge 910001 (Sample Location 14).

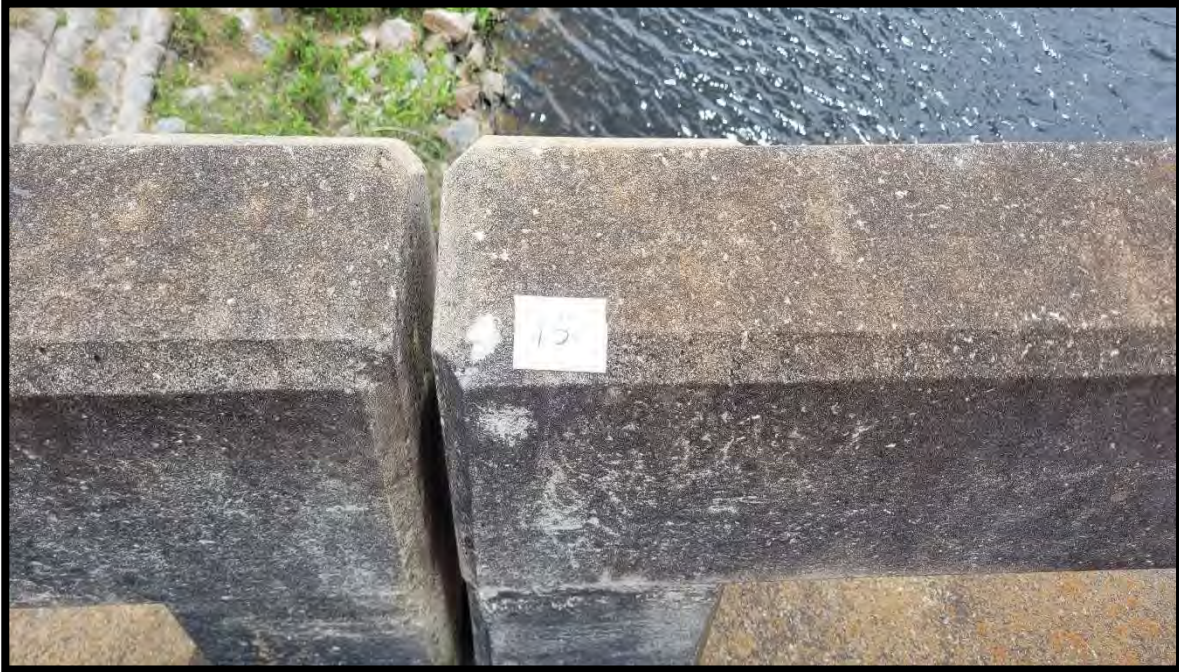
Photograph 17
View of Asbestos Homogeneous Area 5 – Concrete, Class V Coating – Guardrail of Bridge 910001
(Sample Location 15).

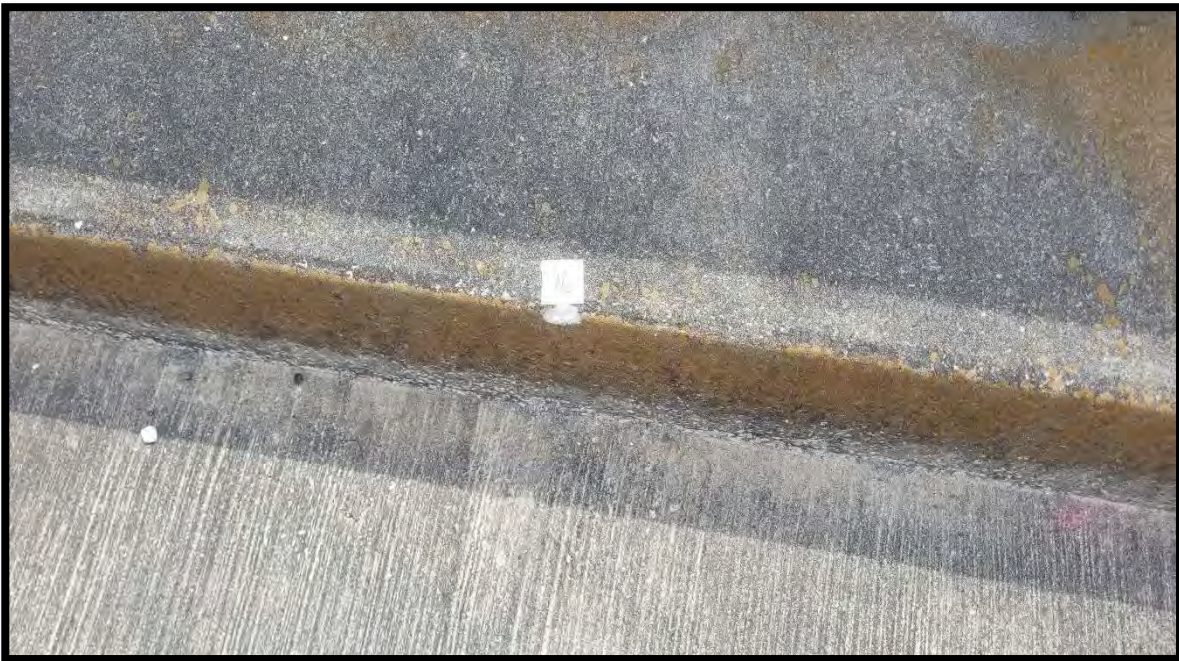
Photograph 18
View of Asbestos Homogeneous Area 6 – Concrete – Sidewalk of Bridge 910001 (Sample Location 16).

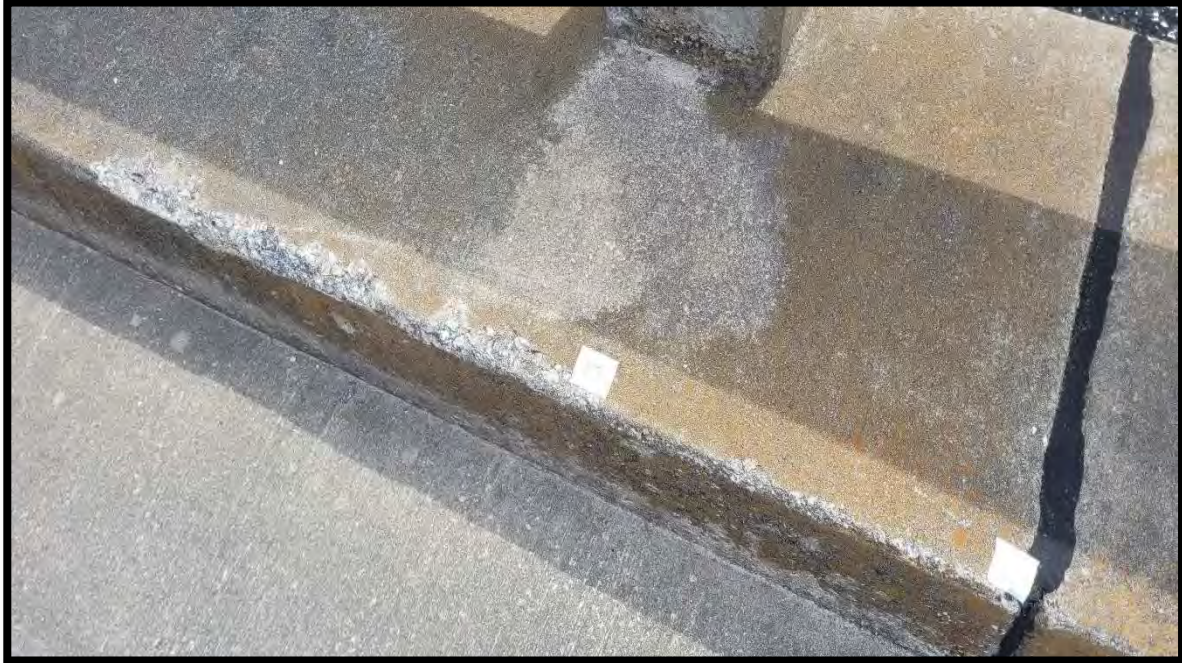
Photograph 19

View of Asbestos Homogeneous Area 6 – Concrete – Sidewalk of Bridge 910001 (Sample Location 17).

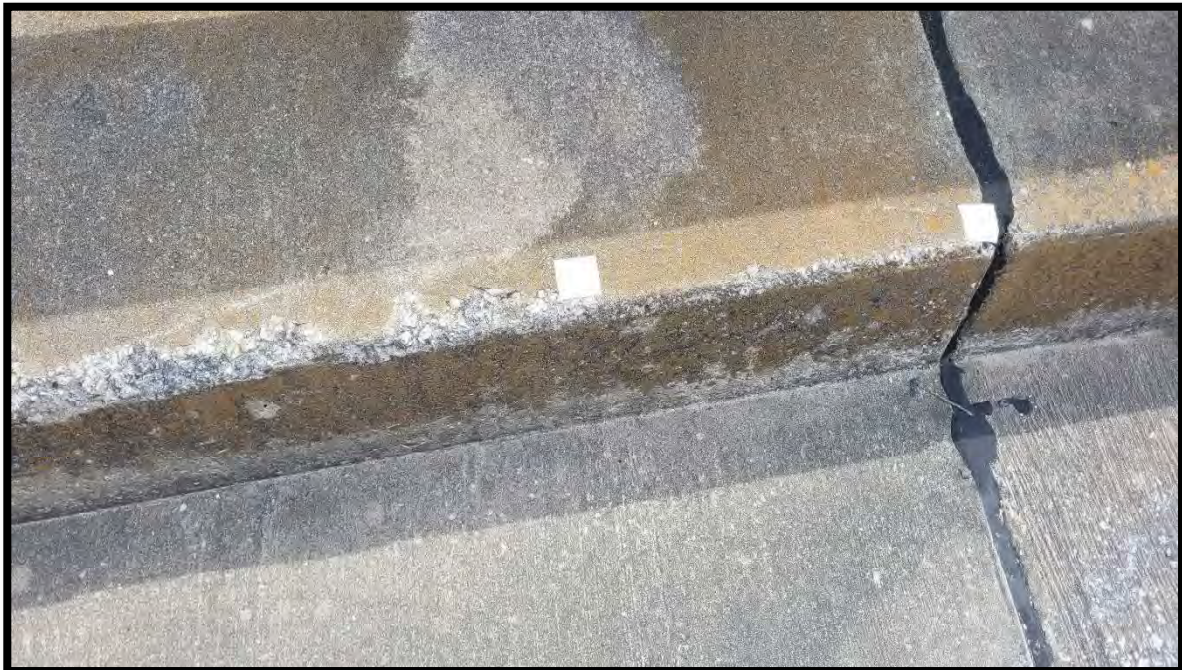
Photograph 20

View of Asbestos Homogeneous Area 6 – Concrete – Sidewalk of Bridge 910001 (Sample Location 18).

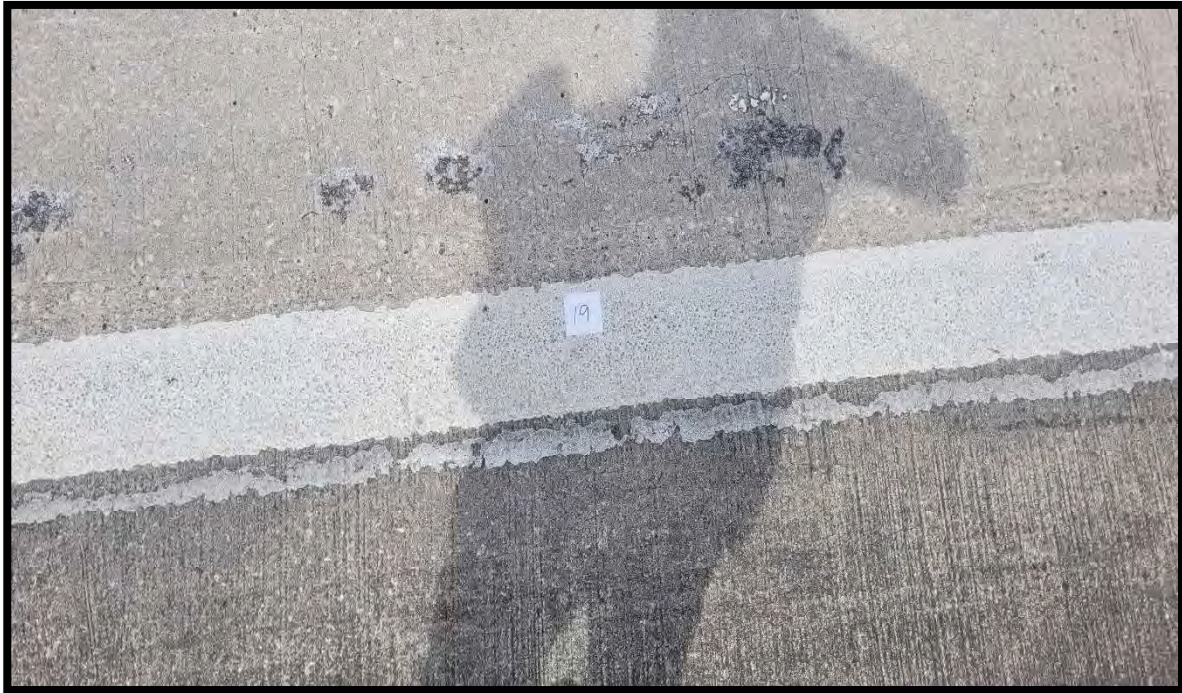
Photograph 21
View of Asbestos Homogeneous Area 7 – White Lane Paint – White Striping of Bridge 910001
(Sample Location 19).

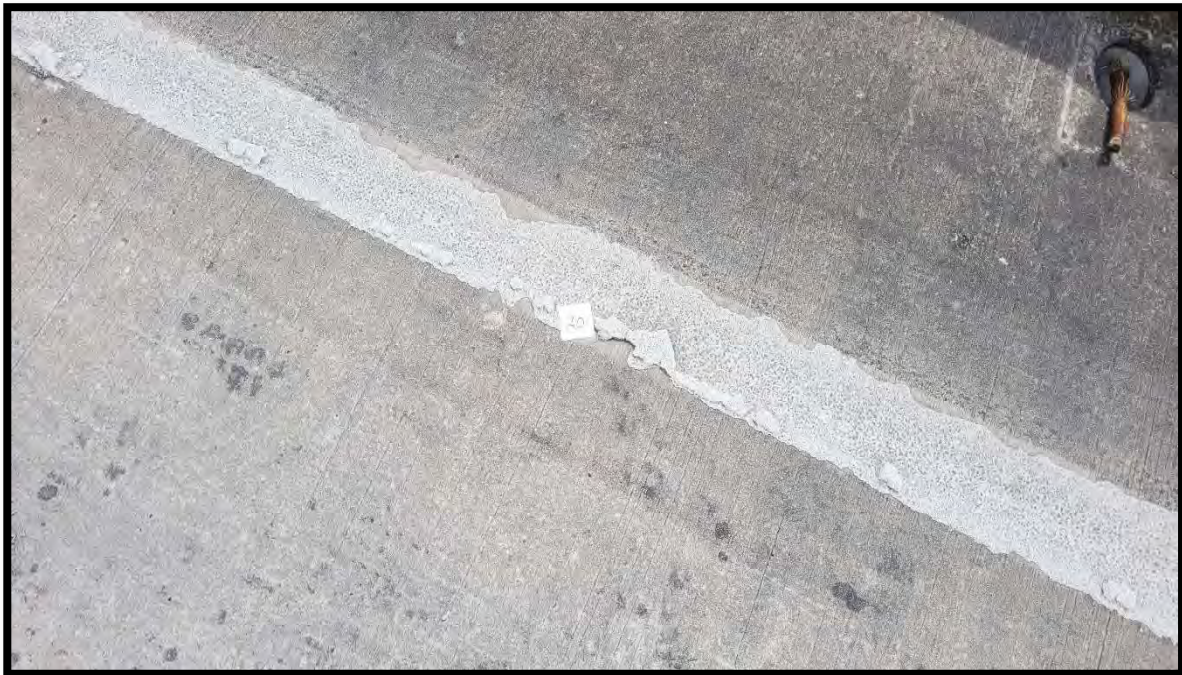
Photograph 22
View of Asbestos Homogeneous Area 7 – White Lane Paint – White Striping of Bridge 910001 (Sample Location 20).

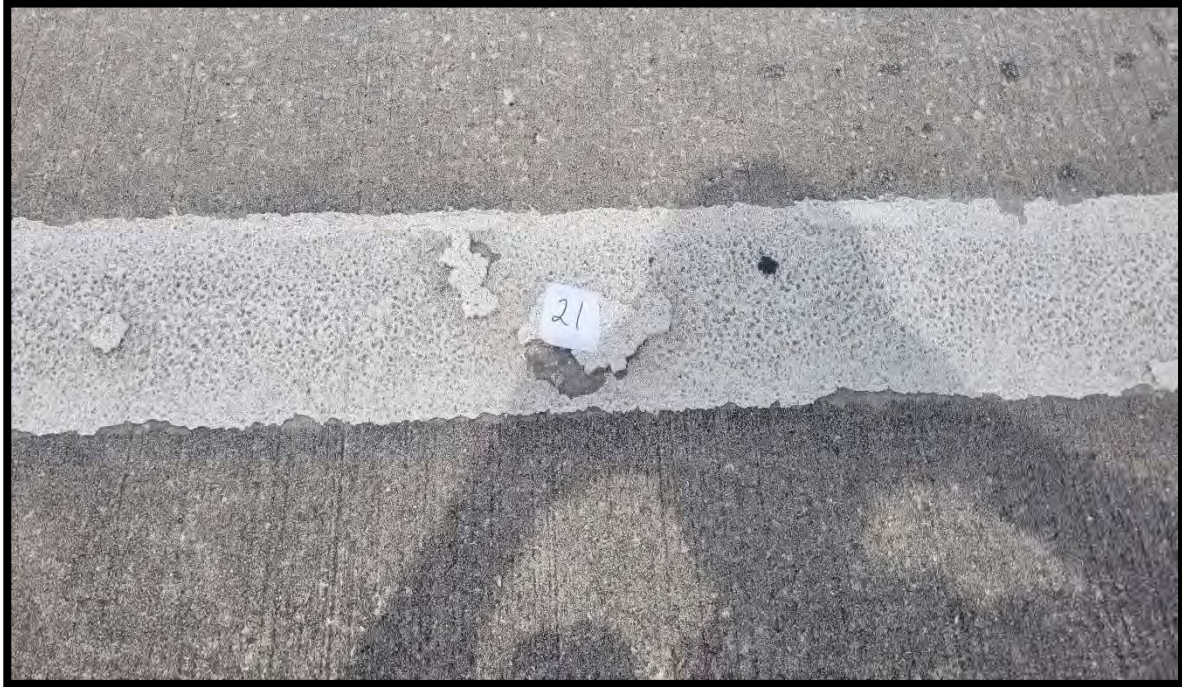
Photograph 23
View of Asbestos Homogeneous Area 7 – White Lane Paint – White Striping of Bridge 910001
(Sample Location 21).

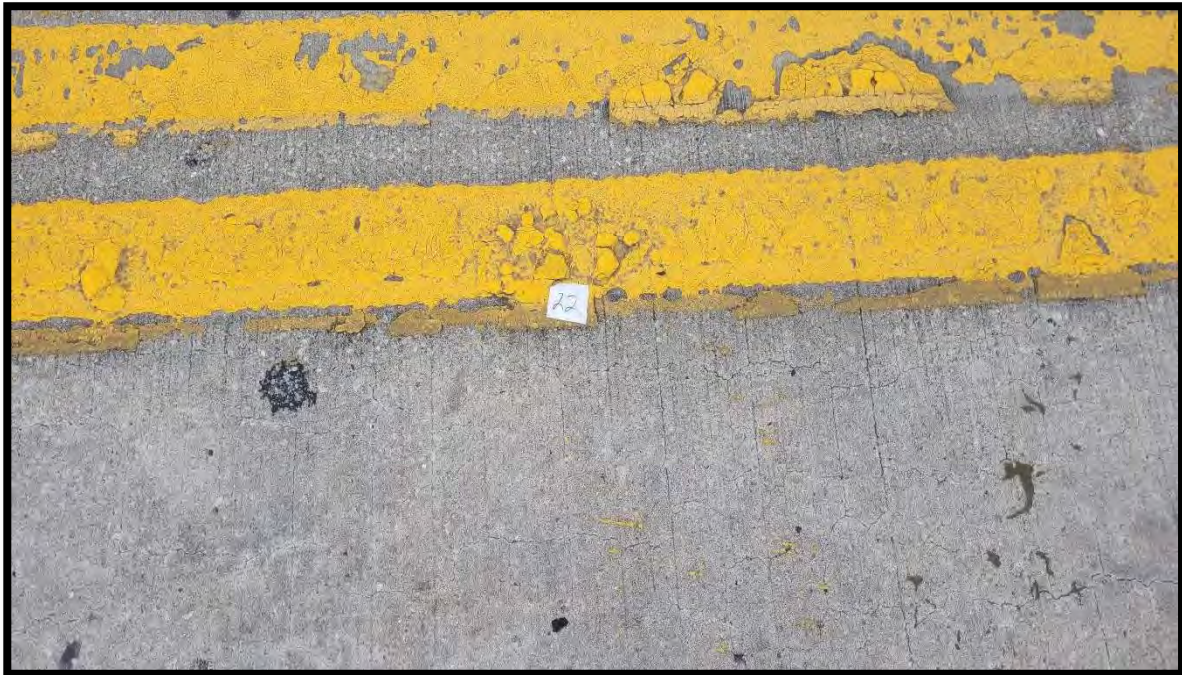
Photograph 24
View of Asbestos Homogeneous Area 8 – Yellow Lane Paint – Yellow Striping of Bridge 910001 (Sample Location 22).

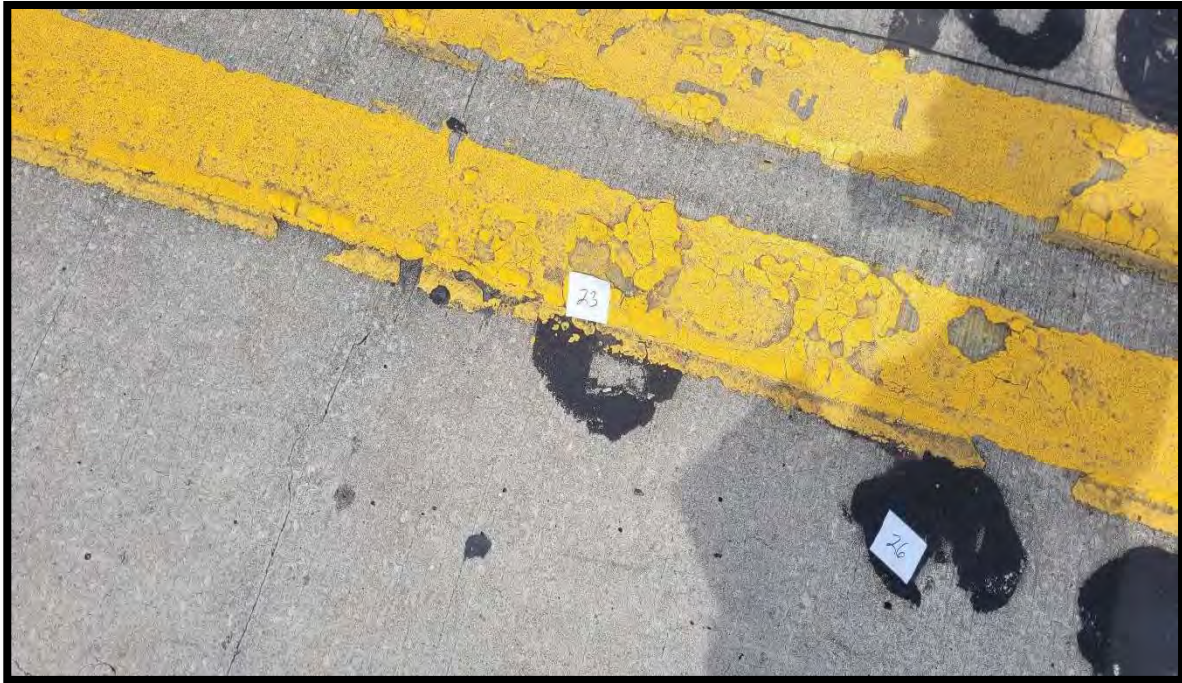
Photograph 25
View of Asbestos Homogeneous Area 8 – Yellow Lane Paint – Yellow Striping of Bridge 910001
(Sample Location 23).

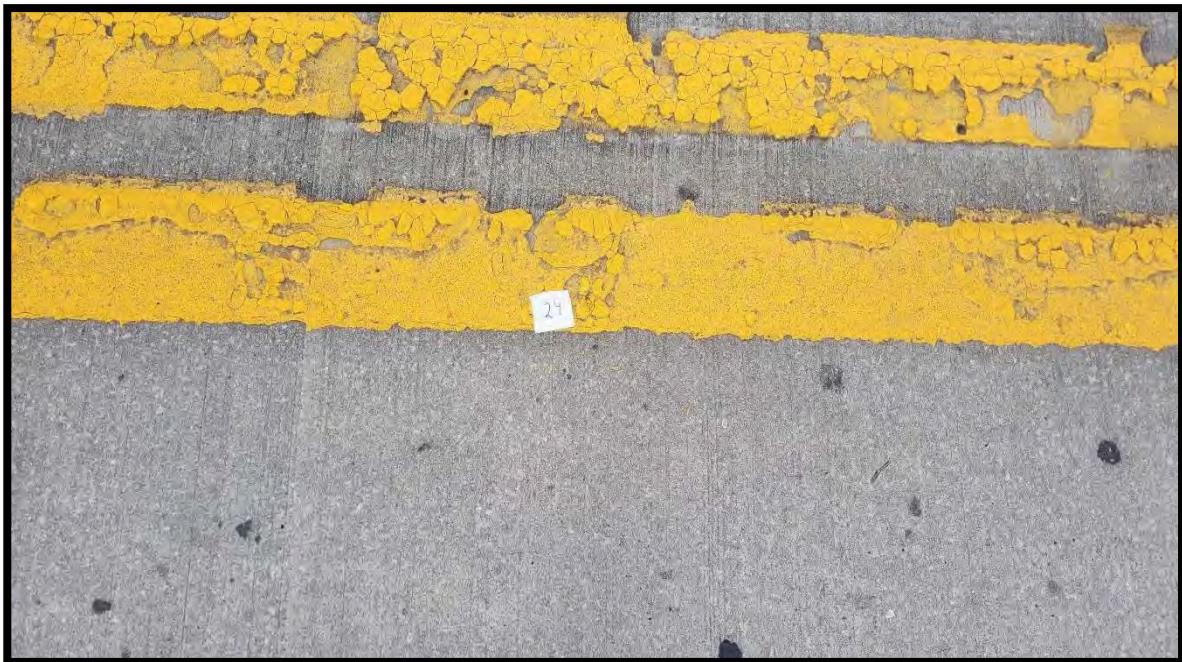
Photograph 26
View of Asbestos Homogeneous Area 8 – Yellow Lane Paint – Yellow Striping of Bridge 910001 (Sample Location 24).

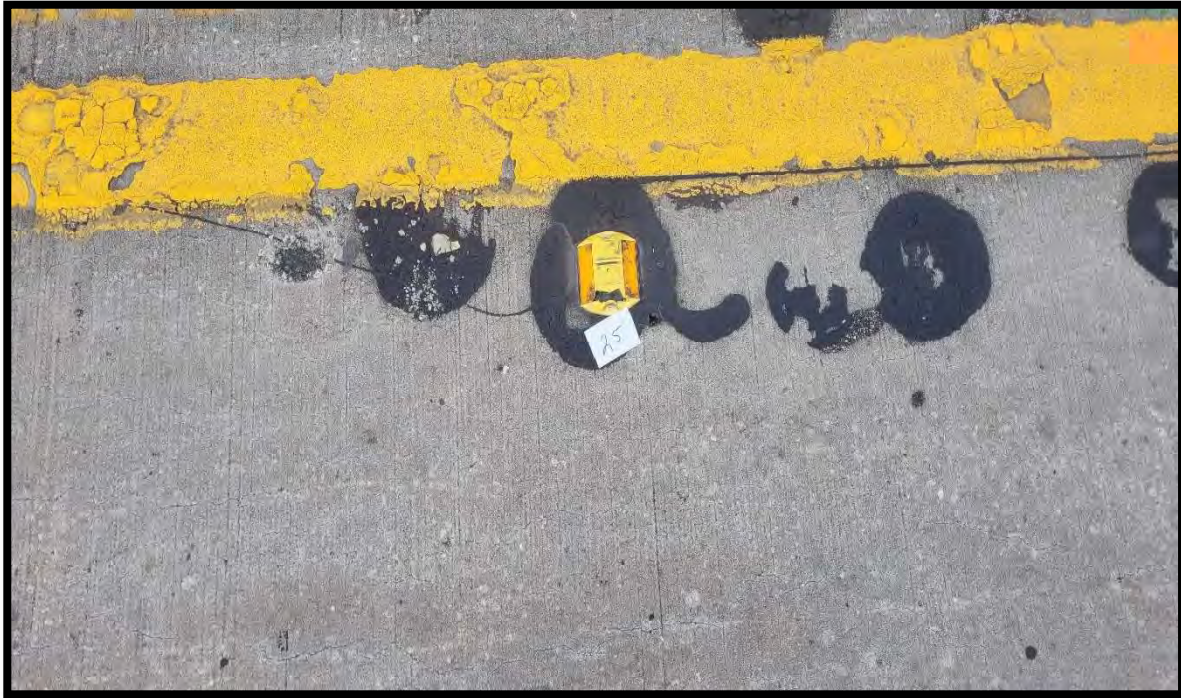
Photograph 27
View of Asbestos Homogeneous Area 9 – Black Adhesive – Surface Reflectors of Bridge 910001
(Sample Location 25).

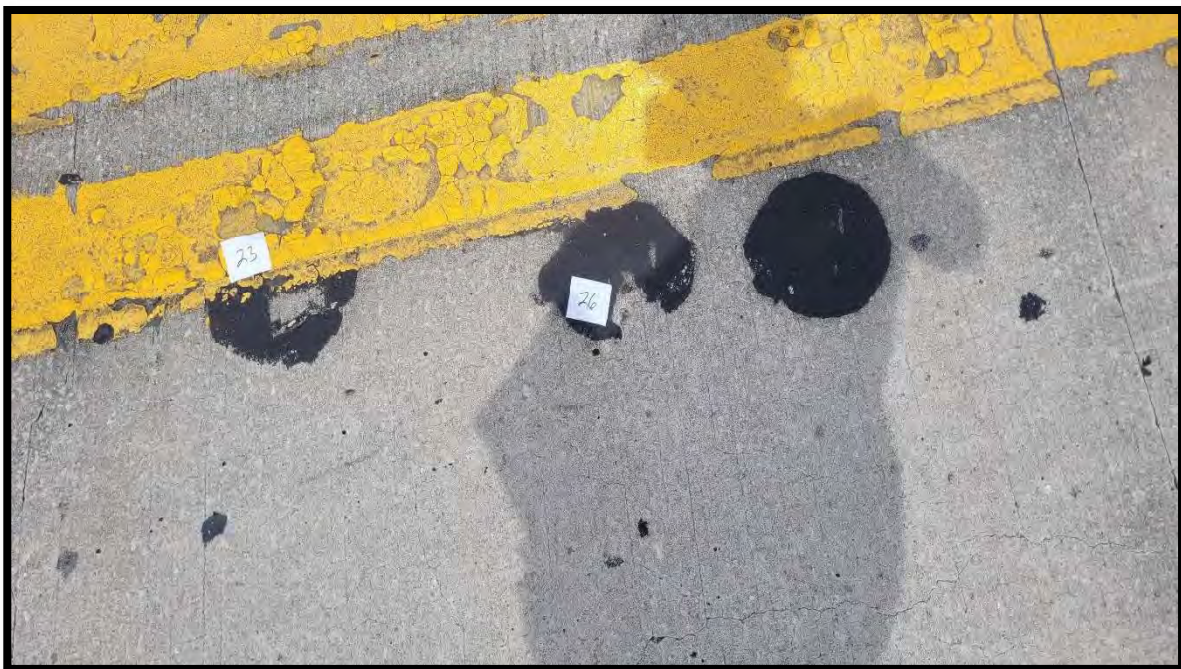
Photograph 28
View of Asbestos Homogeneous Area 9 – Black Adhesive – Surface Reflectors of Bridge 910001 (Sample Location 26).

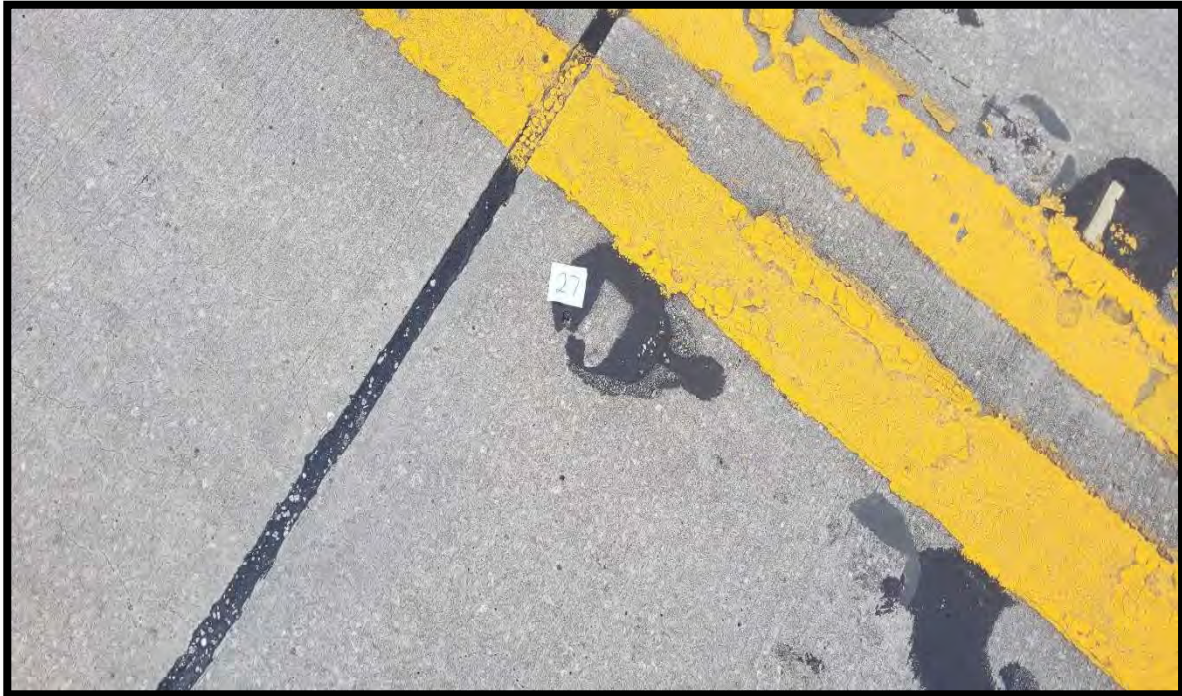
Photograph 29
View of Asbestos Homogeneous Area 9 – Black Adhesive – Surface Reflectors of Bridge 910001
(Sample Location 27).

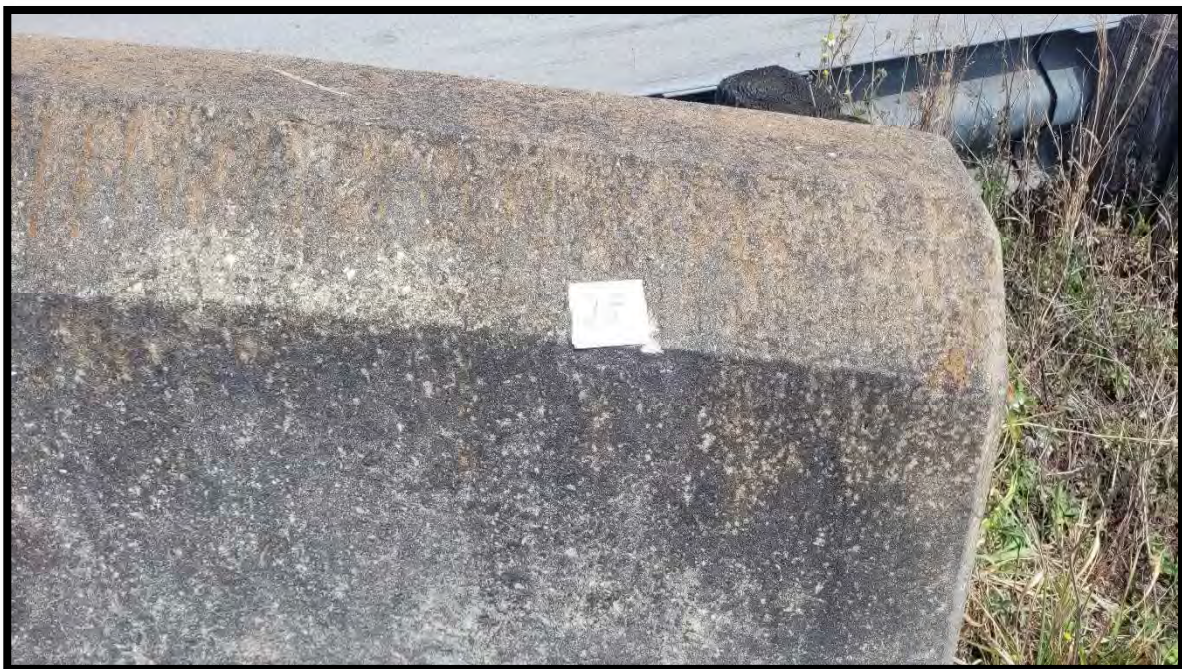
Photograph 30
View of Asbestos Homogeneous Area 10 – Concrete, Class V Coating – Landside Buttress of Bridge 910001
(Sample Location 28).

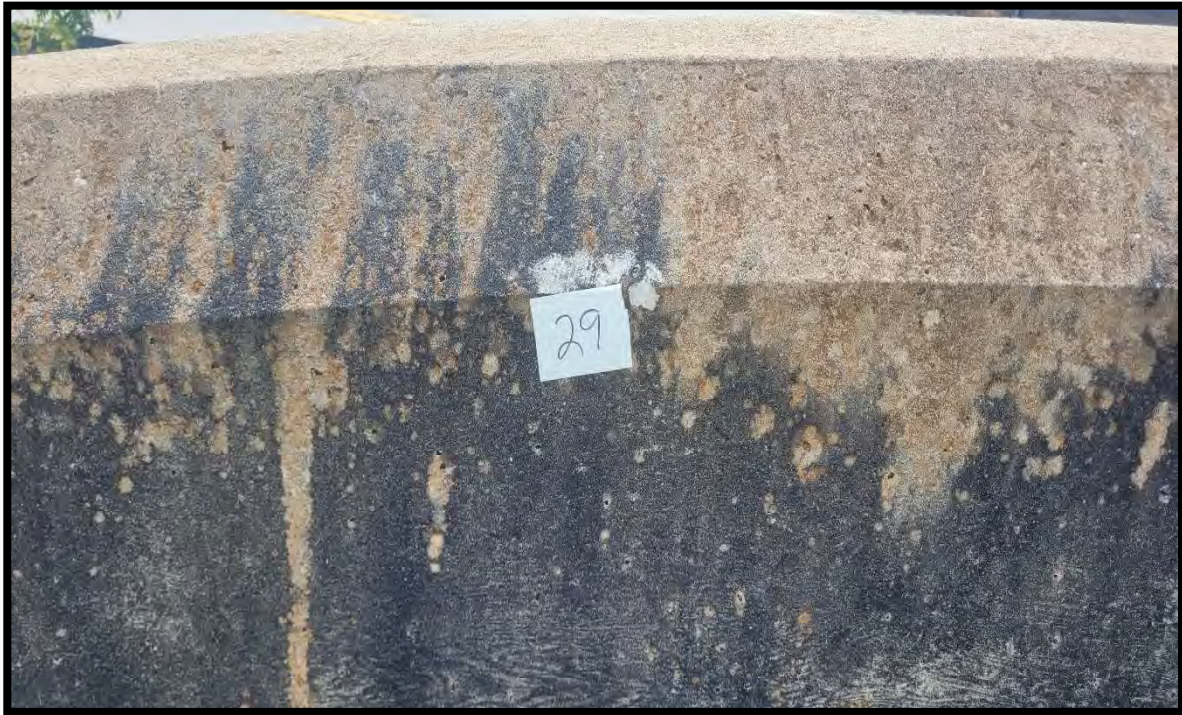
Photograph 31
View of Asbestos Homogeneous Area 10 – Concrete, Class V Coating – Landside Buttress of Bridge 910001
(Sample Location 29).

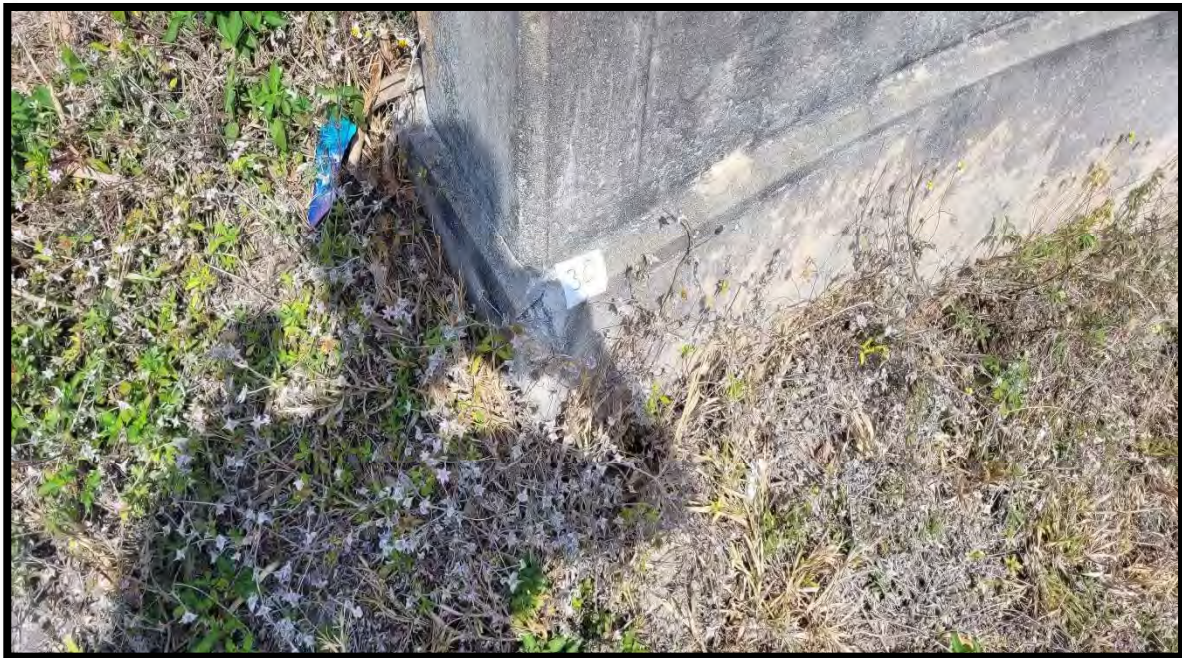
Photograph 32
View of Asbestos Homogeneous Area 10 – Concrete, Class V Coating – Landside Buttress of Bridge 910001
(Sample Location 30).

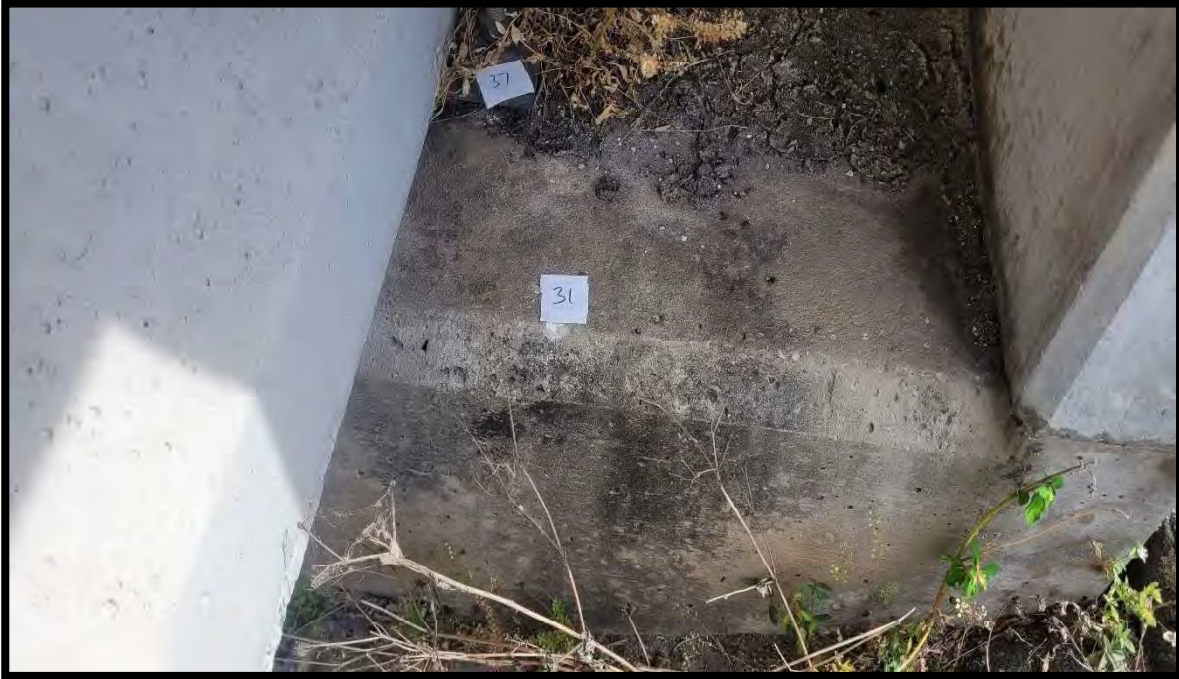
Photograph 33
View of Asbestos Homogeneous Area 11 – Concrete – Pylon Cap (Perpendicular Beam) of Bridge 910001
(Sample Location 31).
