DRAFT CONTAMINATION SCREENING EVALUATION REPORT

S.R. 70 PD&E Study

Limits of Project: From C.R. 721 S to C.R. 599/128th Avenue

Highlands and Okeechobee Counties, Florida

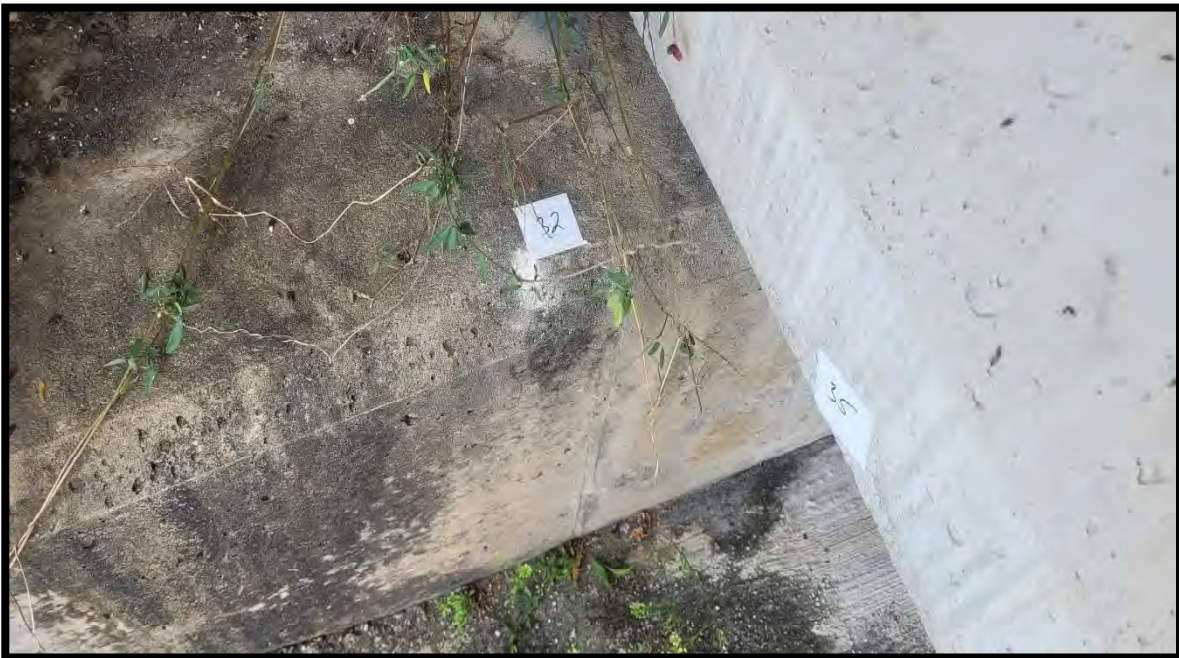
Photograph 34
View of Asbestos Homogeneous Area 11 – Concrete – Pylon Cap (Perpendicular Beam) of Bridge 910001
(Sample Location 32).

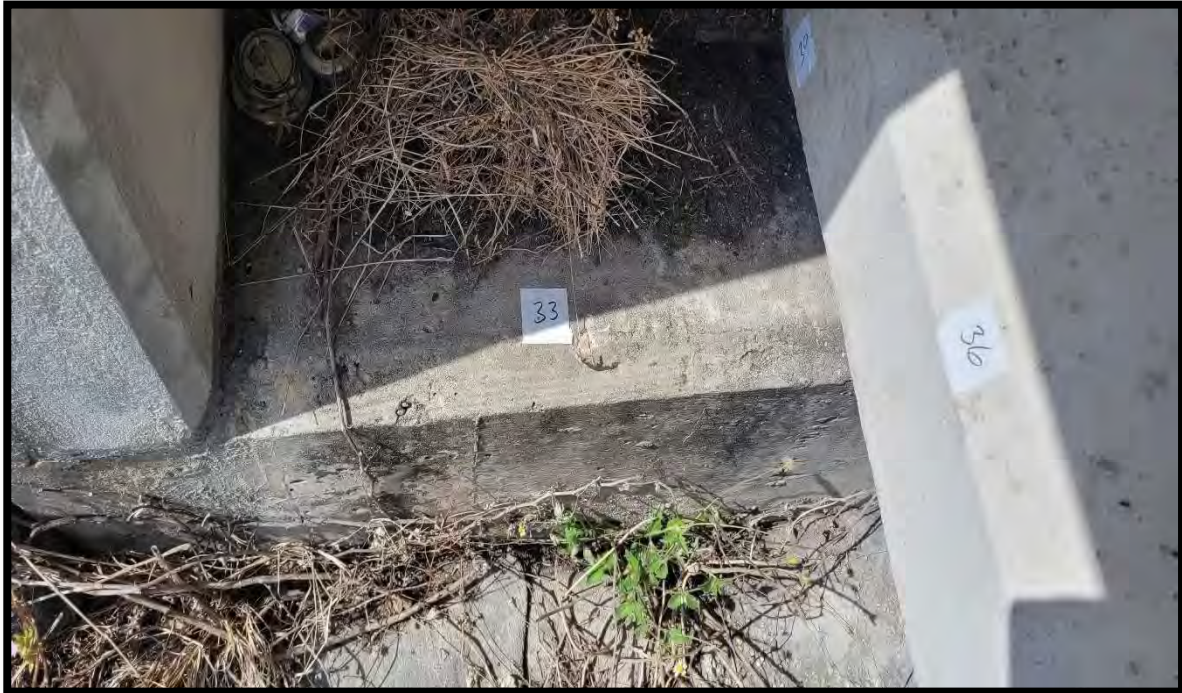
Photograph 35
View of Asbestos Homogeneous Area 11 – Concrete – Pylon Cap (Perpendicular Beam) of Bridge 910001 (Sample Location 33).

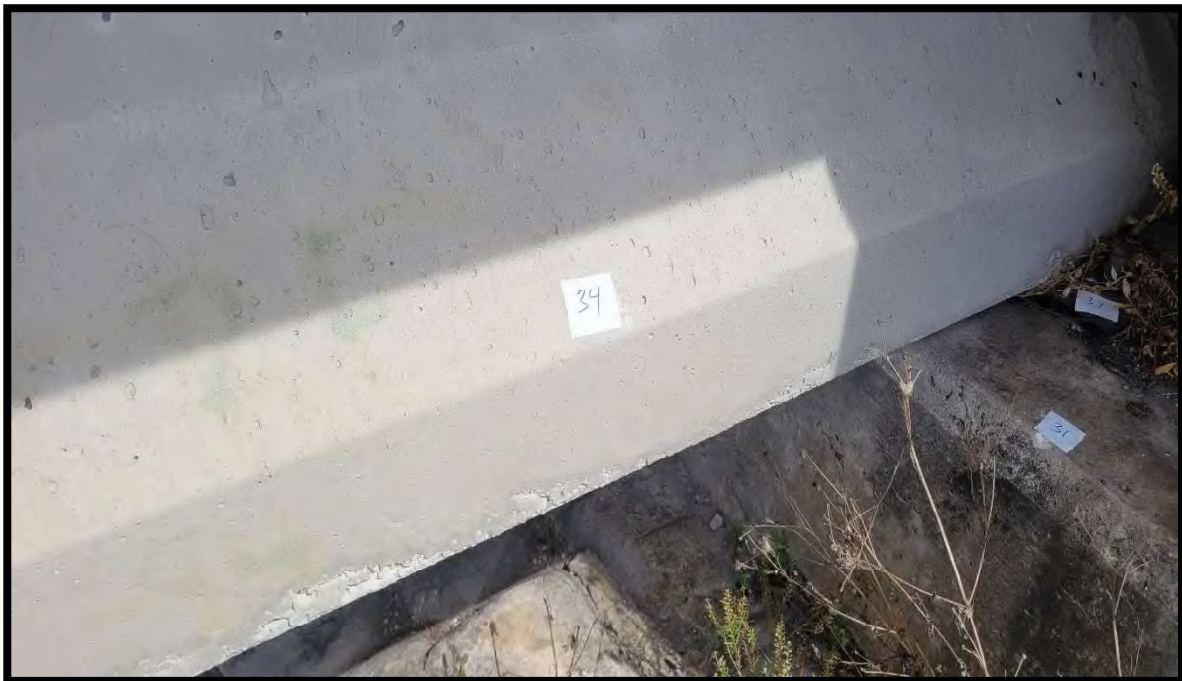
Photograph 36
View of Asbestos Homogeneous Area 12 – Concrete – Parallel I-Beam of Bridge 910001 (Sample Location 34).

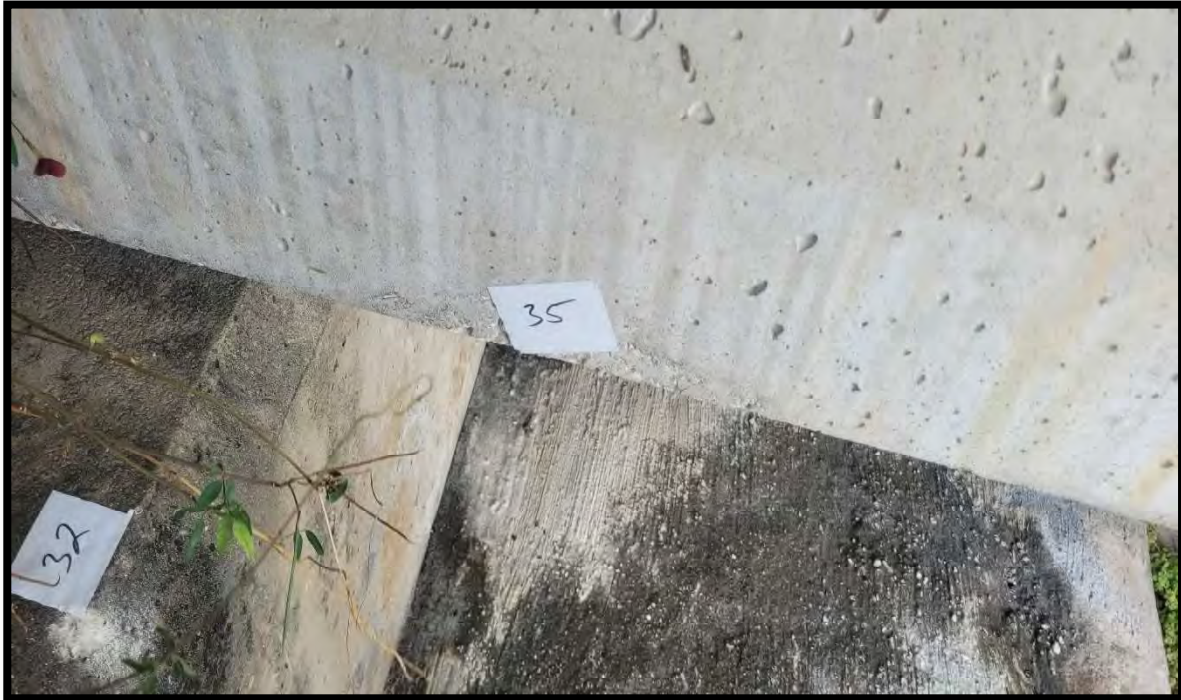
Photograph 37
View of Asbestos Homogeneous Area 12 – Concrete – Parallel I-Beam of Bridge 910001
(Sample Location 35).

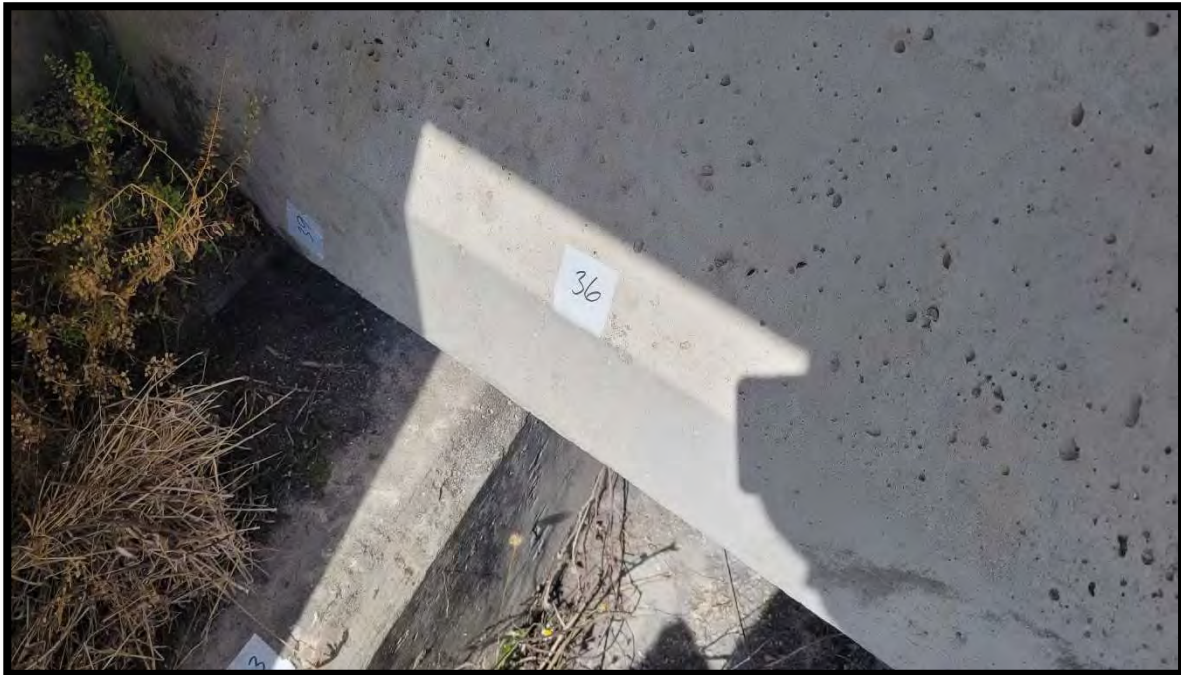
Photograph 38
View of Asbestos Homogeneous Area 12 – Concrete – Parallel I-Beam of Bridge 910001 (Sample Location 36).

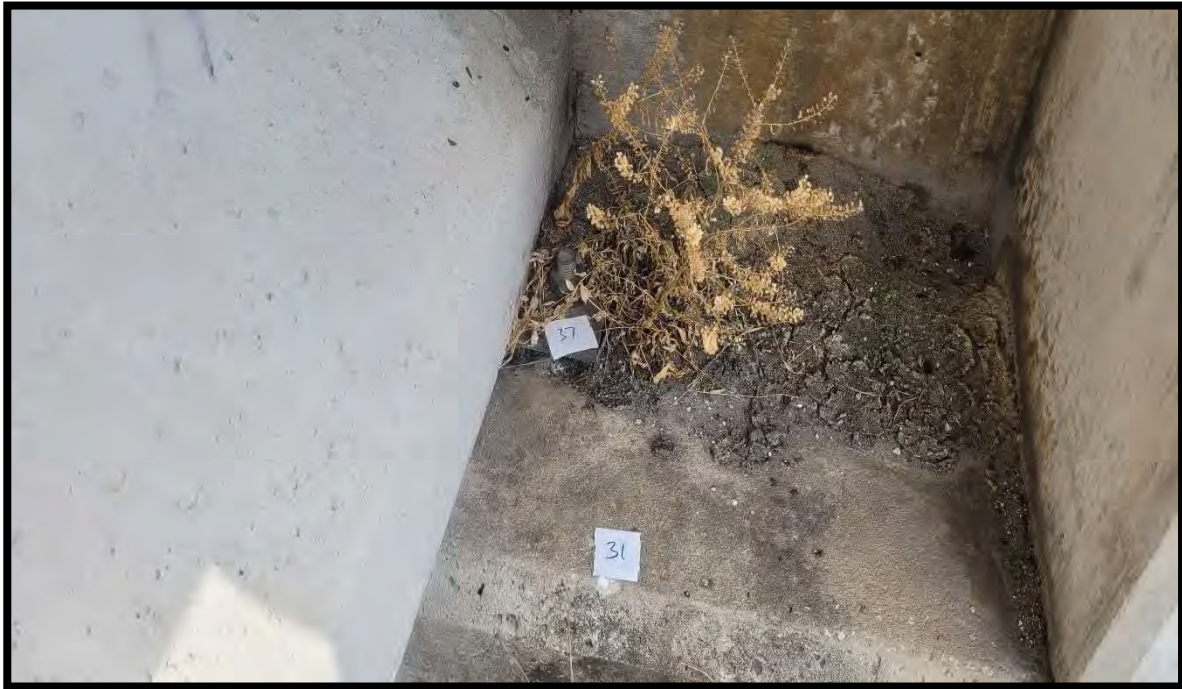
Photograph 39
View of Asbestos Homogeneous Area 13 – Rubber – Vibration Pads of Bridge 910001
(Sample Location 37).

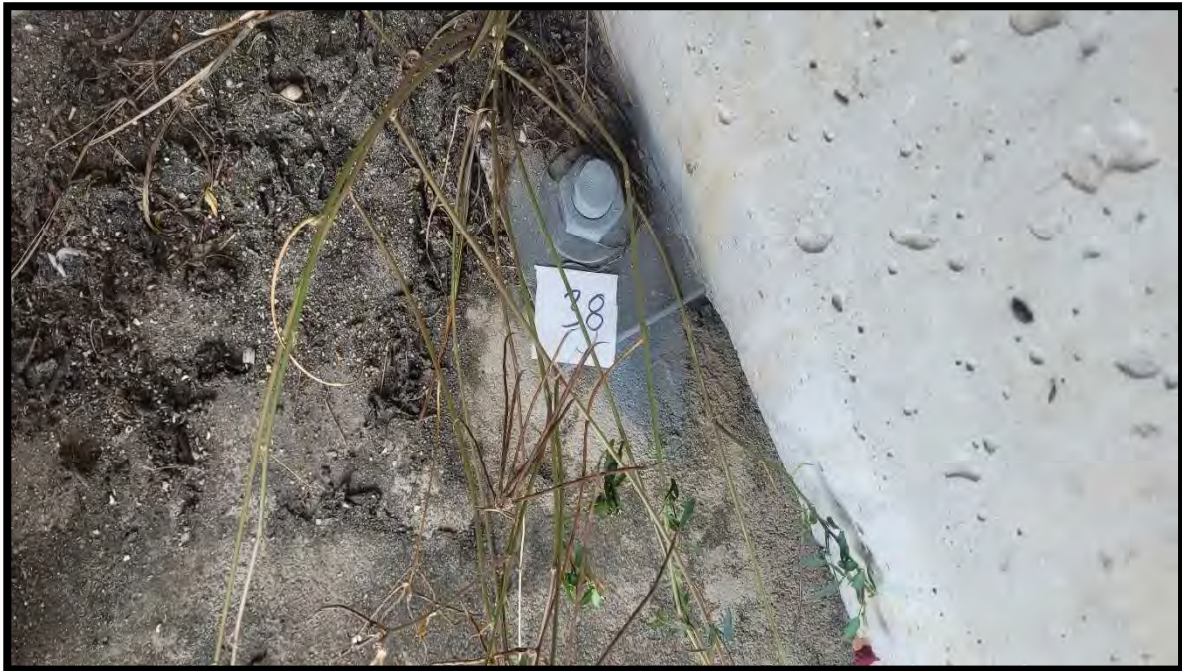
Photograph 40
View of Asbestos Homogeneous Area 13 – Rubber – Vibration Pads of Bridge 910001 (Sample Location 38).

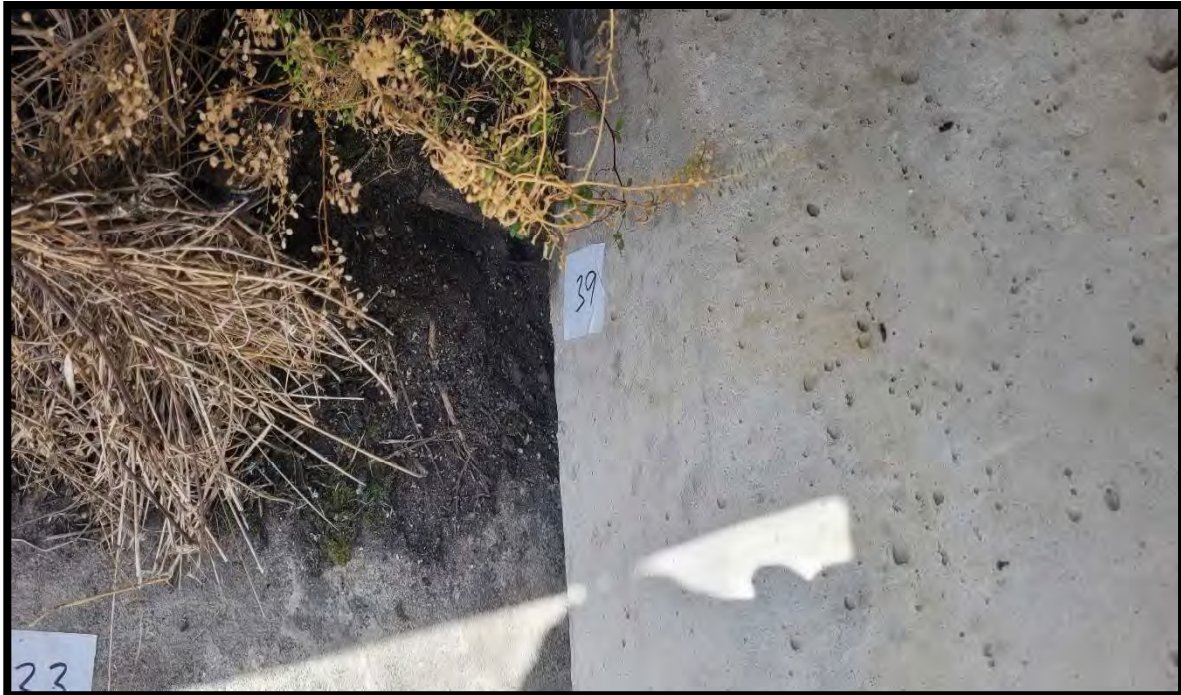
Photograph 41
View of Asbestos Homogeneous Area 13 – Rubber – Vibration Pads of Bridge 910001
(Sample Location 39).

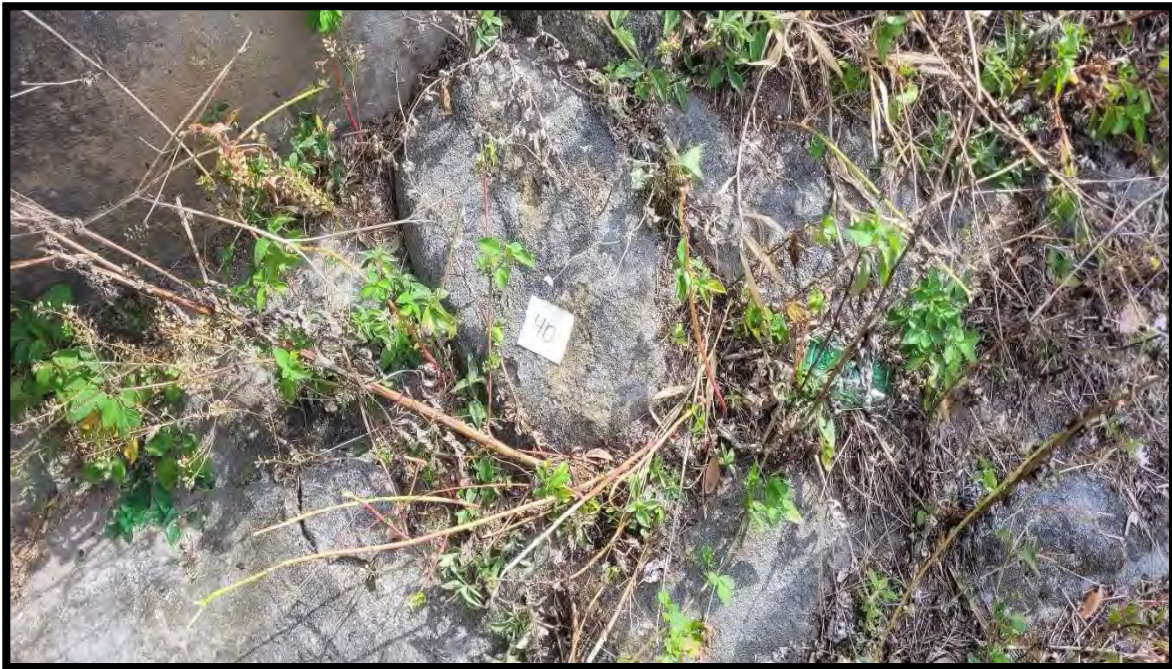
Photograph 42
View of Asbestos Homogeneous Area 14 – Concrete – Rip-Rap of Bridge 910001 (Sample Location 40).

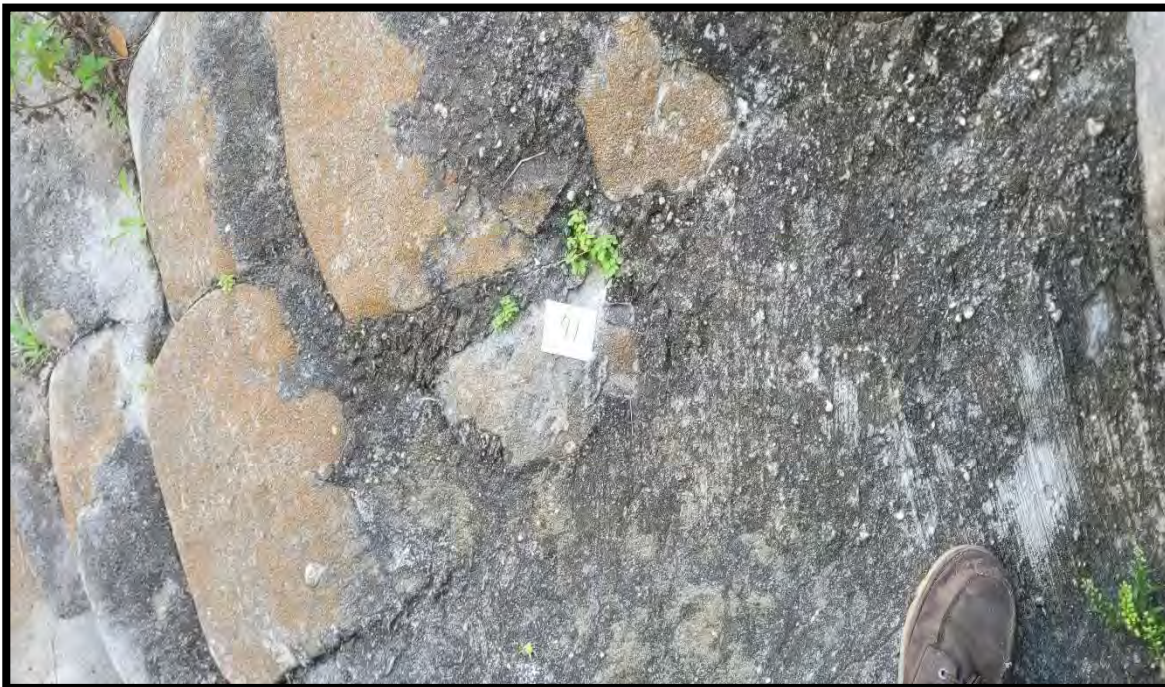
Photograph 43

View of Asbestos Homogeneous Area 14 – Concrete – Rip-Rap of Bridge 910001 (Sample Location 41).

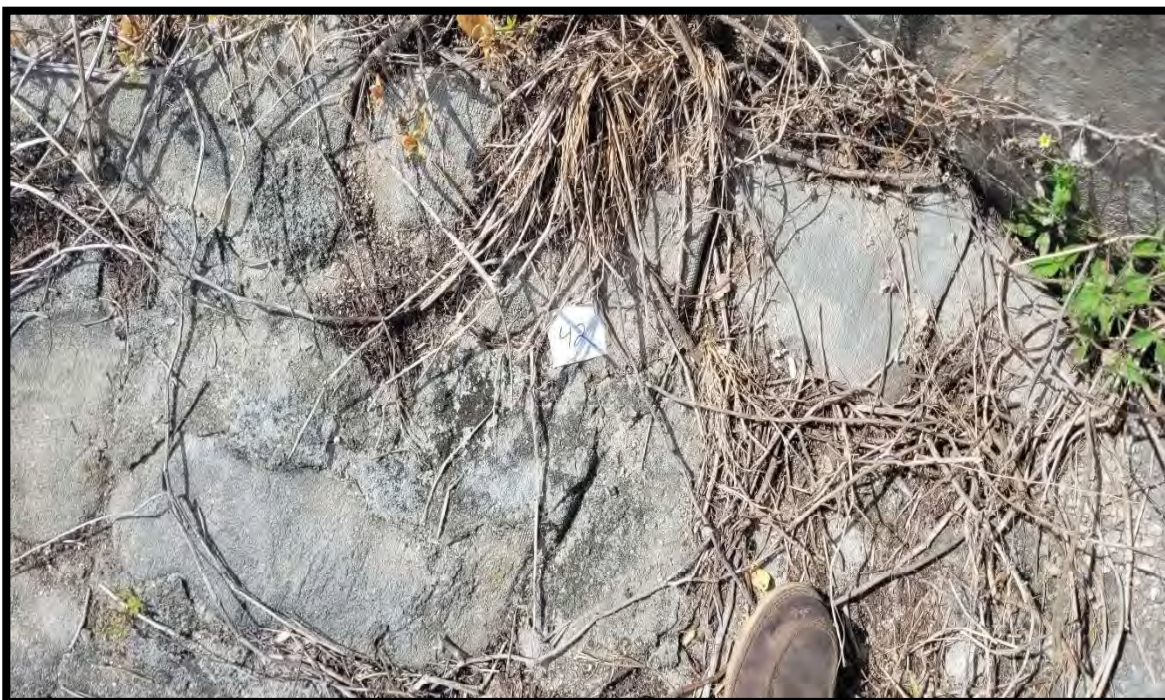
Photograph 44

View of Asbestos Homogeneous Area 14 – Concrete – Rip-Rap of Bridge 910001 (Sample Location 42).

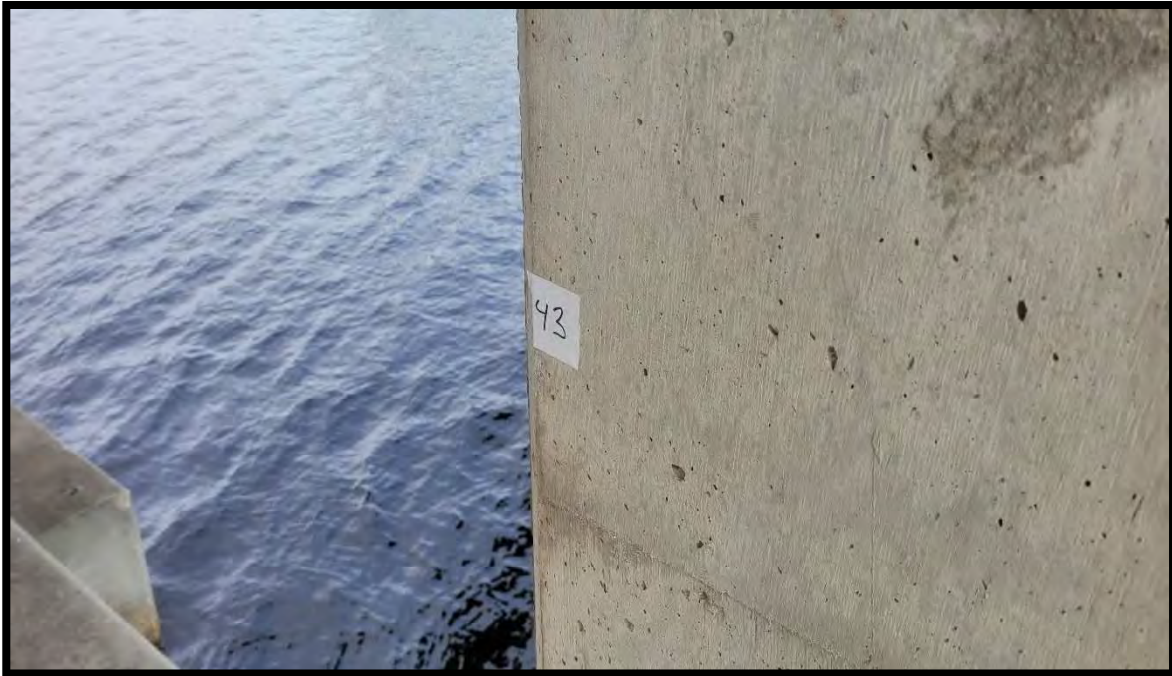
Photograph 45

View of Asbestos Homogeneous Area 15 – Concrete – Support Pylon of Bridge 910001 (Sample Location 43).

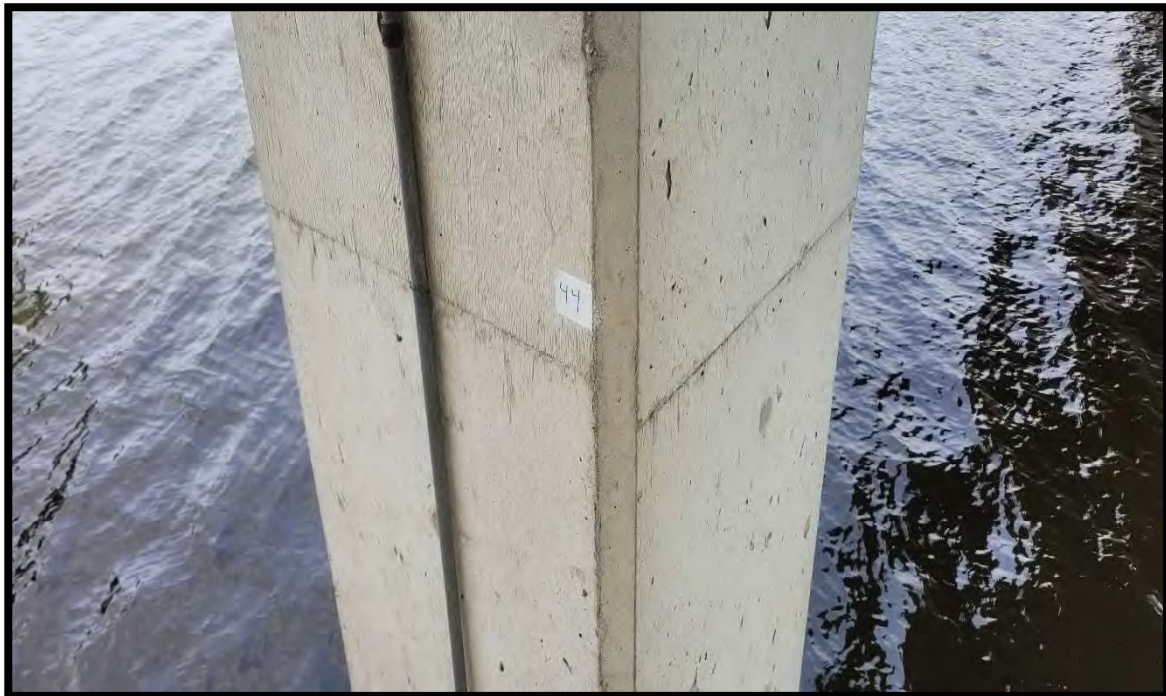
Photograph 46

View of Asbestos Homogeneous Area 15 – Concrete – Support Pylon of Bridge 910001 (Sample Location 44).

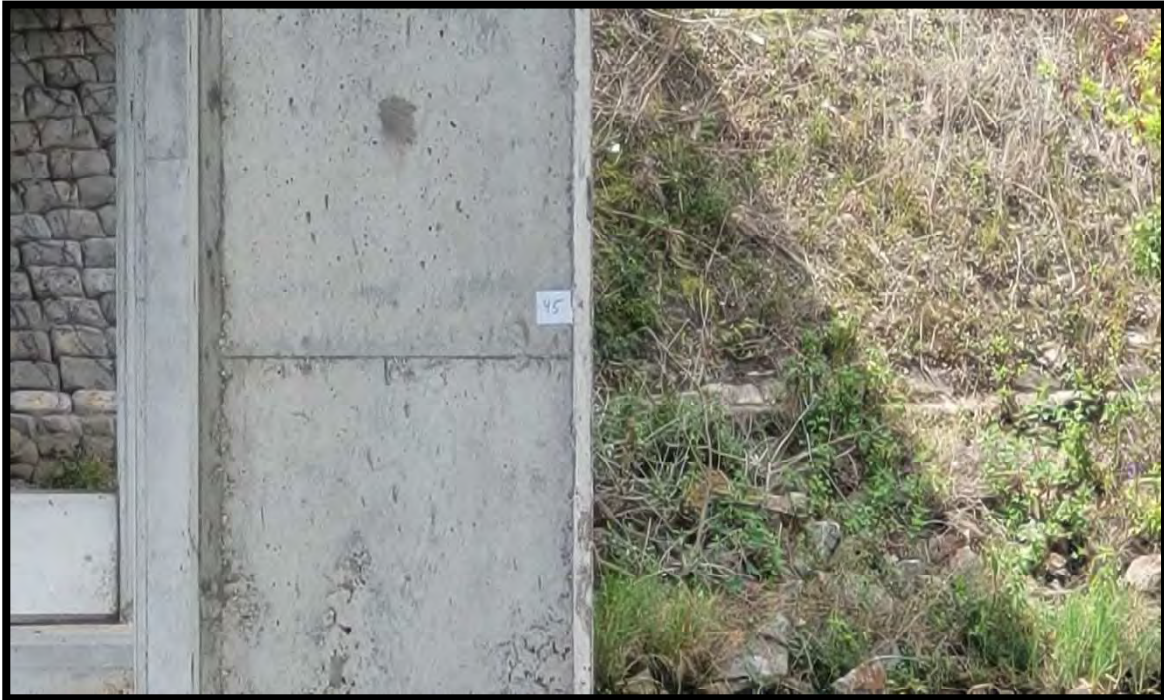
Photograph 47

View of Asbestos Homogeneous Area 15 – Concrete – Support Pylon of Bridge 910001 (Sample Location 45).

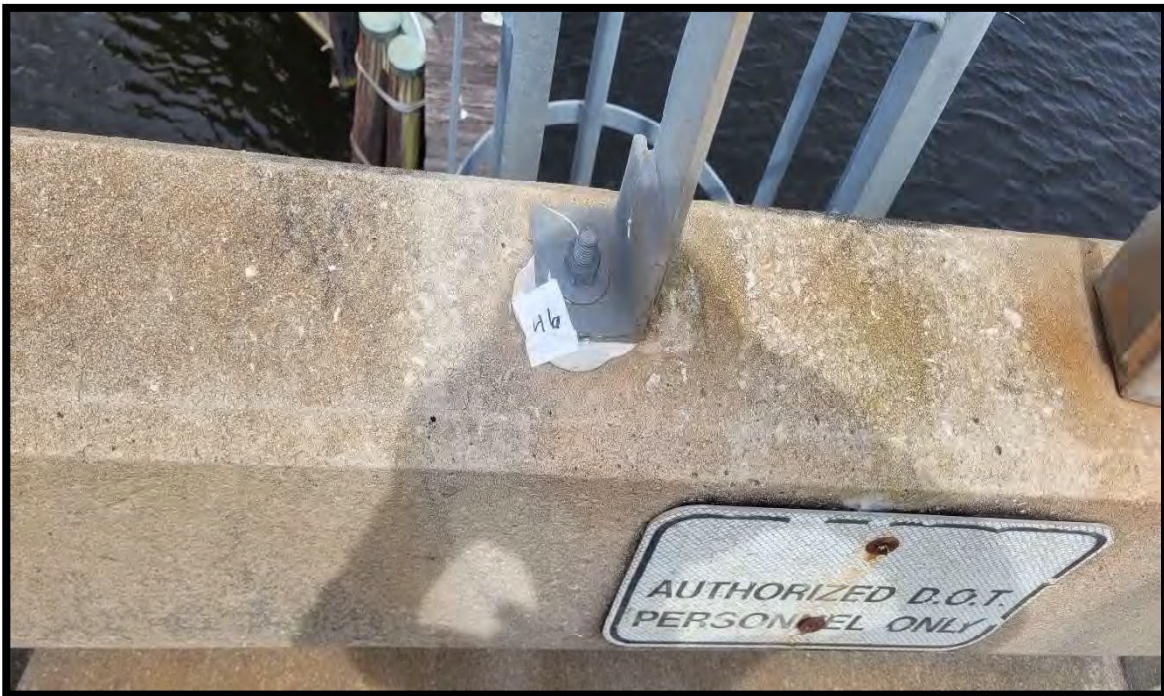
Photograph 48

View of Asbestos Homogeneous Area 16 – White Caulk – Ladder Anchor Points of Bridge 910001 (Sample Location 46).

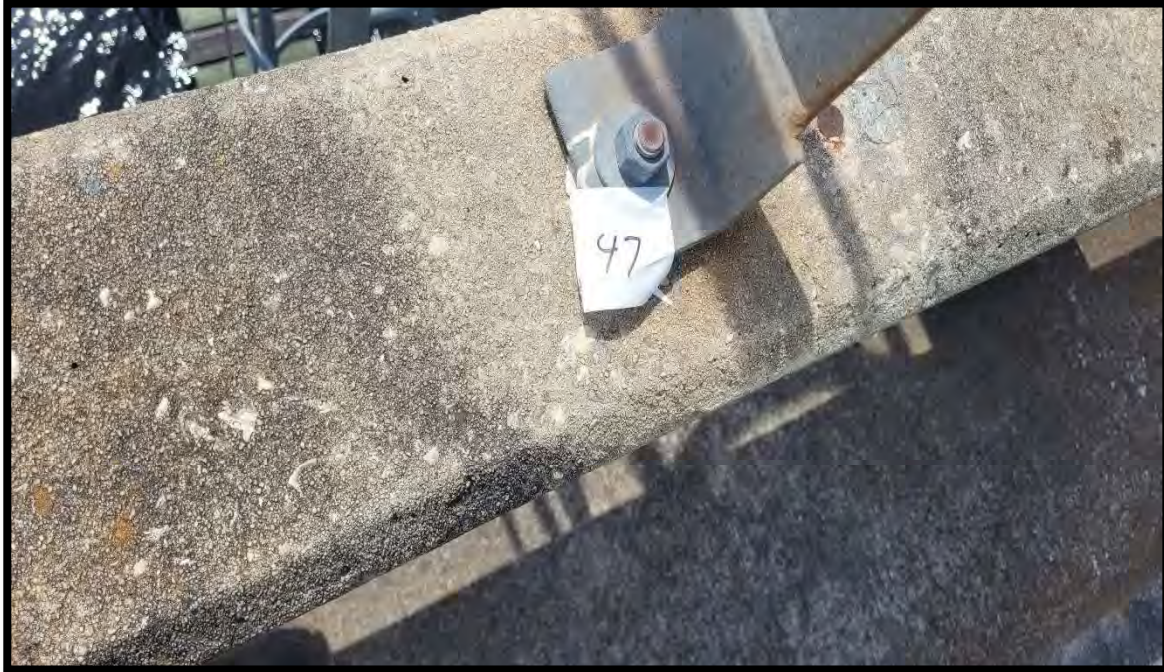
Photograph 49
View of Asbestos Homogeneous Area 16 – White Caulk – Ladder Anchor Points of Bridge 910001
(Sample Location 47).

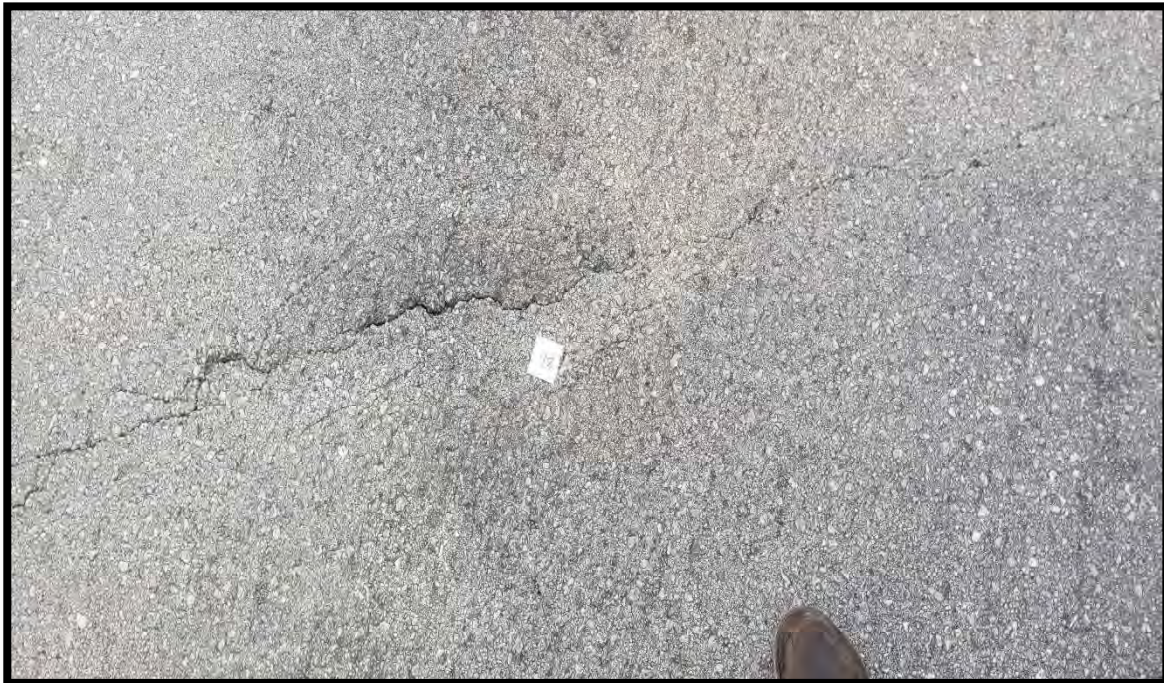
Photograph 50
View of Asbestos Homogeneous Area 17 – Asphalt – Roadway Approach of Bridge 910002 (Sample Location 48).

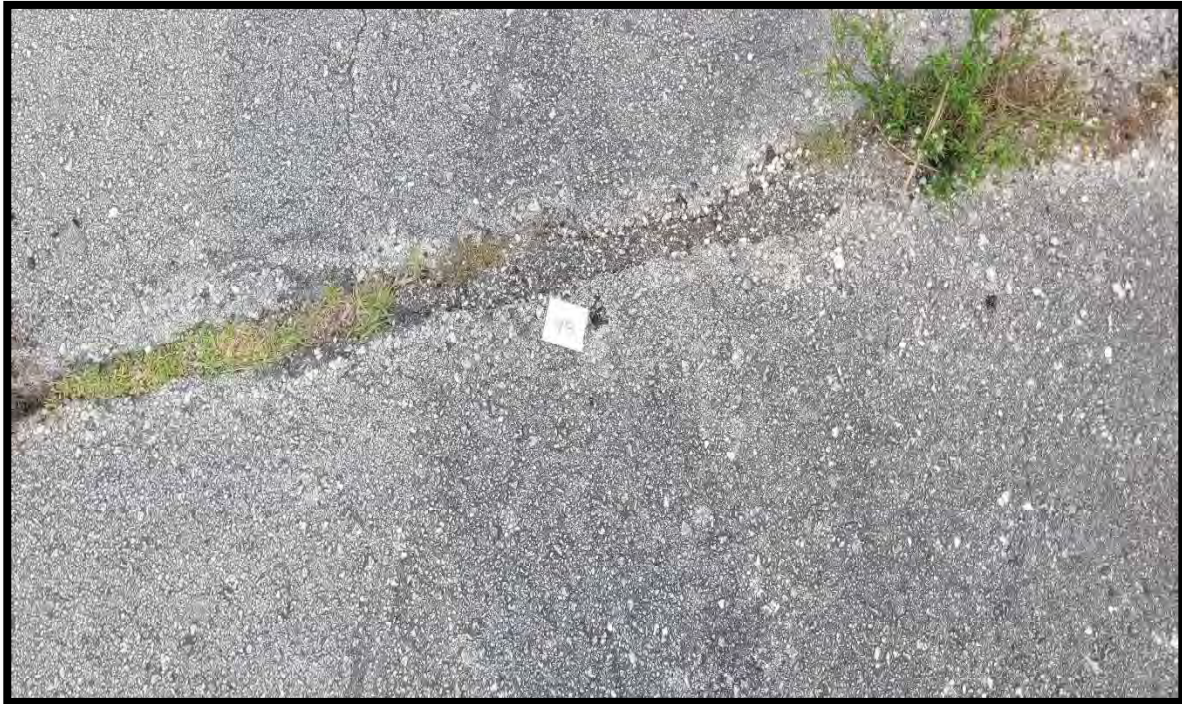
Photograph 51
View of Asbestos Homogeneous Area 17 – Asphalt – Roadway Approach of Bridge 910002
(Sample Location 49).

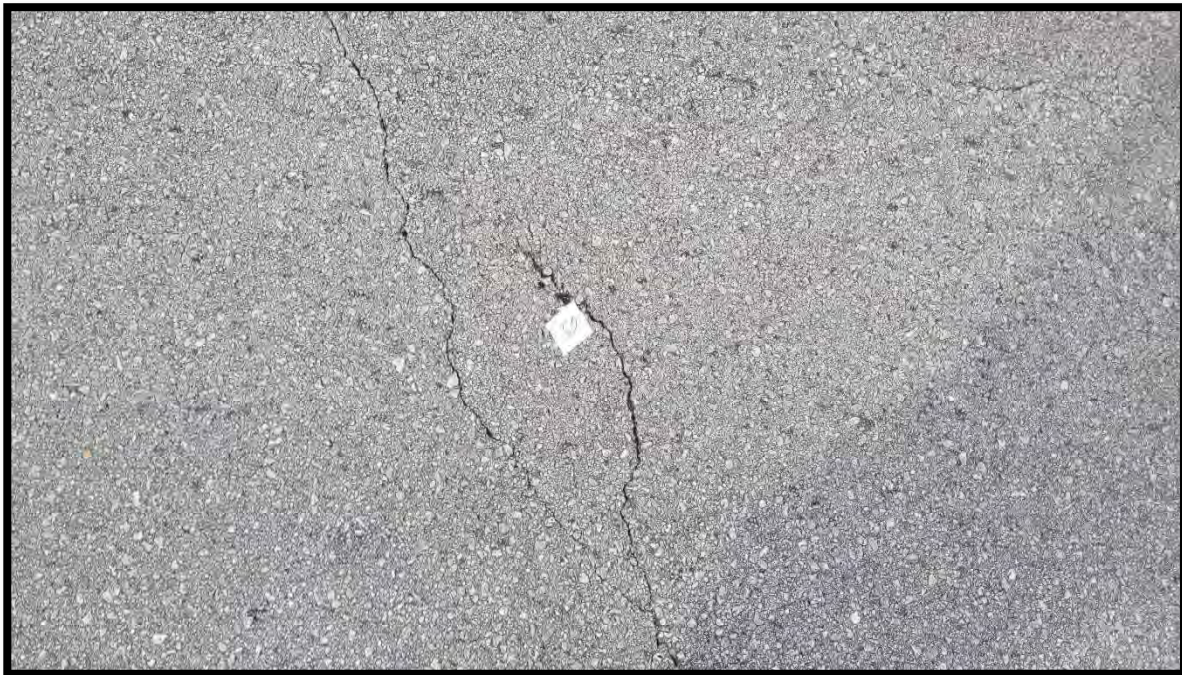
Photograph 52
View of Asbestos Homogeneous Area 17 – Asphalt – Roadway Approach of Bridge 910002 (Sample Location 50).

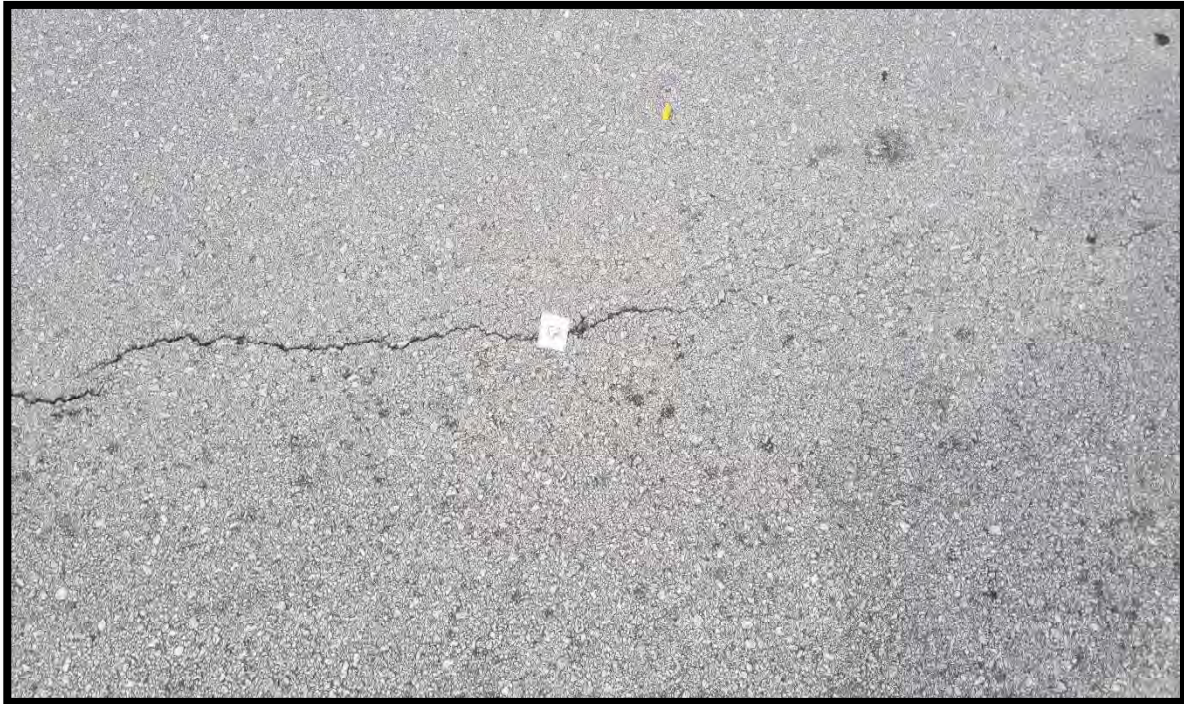
Photograph 53
View of Asbestos Homogeneous Area 18 – Asphalt – Bridge Roadway of Bridge 910002
(Sample Location 52).

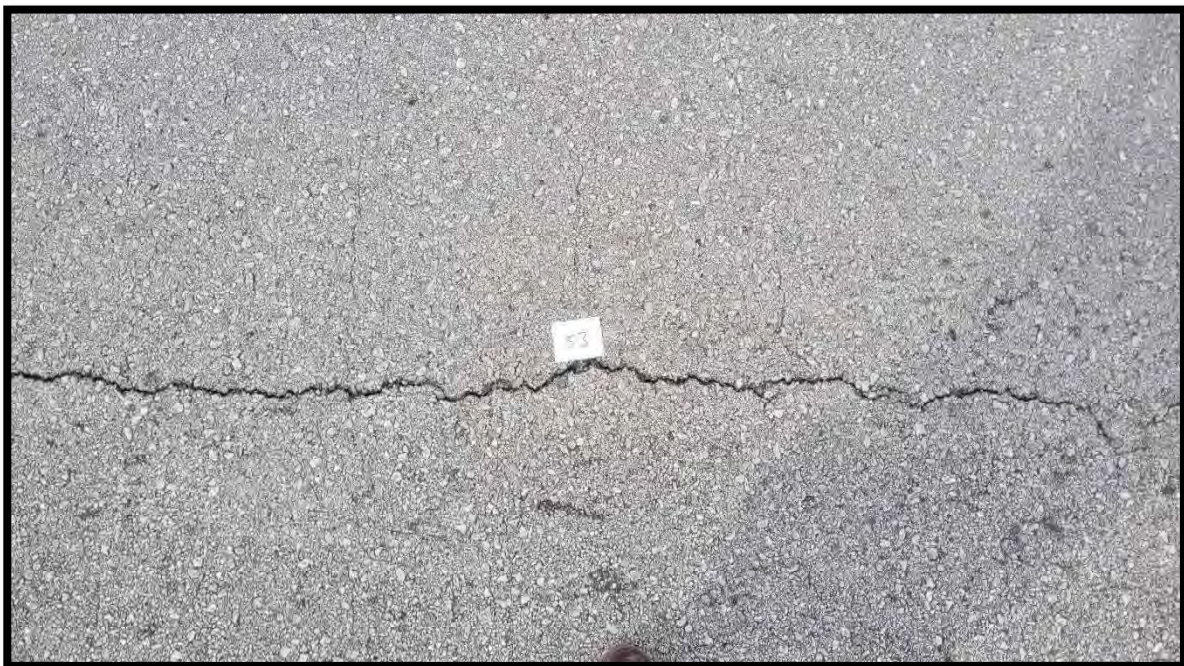
Photograph 54
View of Asbestos Homogeneous Area 18 – Asphalt – Bridge Roadway of Bridge 910002 (Sample Location 53).

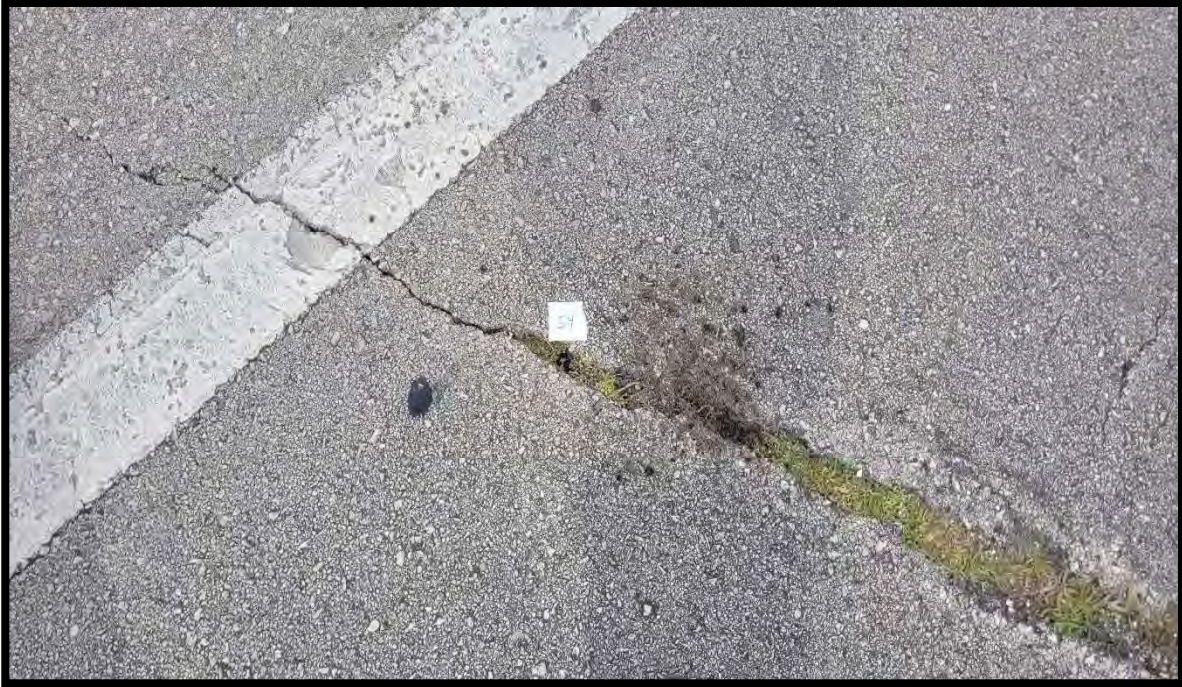
Photograph 55
View of Asbestos Homogeneous Area 19 – Asphalt – Expansion Joint of Bridge 910002
(Sample Location 54).

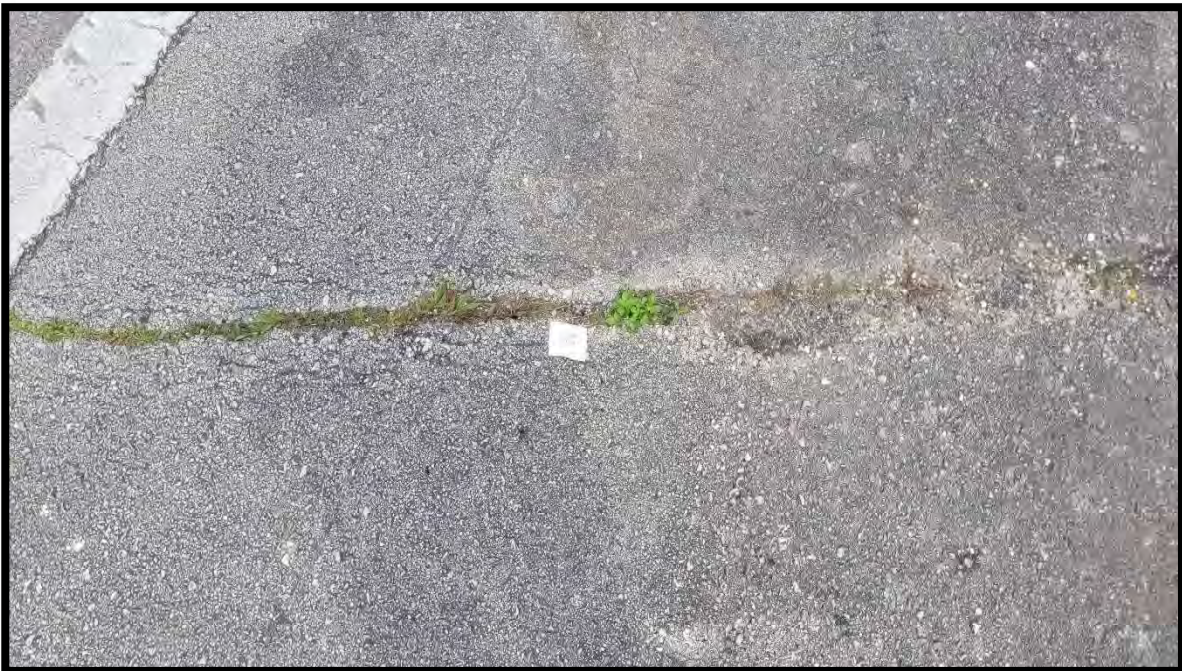
Photograph 56
View of Asbestos Homogeneous Area 19 – Asphalt – Expansion Joint of Bridge 910002 (Sample Location 55).

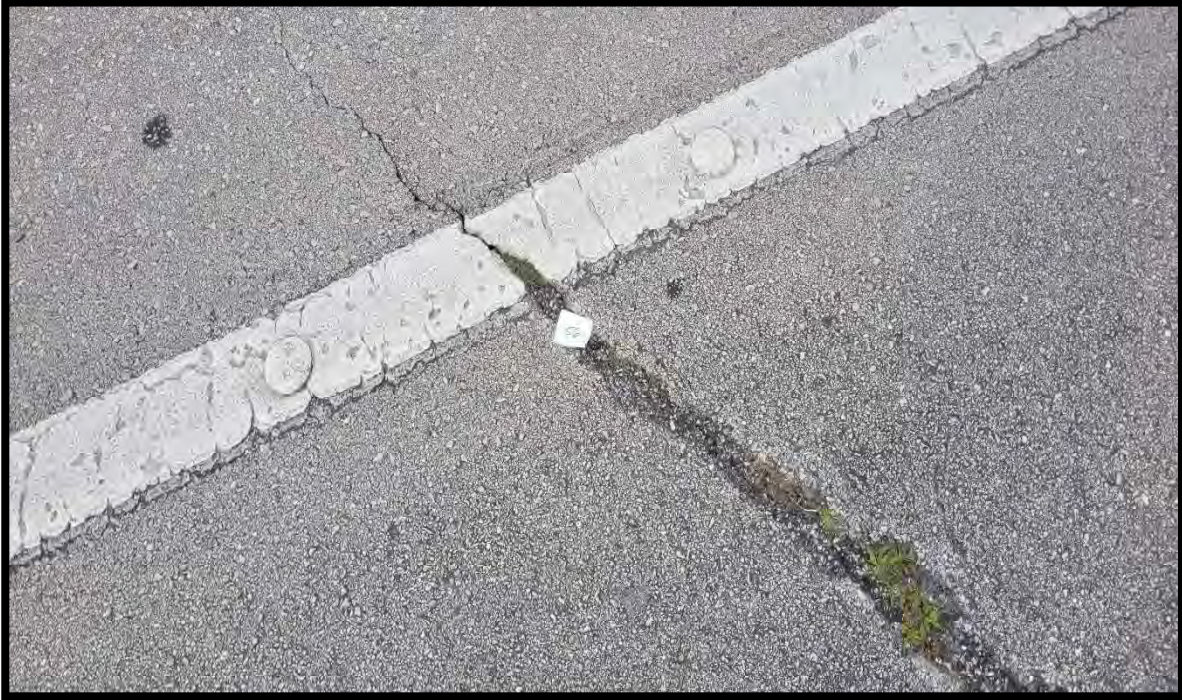
Photograph 57
View of Asbestos Homogeneous Area 19 – Asphalt – Expansion Joint of Bridge 910002
(Sample Location 56).

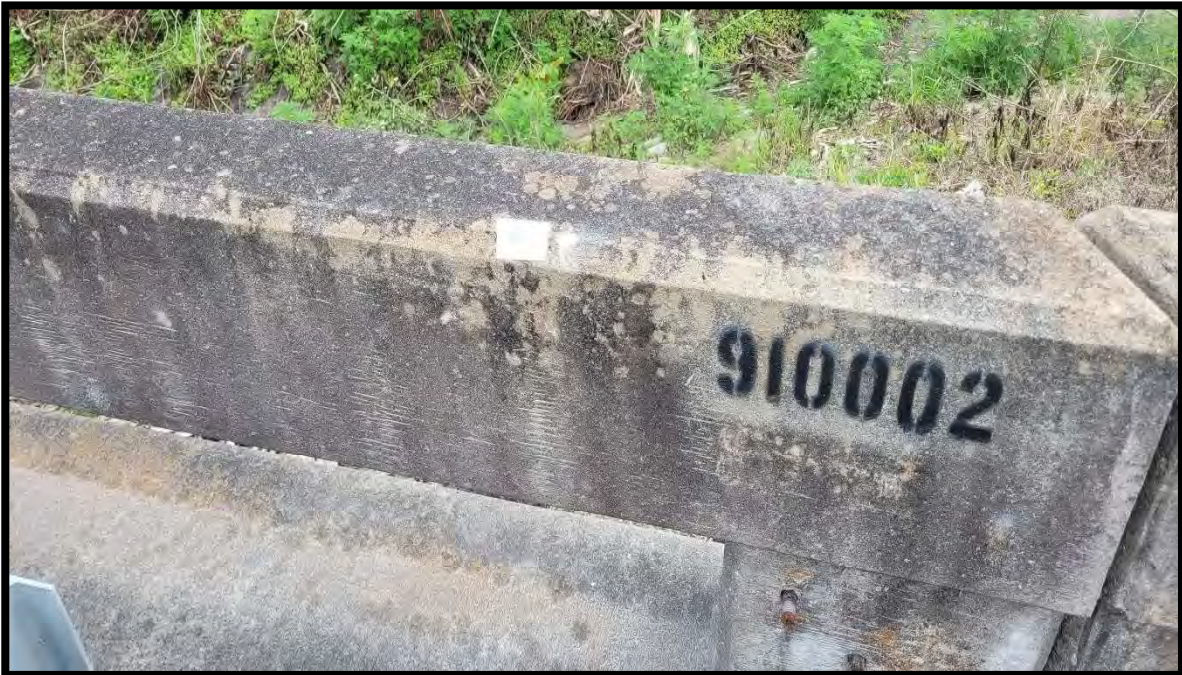
Photograph 58
View of Asbestos Homogeneous Area 20 – Concrete – Guardrail of Bridge 910002 (Sample Location 57).

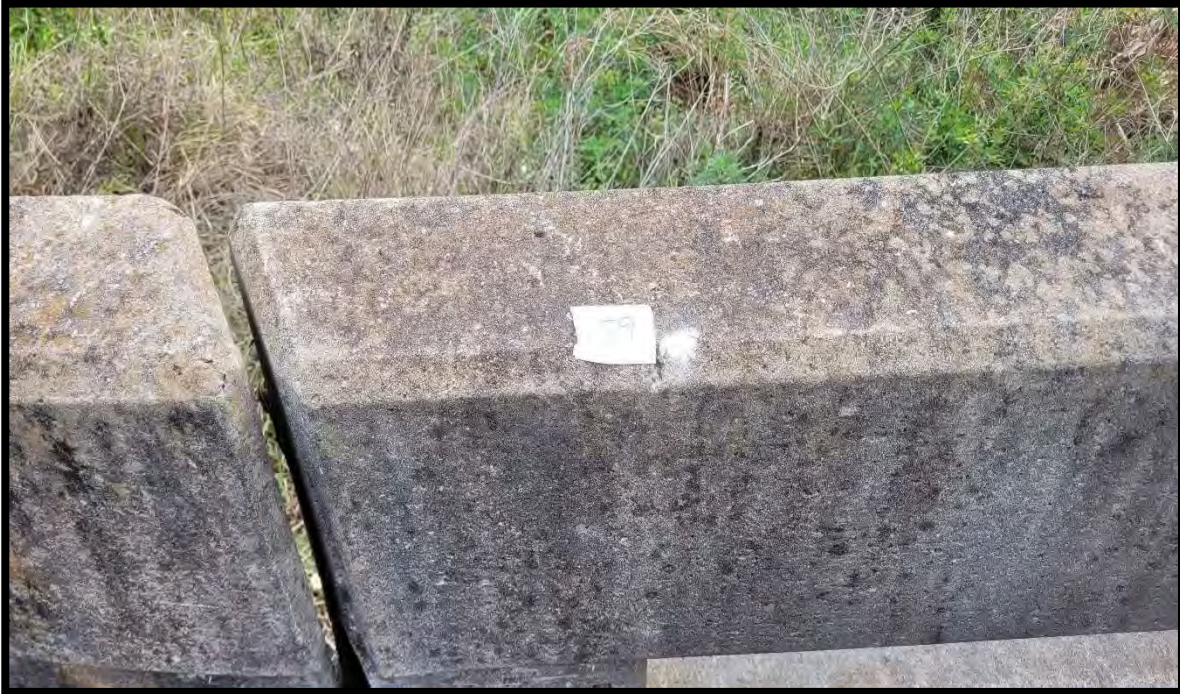
Photograph 59

View of Asbestos Homogeneous Area 20 – Concrete – Guardrail of Bridge 910002 (Sample Location 59).

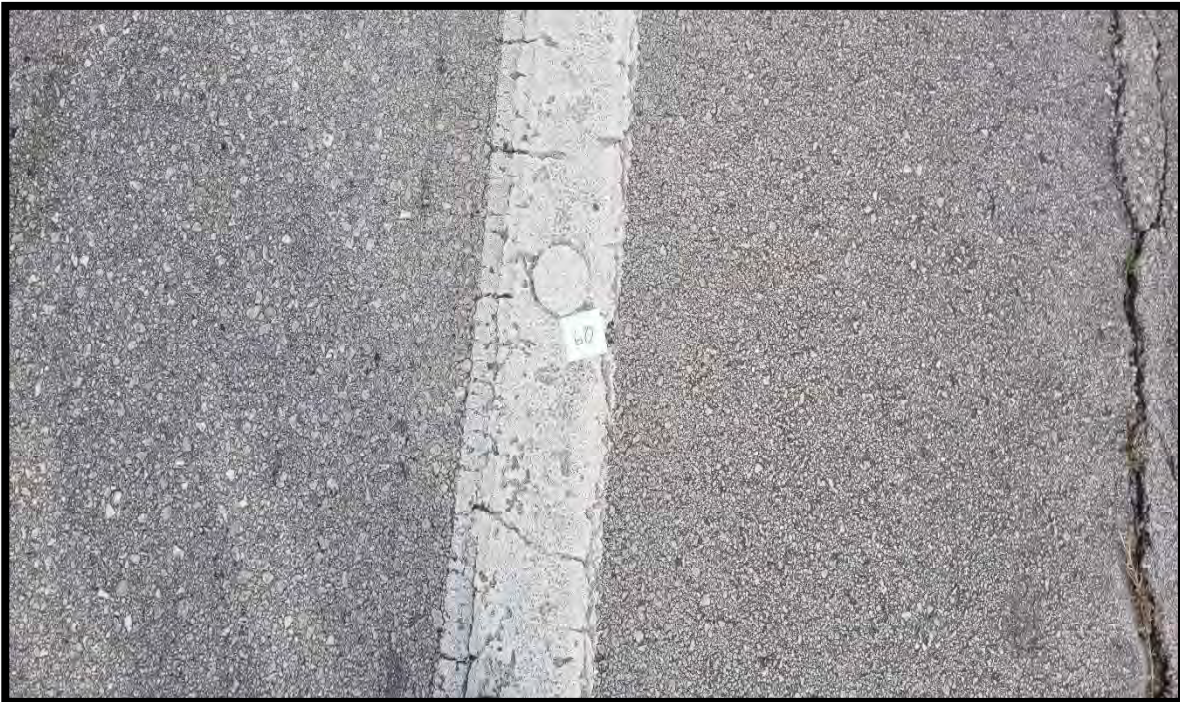
Photograph 60

View of Asbestos Homogeneous Area 21 – White Paint – White Striping of Bridge 910002 (Sample Location 60).
