DRAFT CONTAMINATION SCREENING EVALUATION REPORT

S.R. 70 PD&E Study

Limits of Project: From C.R. 721 S to C.R. 599/128th Avenue

Highlands and Okeechobee Counties, Florida

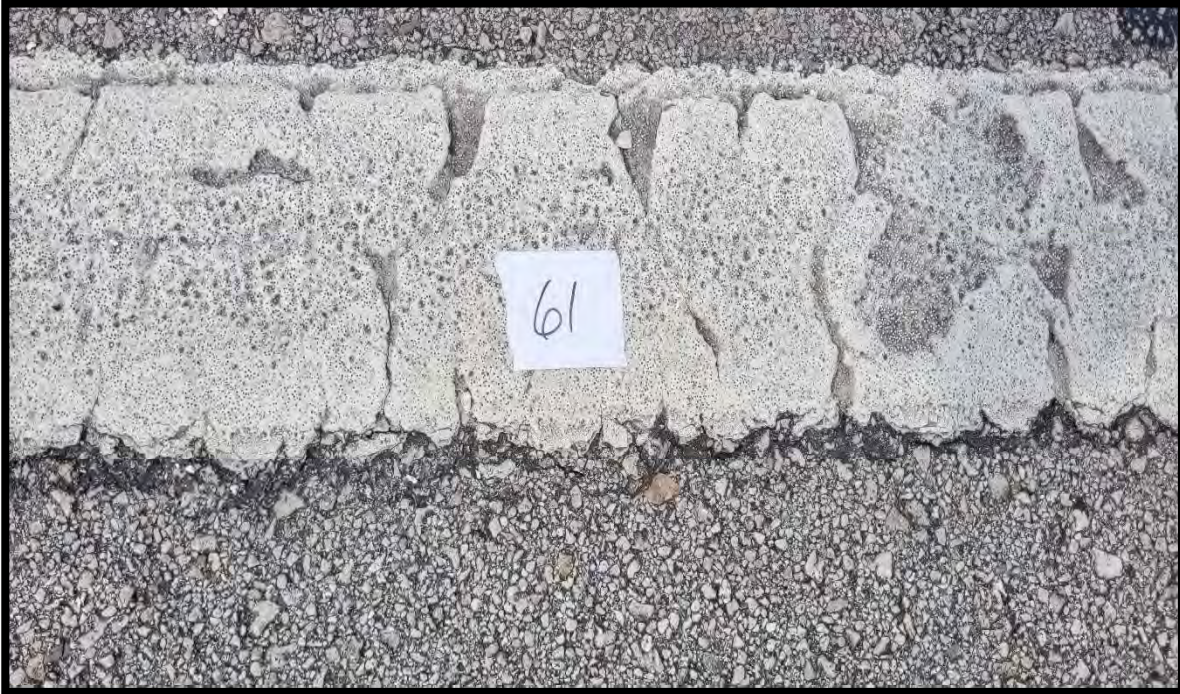
Photograph 61

View of Asbestos Homogeneous Area 21 – White Paint – White Striping of Bridge 910002 (Sample Location 61).

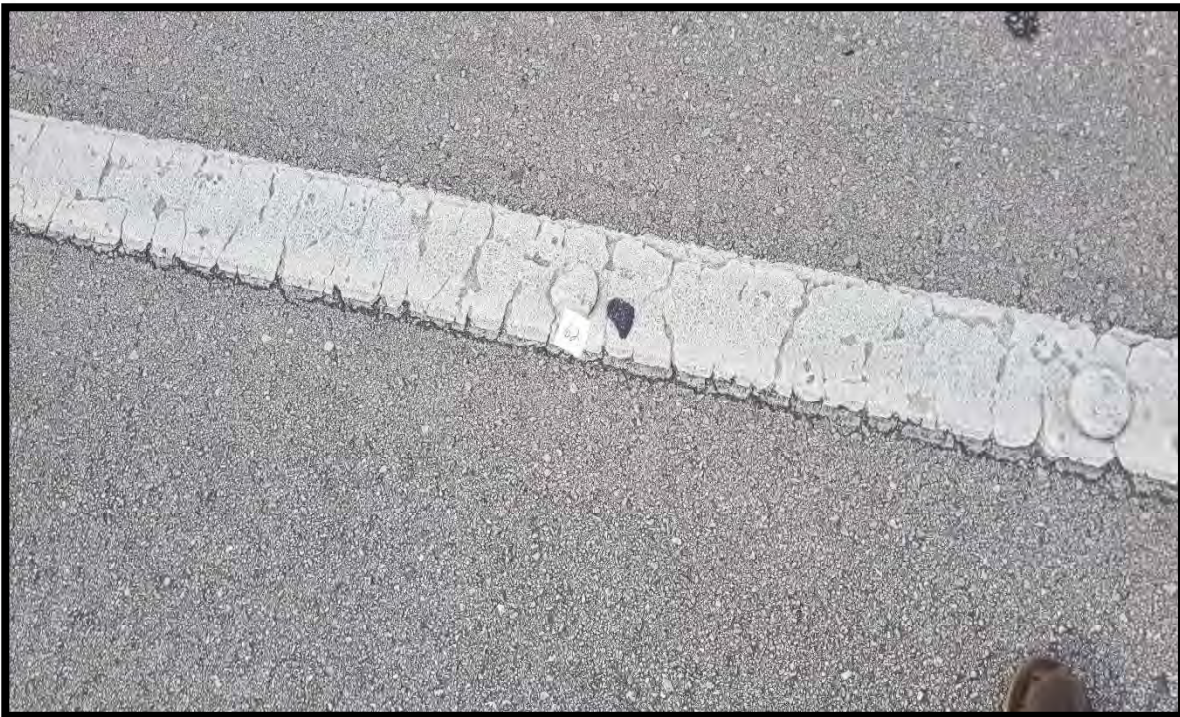
Photograph 62

View of Asbestos Homogeneous Area 21 – White Paint – White Striping of Bridge 910002 (Sample Location 62).

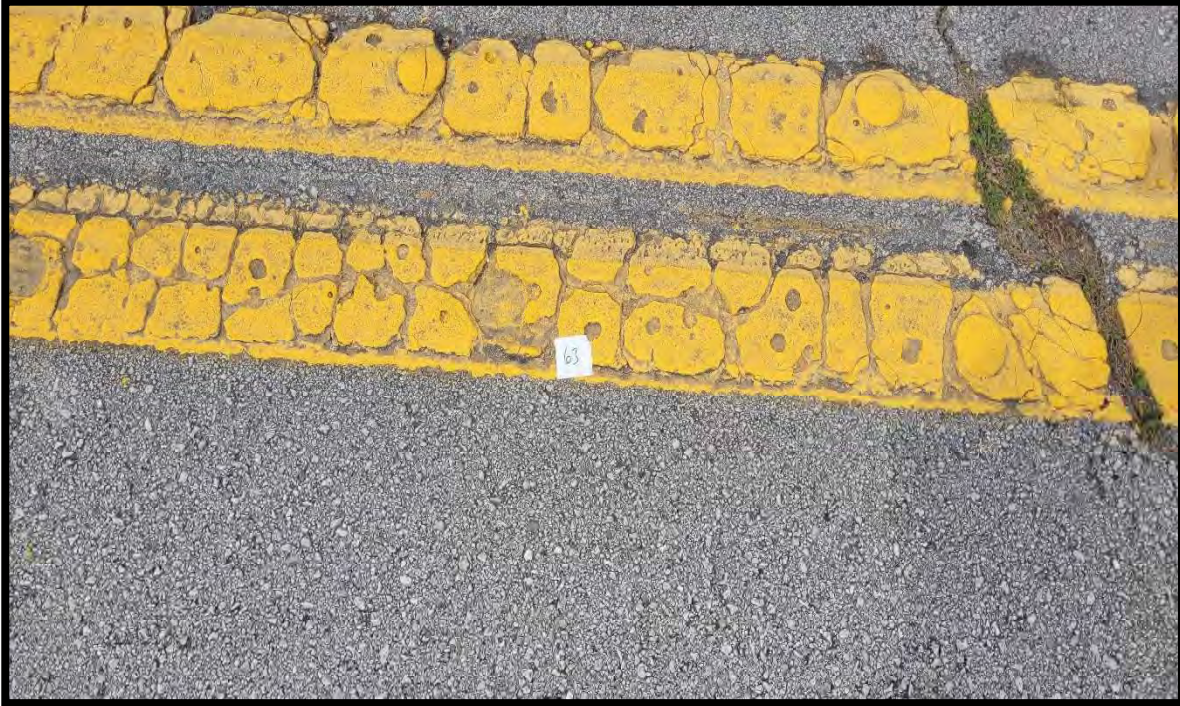
Photograph 63

View of Asbestos Homogeneous Area 22 – Yellow Paint – Yellow Striping of Bridge 910002 (Sample Location 63).

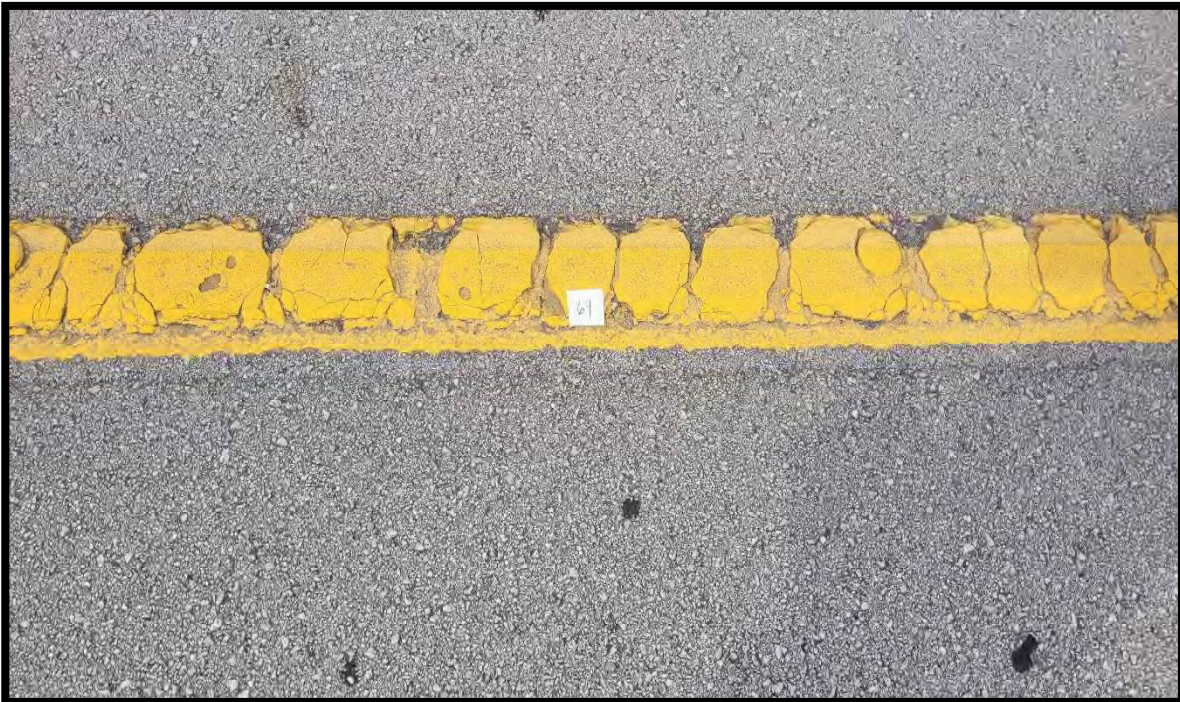
Photograph 64

View of Asbestos Homogeneous Area 22 – Yellow Paint – Yellow Striping of Bridge 910002 (Sample Location 64).

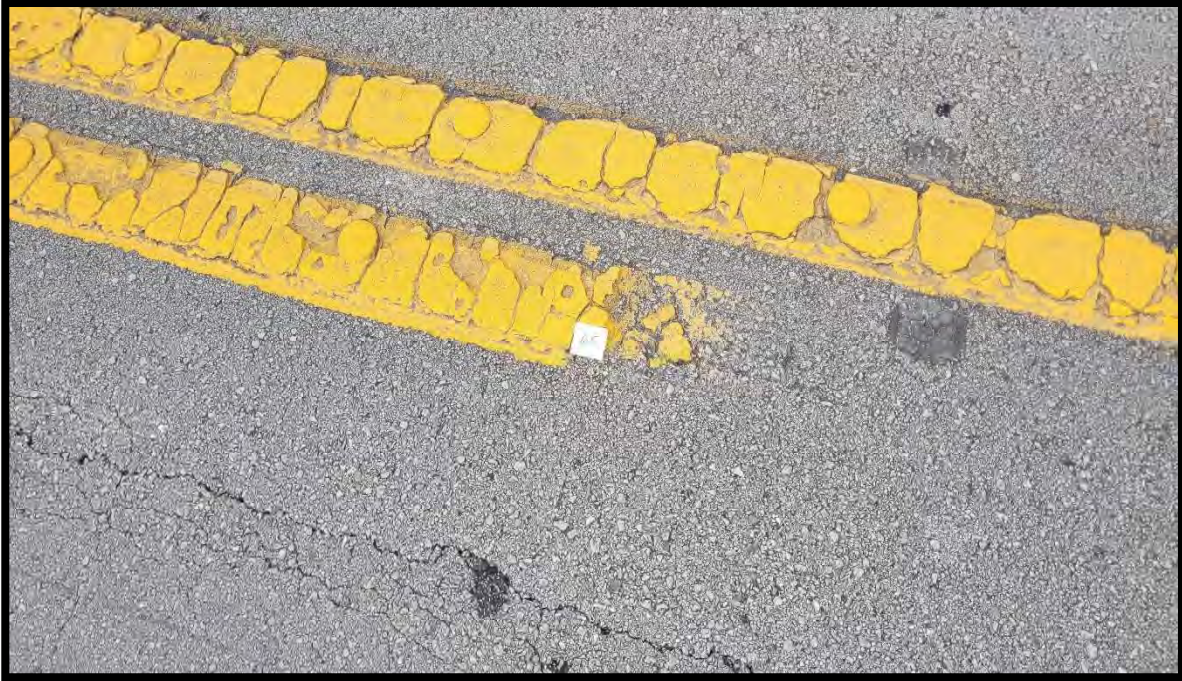
Photograph 65

View of Asbestos Homogeneous Area 22 – Yellow Paint – Yellow Striping of Bridge 910002 (Sample Location 65).

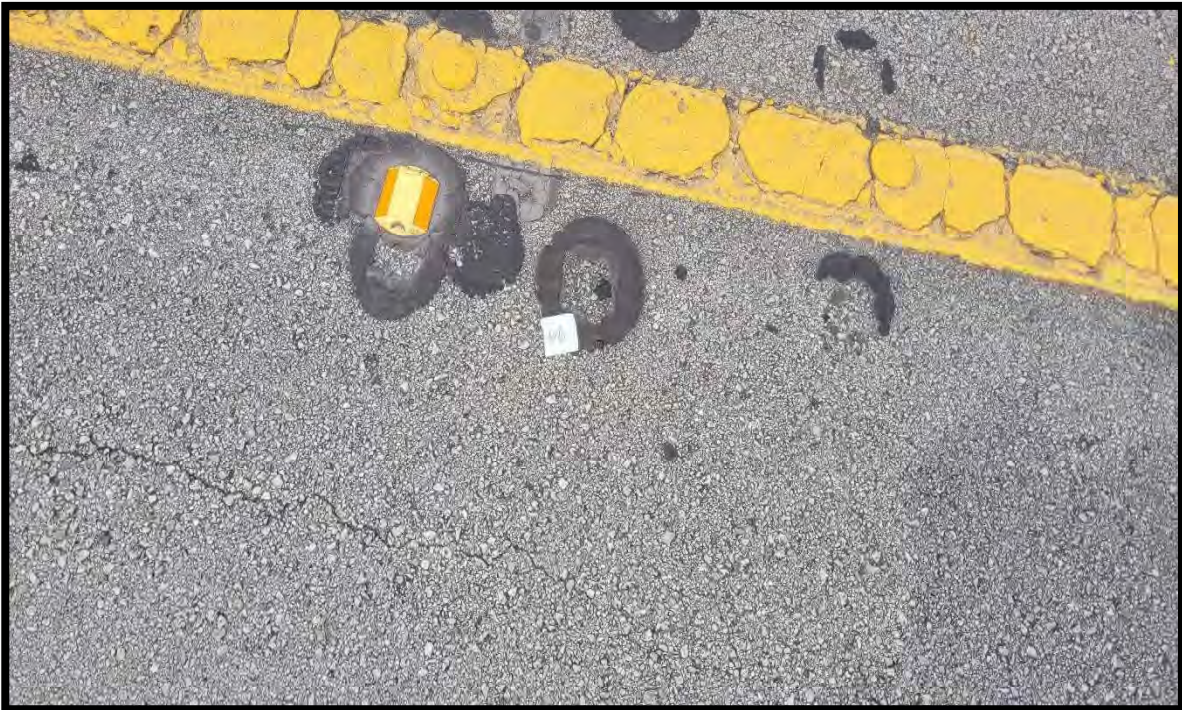
Photograph 66

View of Asbestos Homogeneous Area 23 – Black Mastic – Roadbed Reflectors of Bridge 910002 (Sample Location 66).

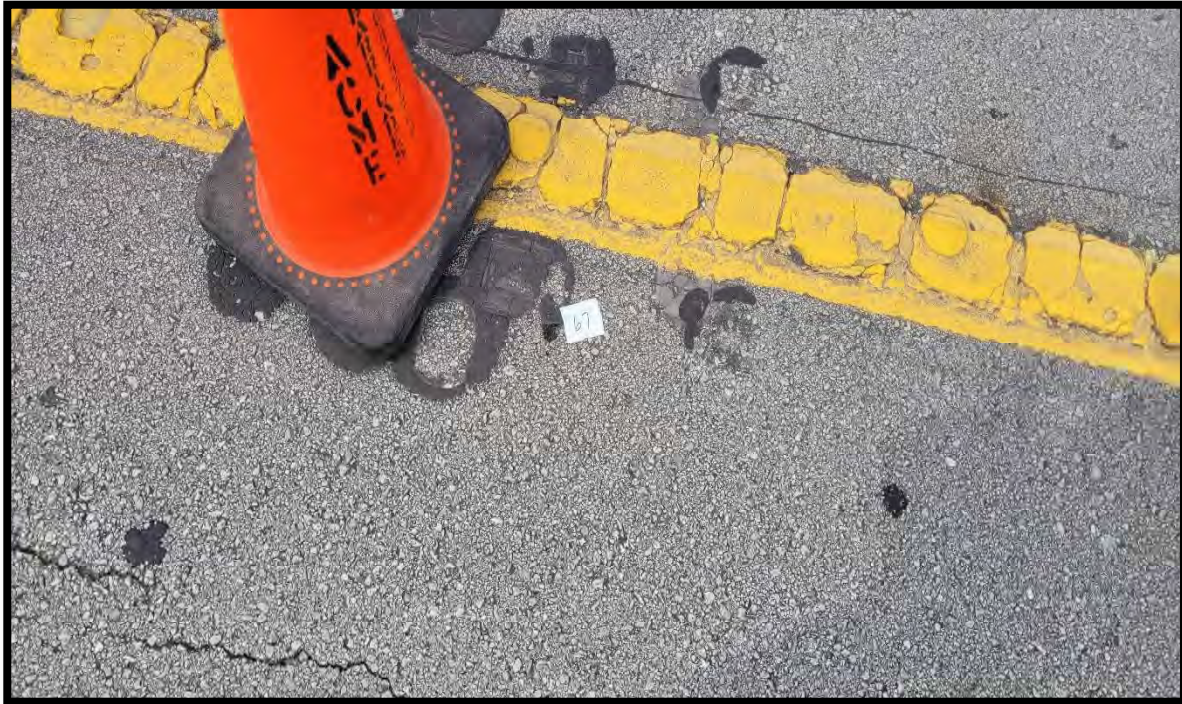
Photograph 67

View of Asbestos Homogeneous Area 23 – Black Mastic – Roadbed Reflectors of Bridge 910002 (Sample Location 67).

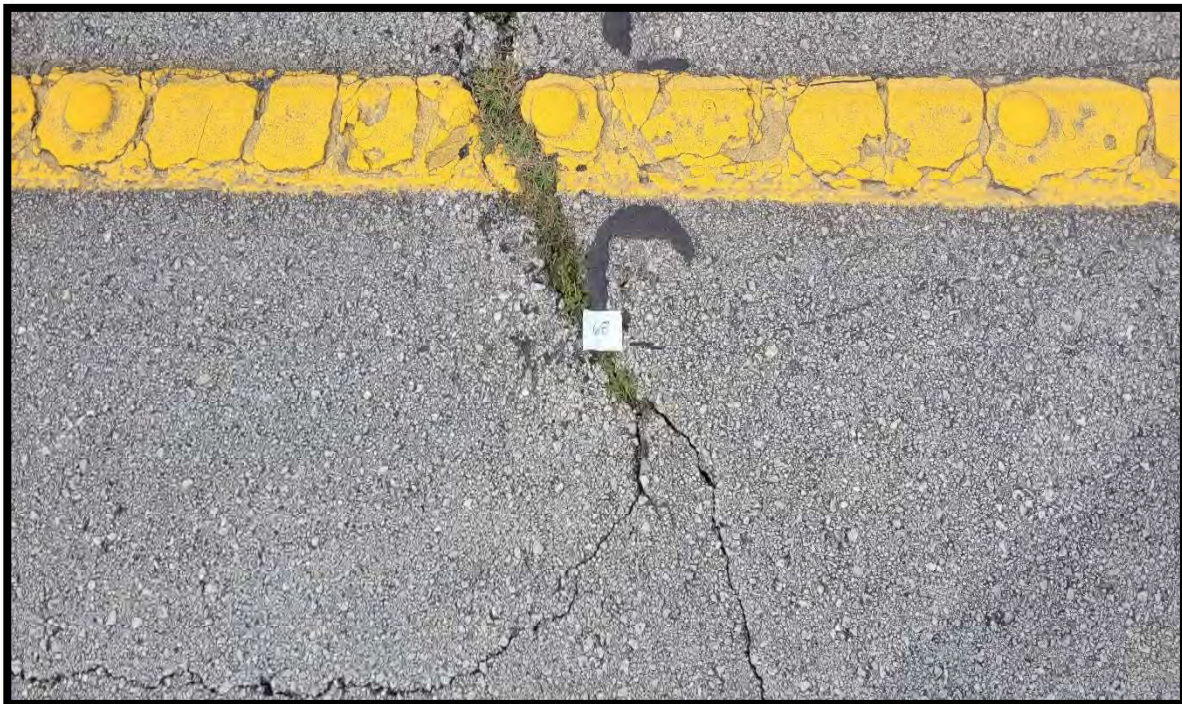
Photograph 68

View of Asbestos Homogeneous Area 23 – Black Mastic – Roadbed Reflectors of Bridge 910002 (Sample Location 68).

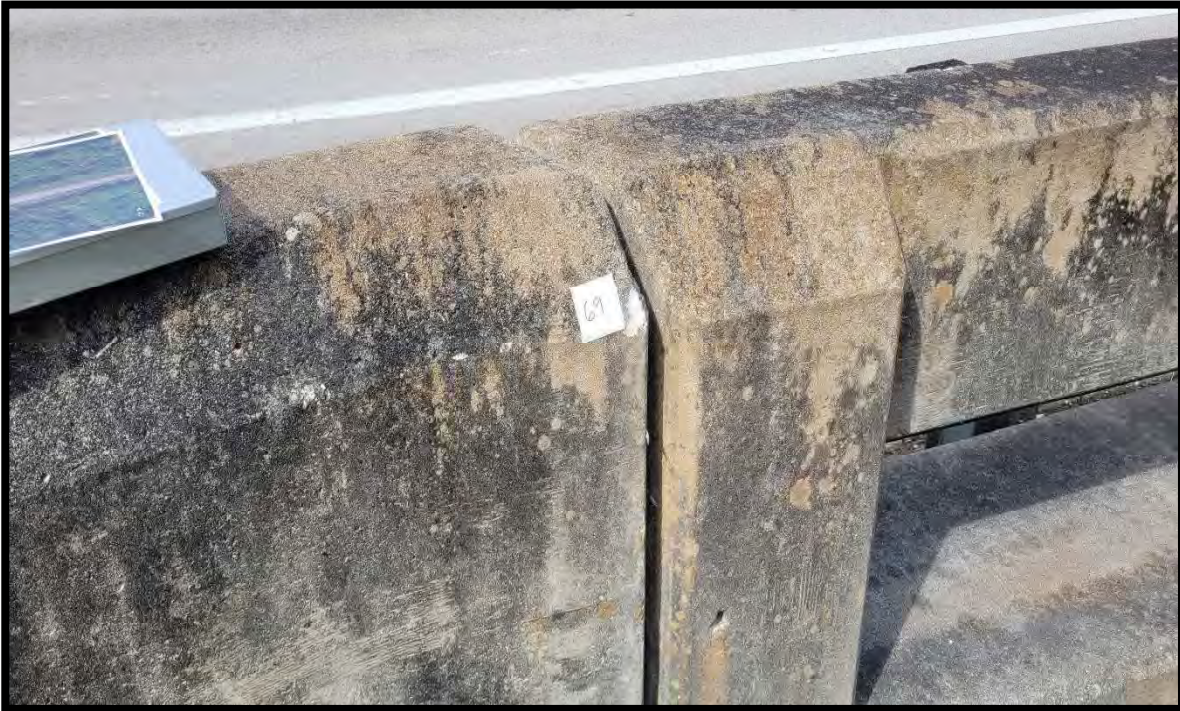
Photograph 69

View of Asbestos Homogeneous Area 24 – Concrete – Landside Buttress of Bridge 910002 (Sample Location 69).

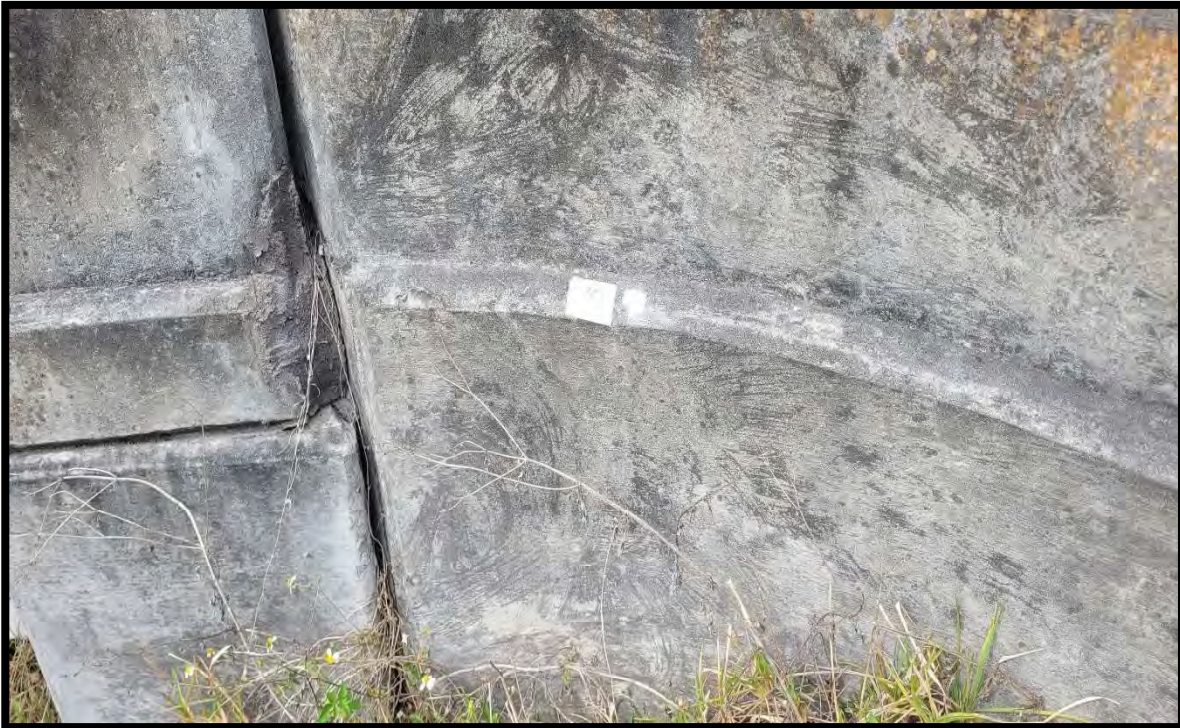
Photograph 70

View of Asbestos Homogeneous Area 24 – Concrete – Landside Buttress of Bridge 910002 (Sample Location 70).

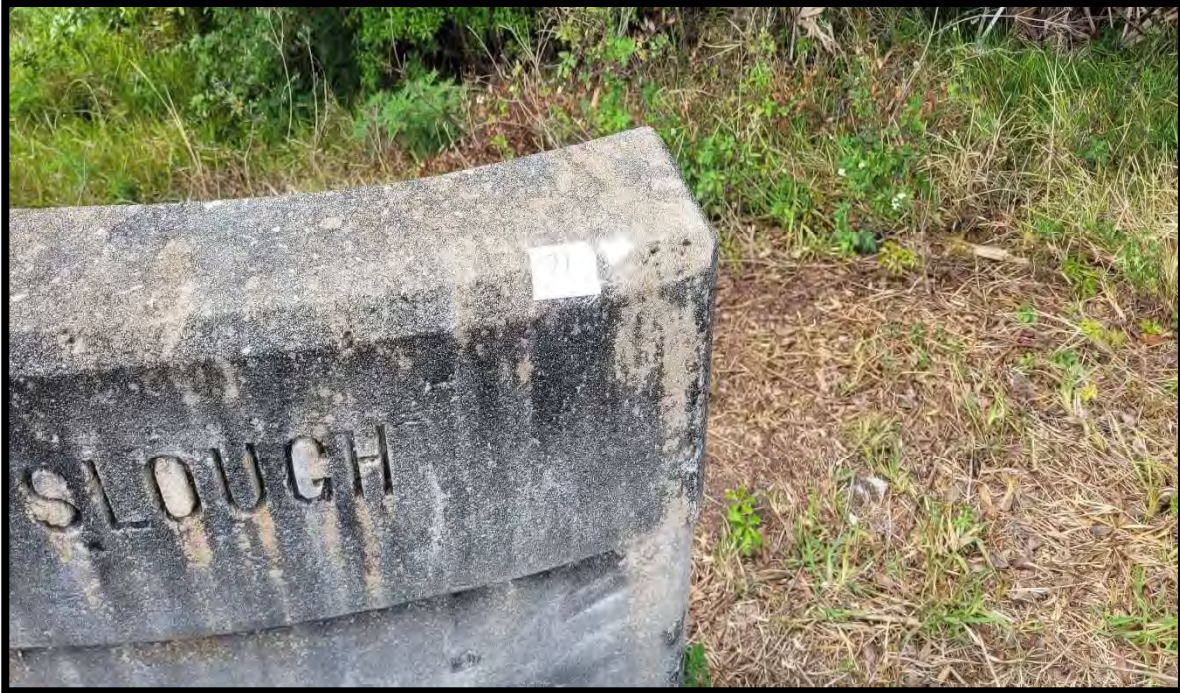
Photograph 71

View of Asbestos Homogeneous Area 24 – Concrete – Landside Buttress of Bridge 910002 (Sample Location 71).

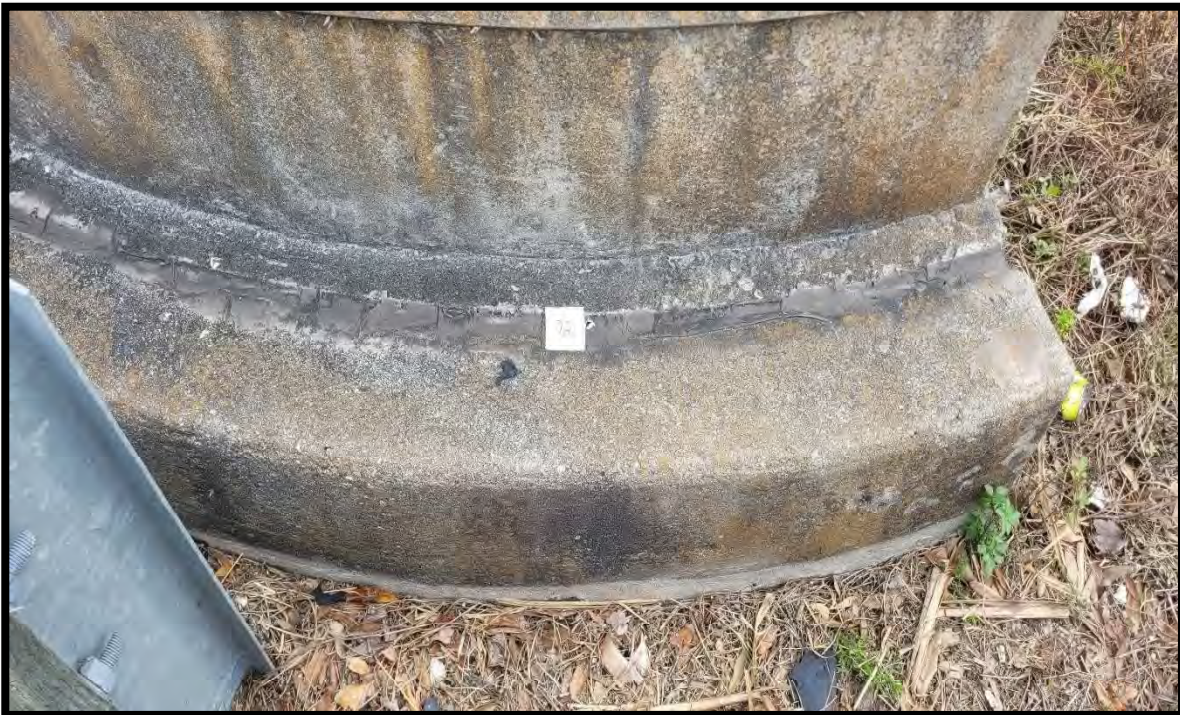
Photograph 72

View of Asbestos Homogeneous Area 25 – Grey Sealant – Seams, Cracks of Bridge 910002 (Sample Location 72).

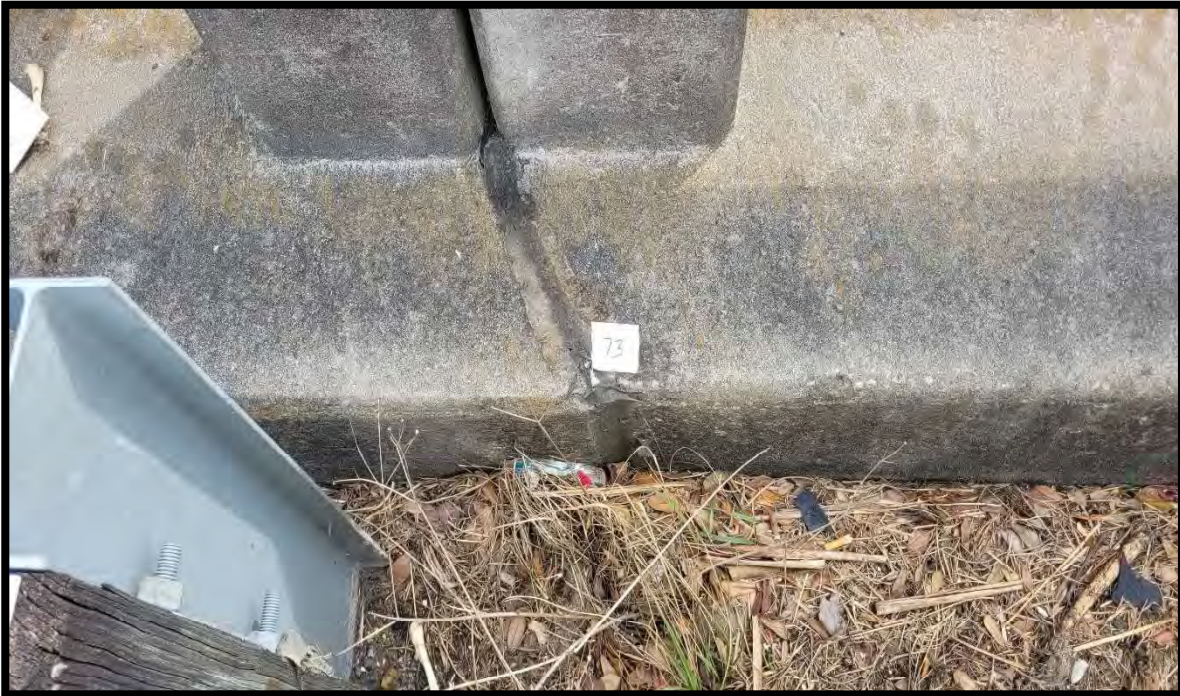
Photograph 73

View of Asbestos Homogeneous Area 25 – Grey Sealant – Seams, Cracks of Bridge 910002 (Sample Location 73).

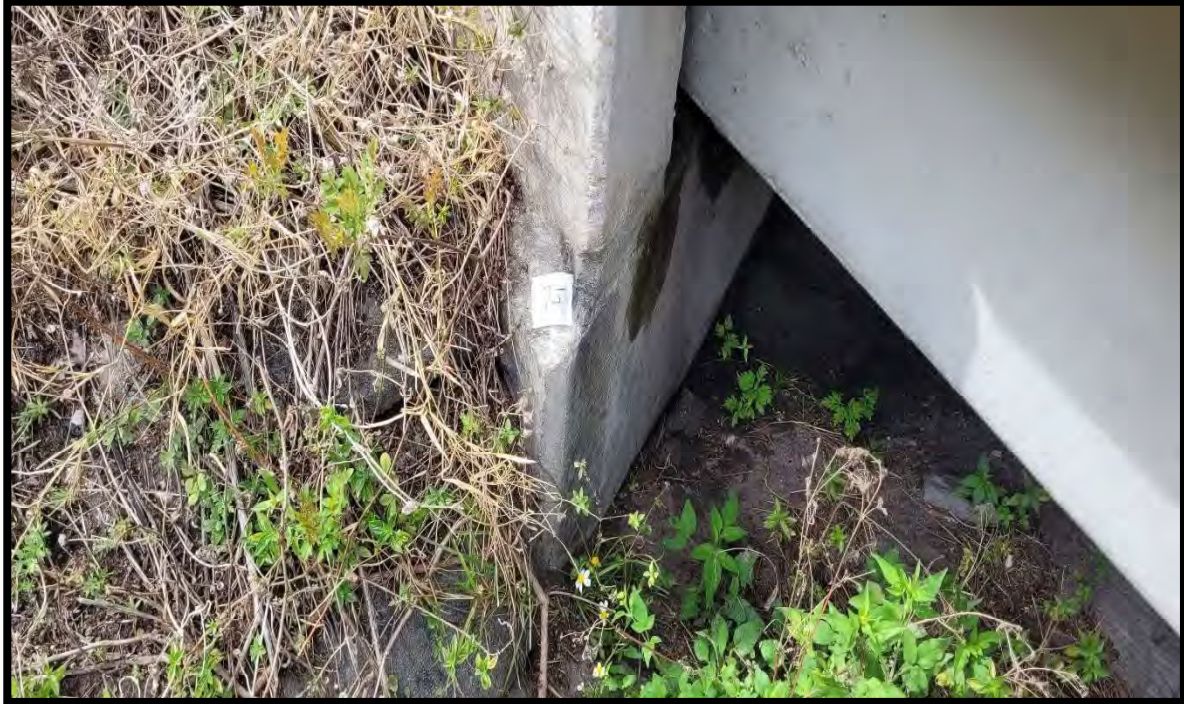
Photograph 75

View of Asbestos Homogeneous Area 26 – Concrete – Pylon Cap, Perpendicular Support Beam of Bridge 910002 (Sample Location 75).

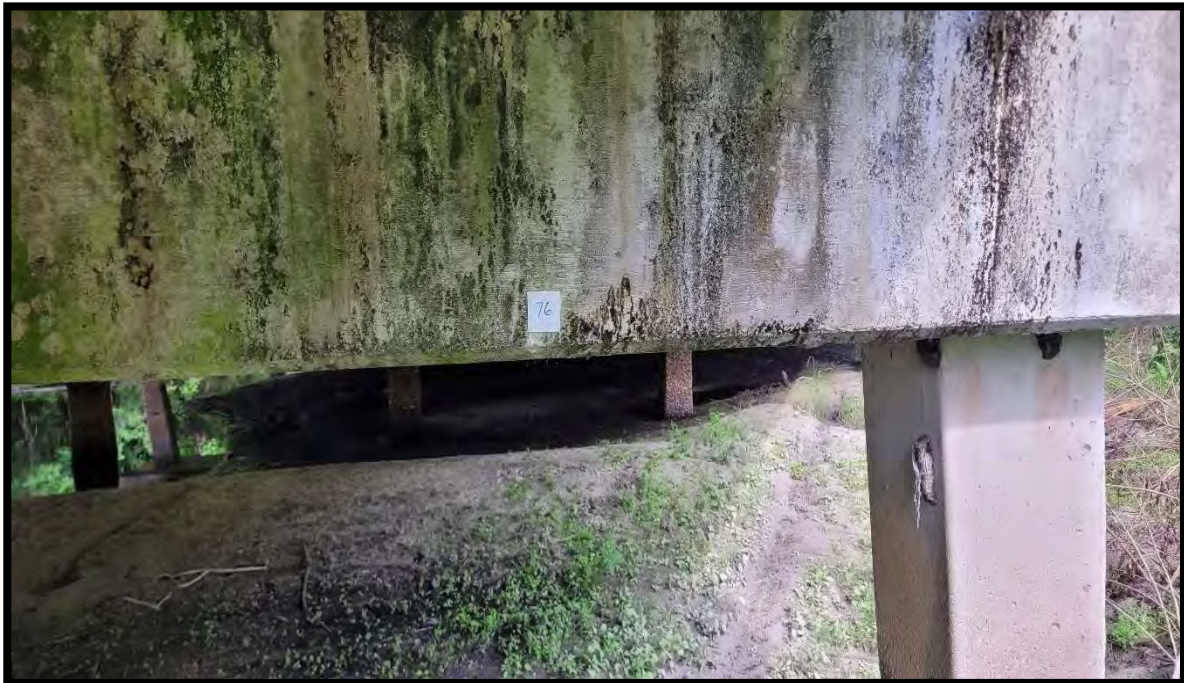
Photograph 76

View of Asbestos Homogeneous Area 26 – Concrete – Pylon Cap, Perpendicular Support Beam of Bridge 910002 (Sample Location 76).

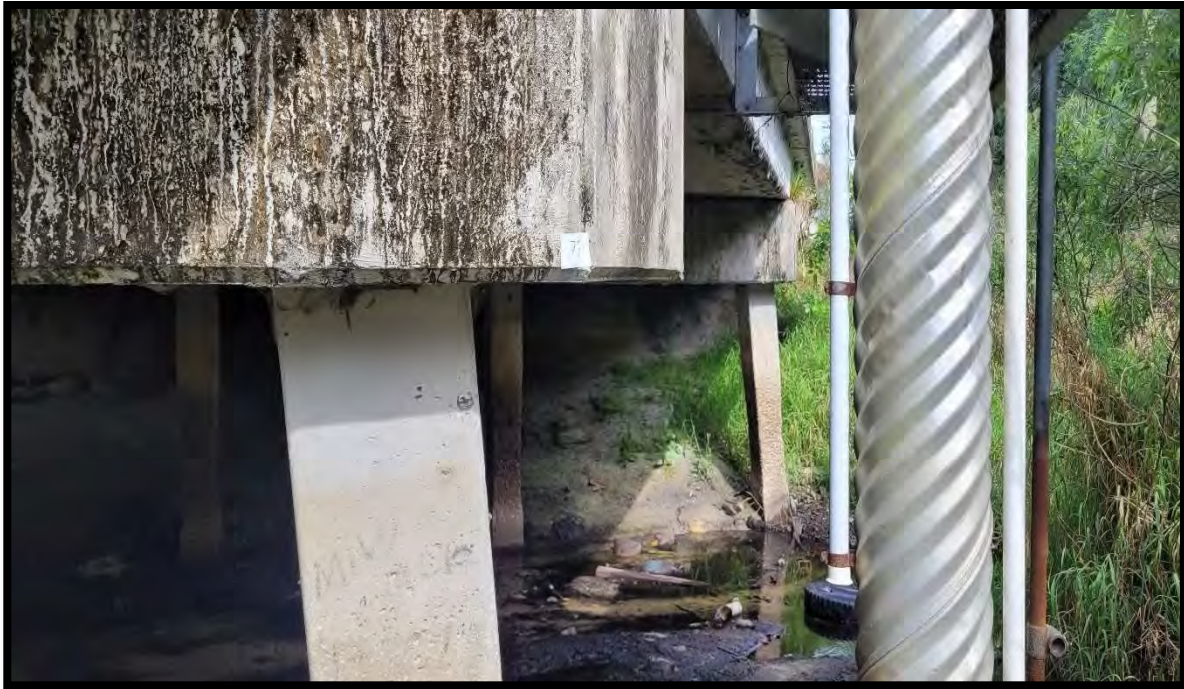
Photograph 77

View of Asbestos Homogeneous Area 26 – Concrete – Pylon Cap, Perpendicular Support Beam of Bridge 910002 (Sample Location 77).

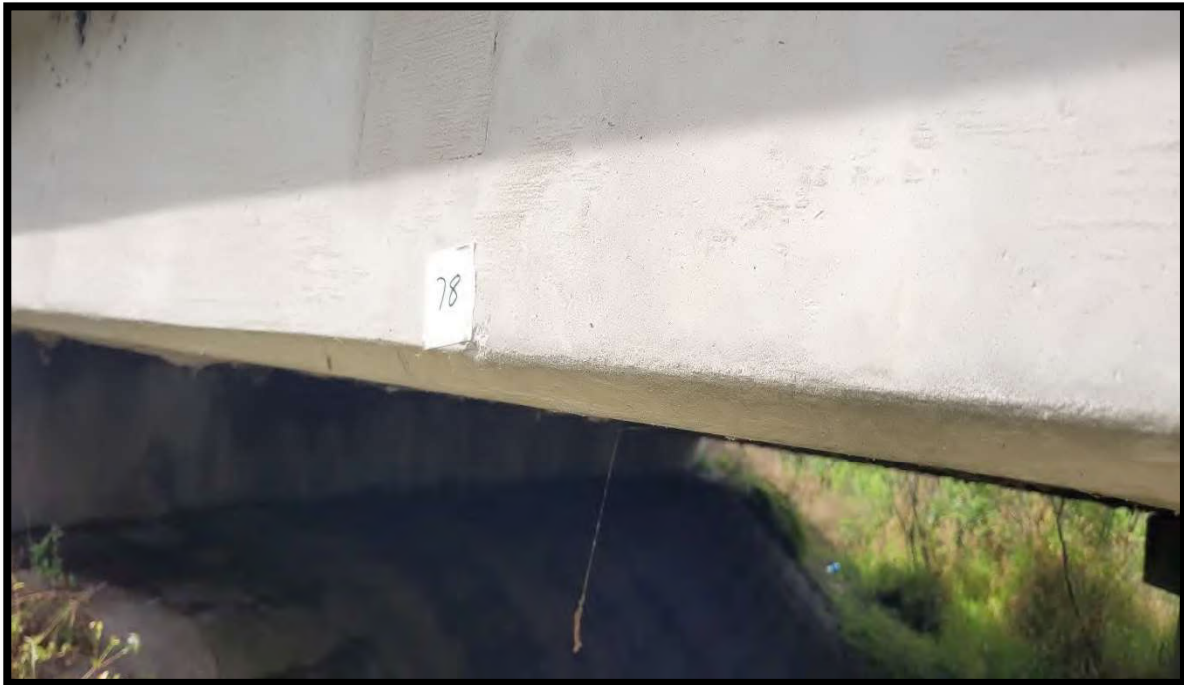
Photograph 78

View of Asbestos Homogeneous Area 27 – Concrete – Bridge Slab, Support In Lieu of I-Beam of Bridge 910002 (Sample Location 78).

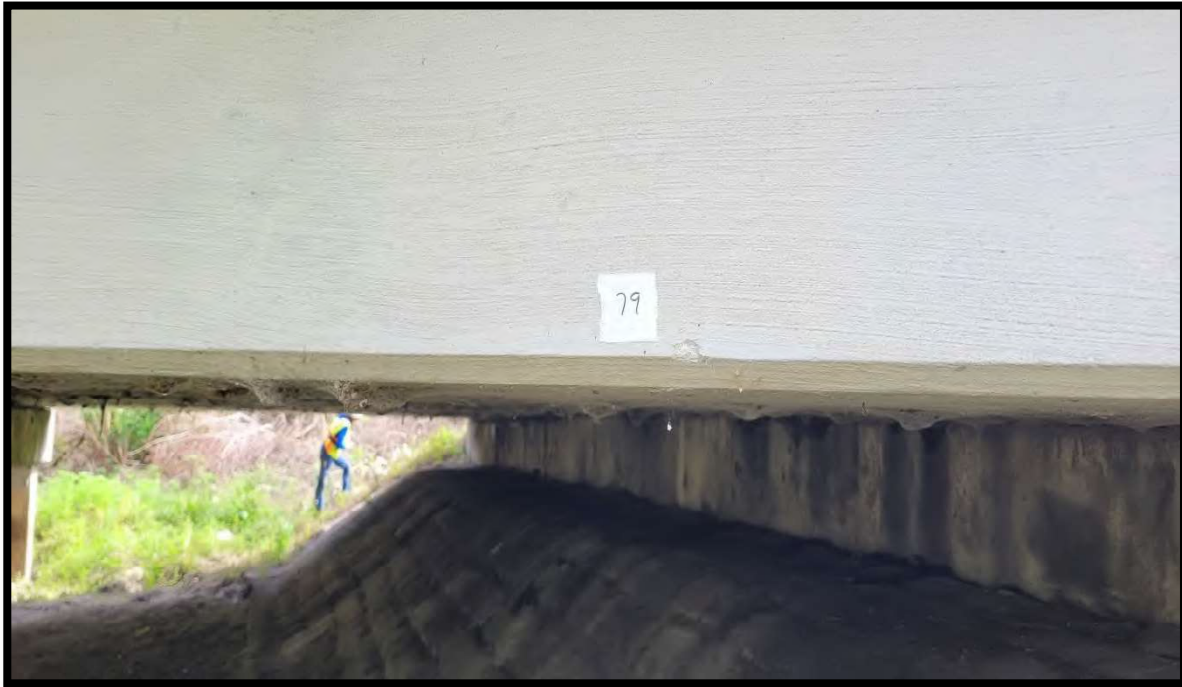
Photograph 79
View of Asbestos Homogeneous Area 27 – Concrete – Bridge Slab, Support In Lieu of I-Beam of Bridge 910002
(Sample Location 79).

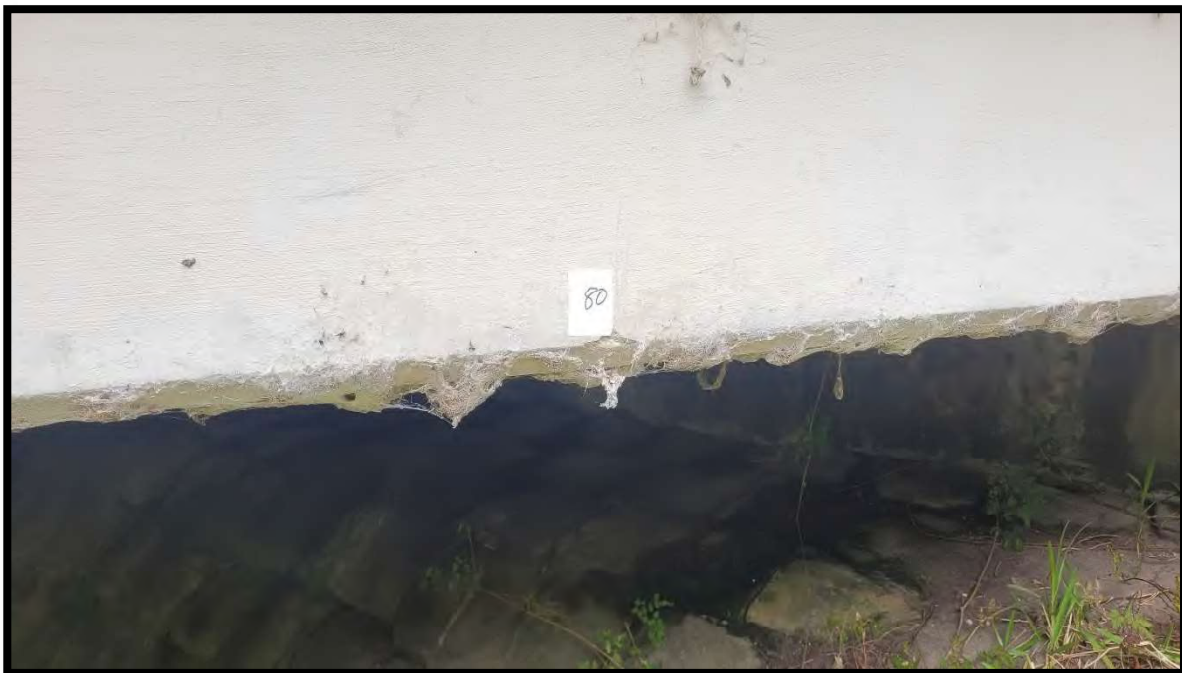
Photograph 80
View of Asbestos Homogeneous Area 27 – Concrete – Bridge Slab, Support In Lieu of I-Beam of Bridge 910002
(Sample Location 80).

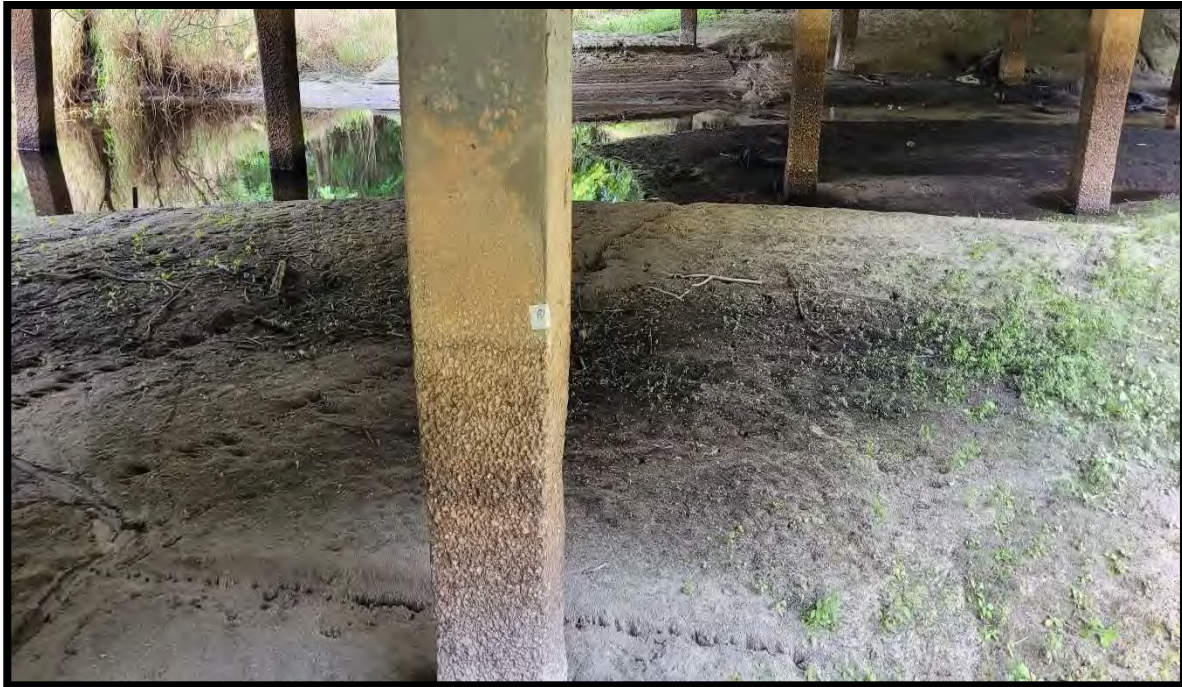
Photograph 81

View of Asbestos Homogeneous Area 28 – Concrete – Support Pylon of Bridge 910002 (Sample Location 81).

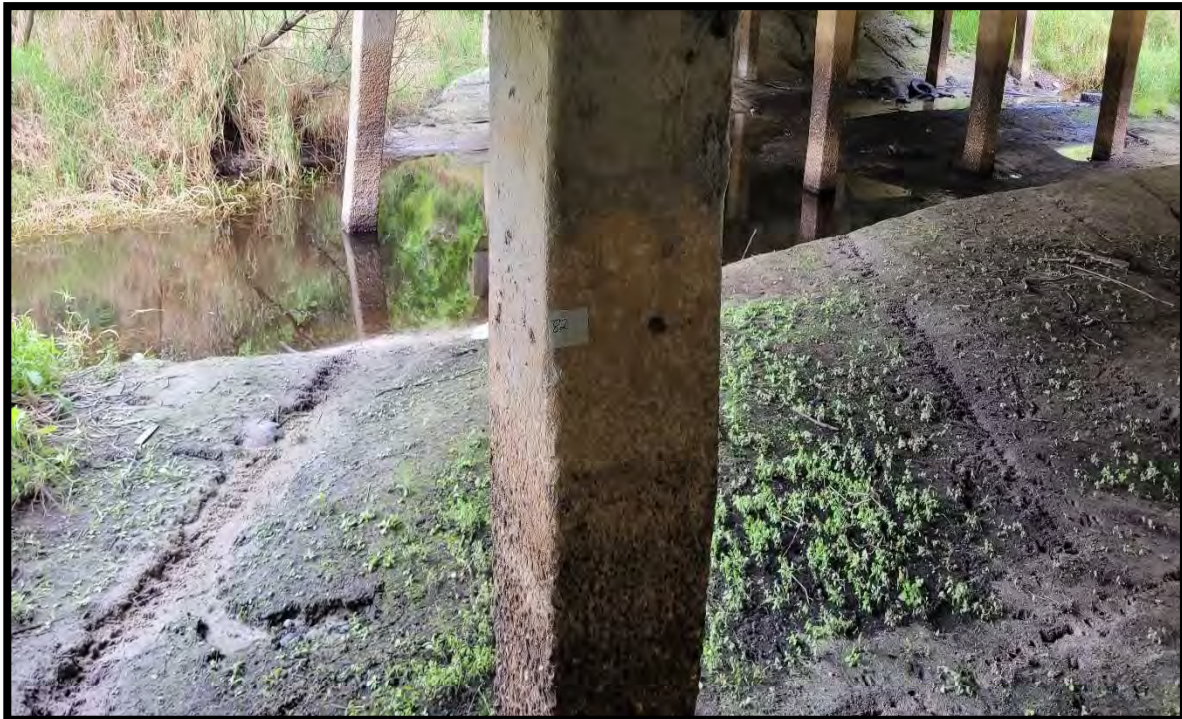
Photograph 82

View of Asbestos Homogeneous Area 28 – Concrete – Support Pylon of Bridge 910002 (Sample Location 82).

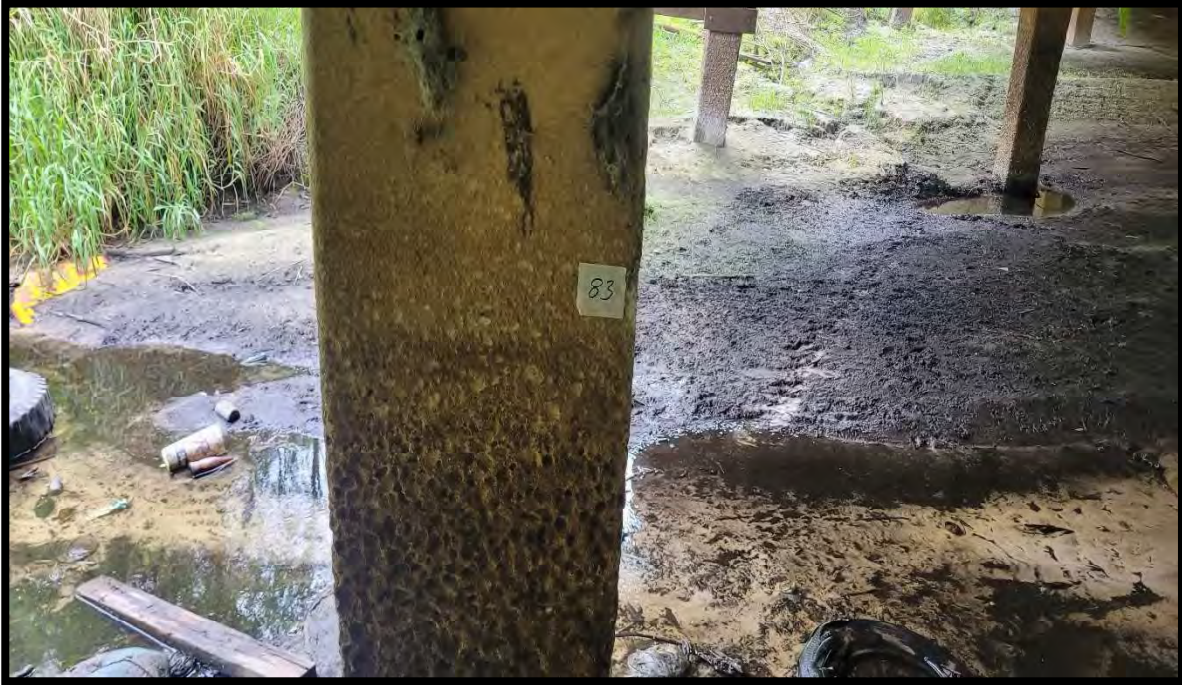
Photograph 83

View of Asbestos Homogeneous Area 28 – Concrete – Support Pylon of Bridge 910002 (Sample Location 83).

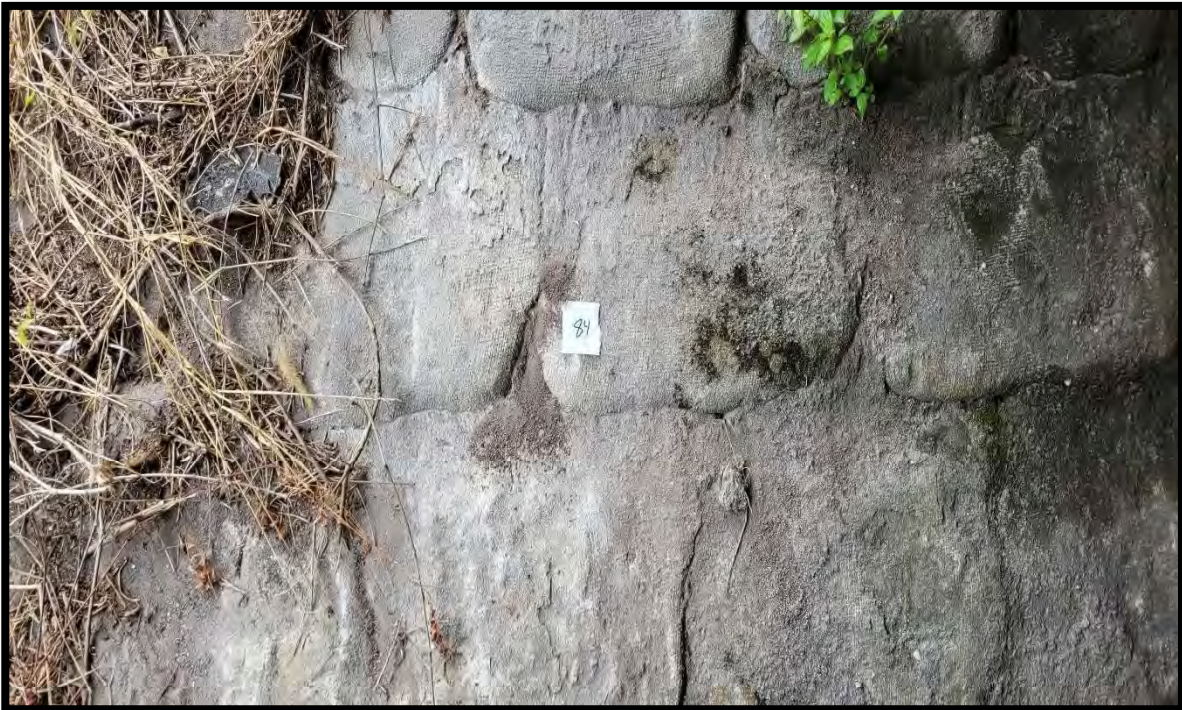
Photograph 84

View of Asbestos Homogeneous Area 29 – Concrete – Rip-Rap of Bridge 910002 (Sample Location 84).

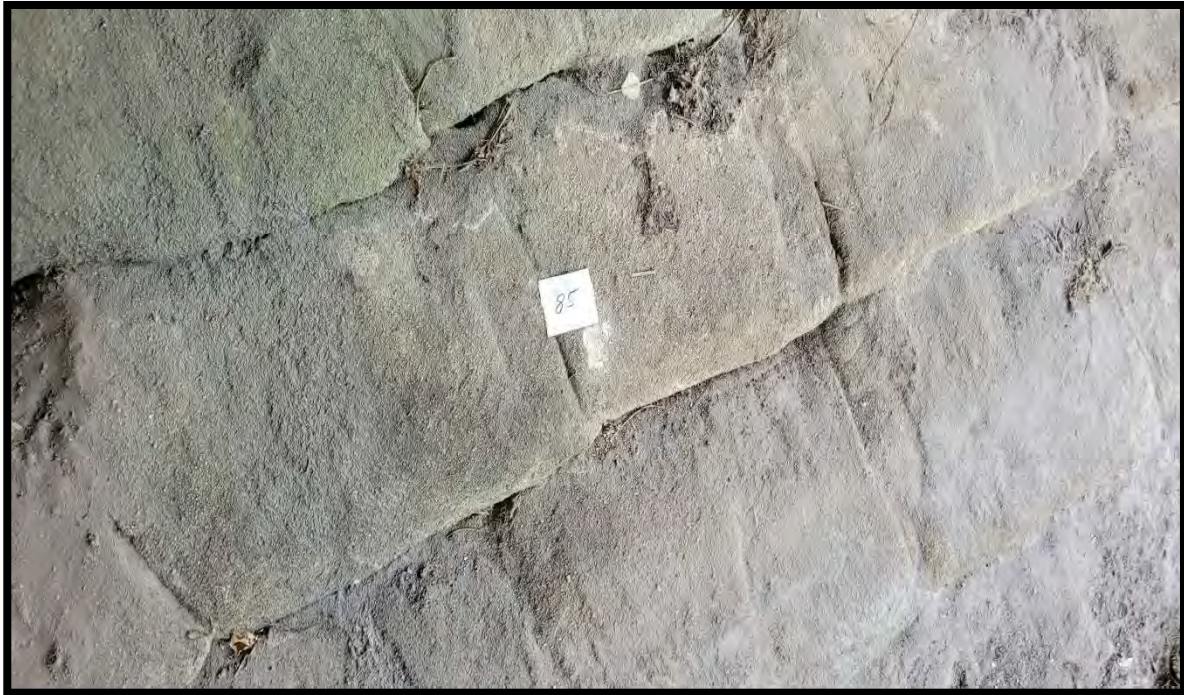
Photograph 85

View of Asbestos Homogeneous Area 29 – Concrete – Rip-Rap of Bridge 910002 (Sample Location 85).

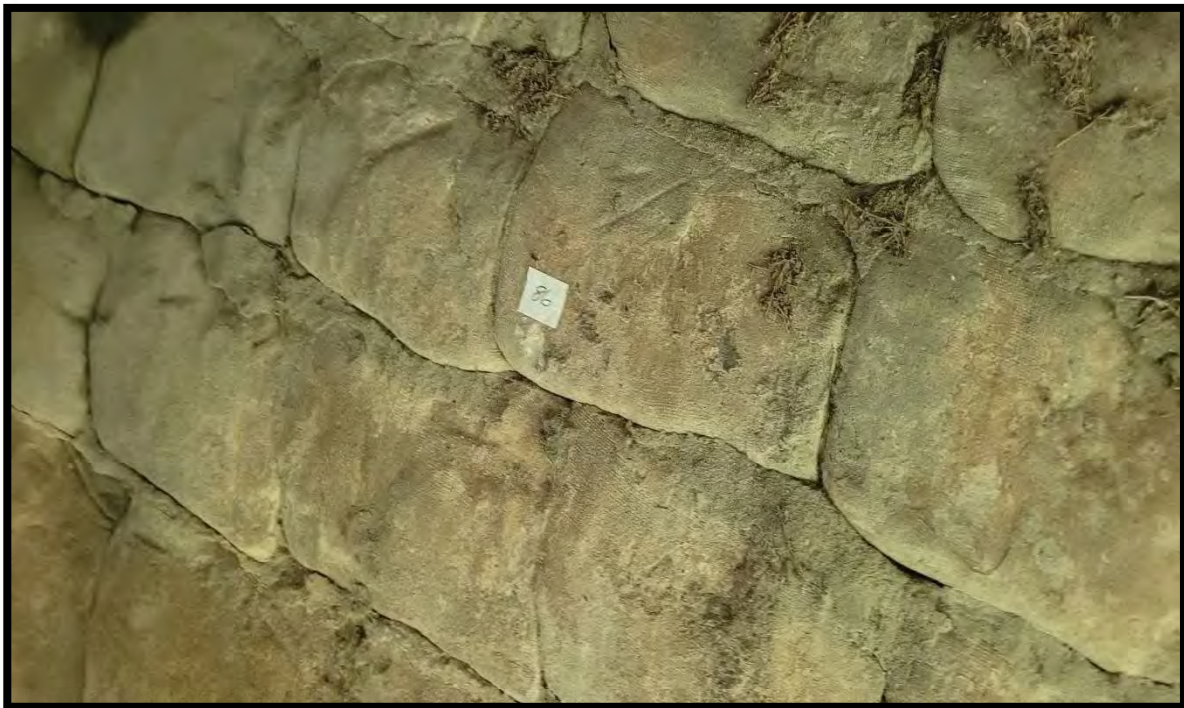
Photograph 86

View of Asbestos Homogeneous Area 29 – Concrete – Rip-Rap of Bridge 910002 (Sample Location 86).

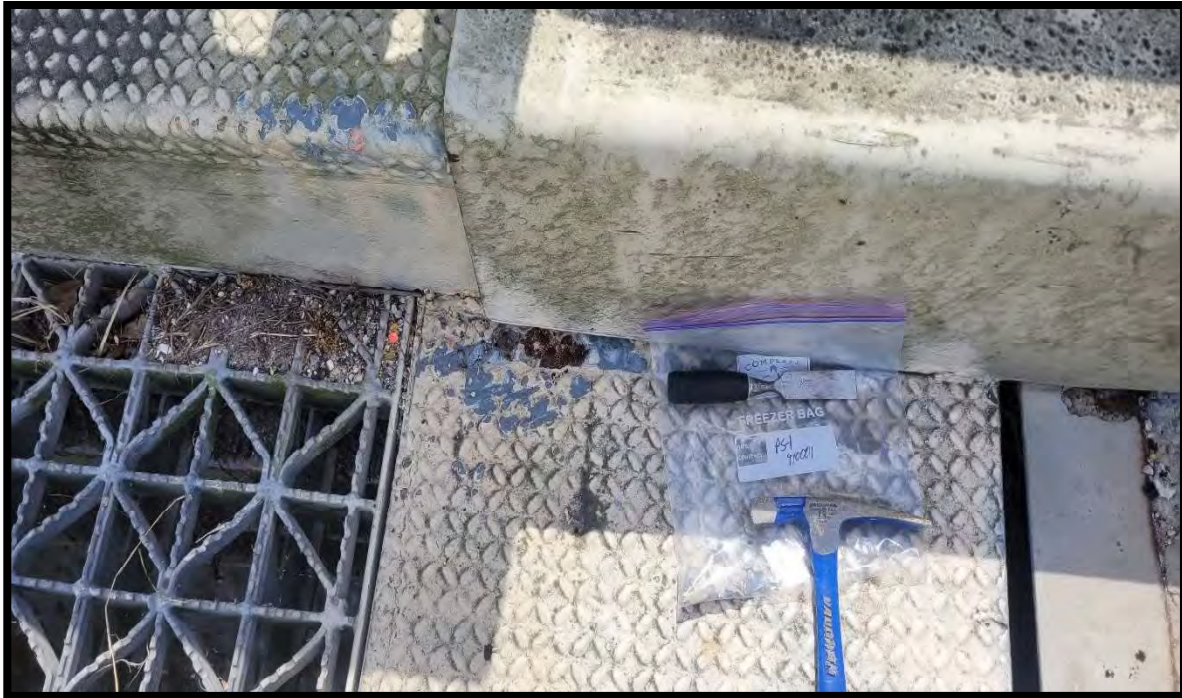
Photograph 87
View of Metal Based Coatings Sample PS-1 Tan Coating – Bridge 910001.

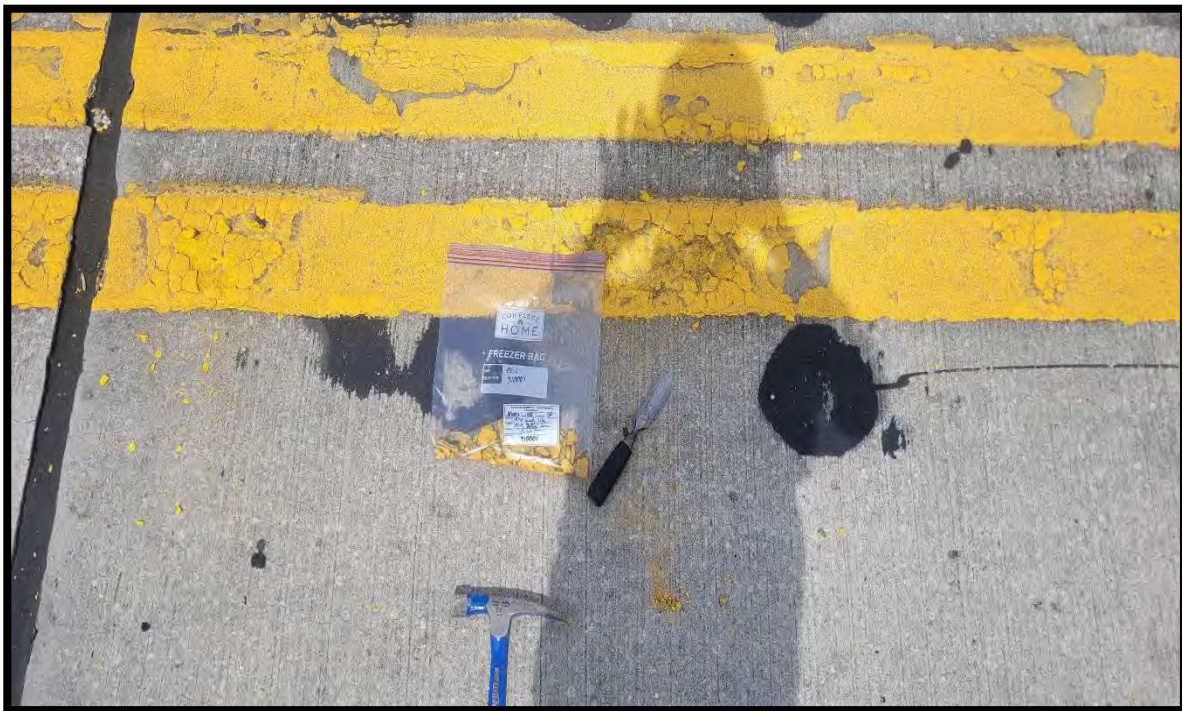
Photograph 88
View of Metal Based Coatings Sample PS-2 Yellow Lane Paint – Bridge 910001.
