DRAFT CONTAMINATION SCREENING EVALUATION REPORT

S.R. 70 PD&E Study

Limits of Project: From C.R. 721 S to C.R. 599/128th Avenue

Highlands and Okeechobee Counties, Florida

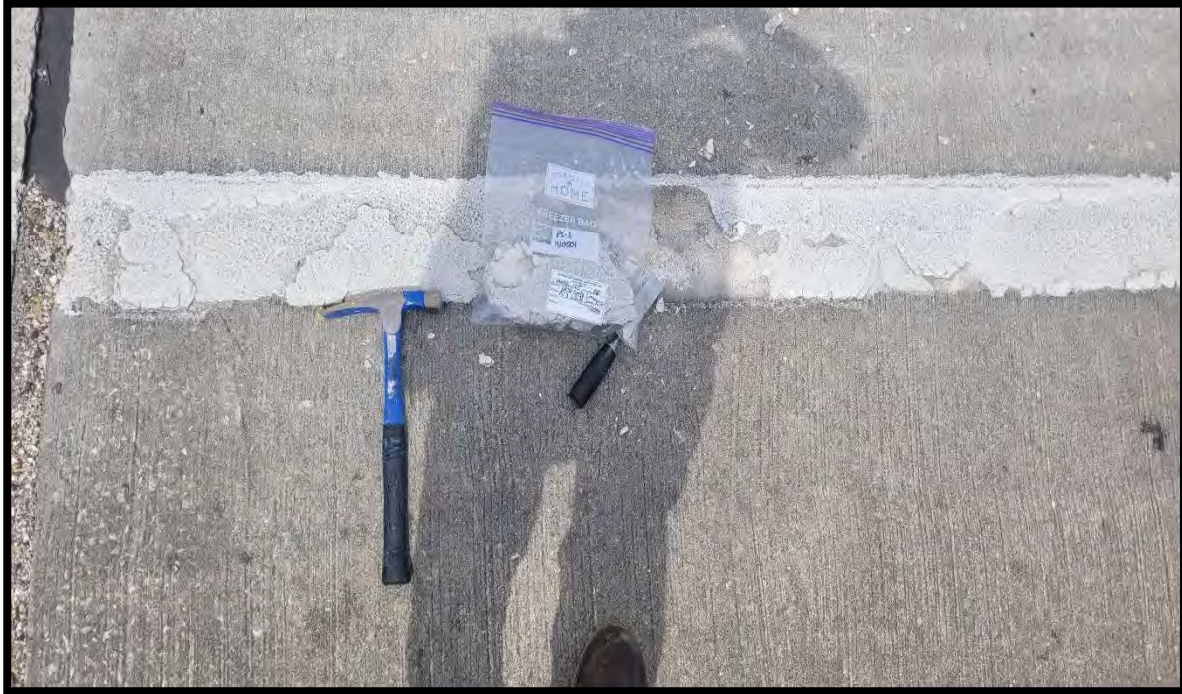
Photograph 89
View of Metal Based Coatings Sample PS-3 White Lane Paint – Bridge 910001.

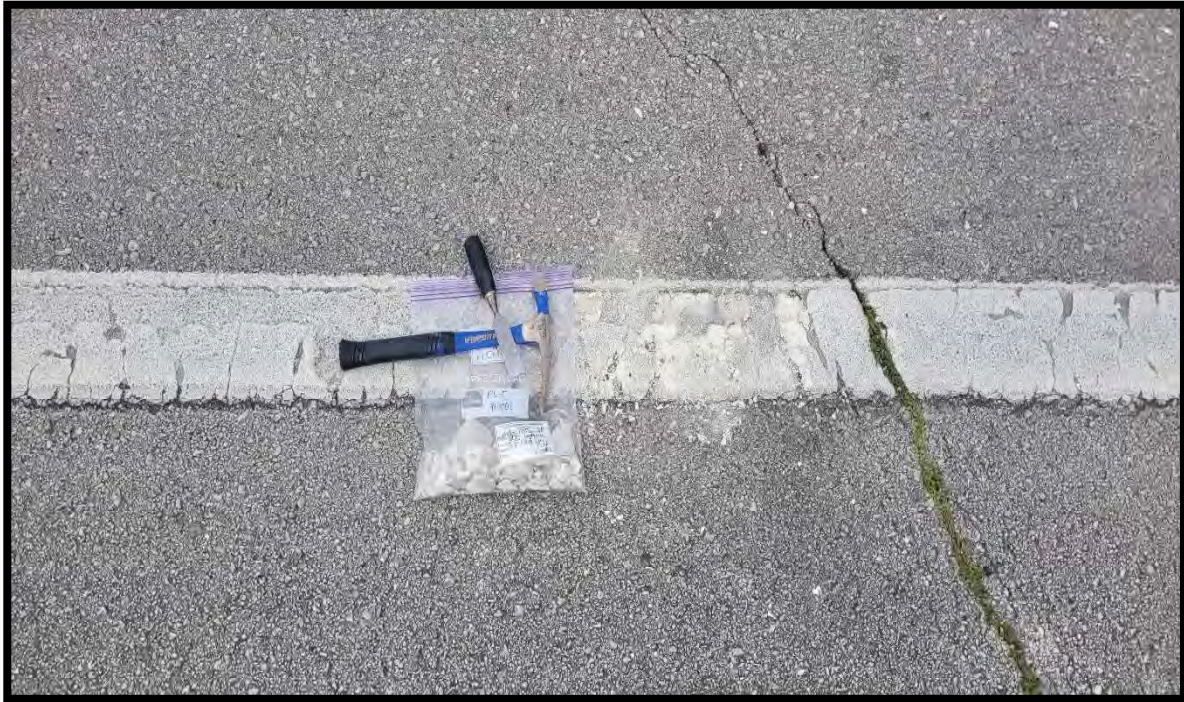
Photograph 91
View of Metal Based Coatings Sample PS-5 White Lane Paint – Bridge 910002.
